Product Safety Recall

N212333380 Rear Seat Belt Retractor Bolt Not Installed

Release Date: September 2021

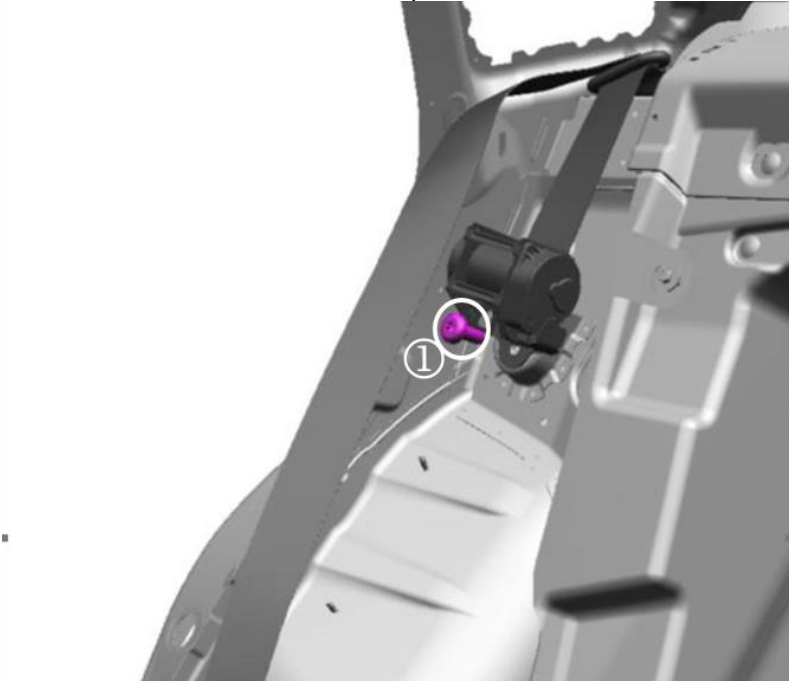
5893822

2. Check for the presence of a bolt at location (1), the seat belt retractor anchor.
 - If a bolt is present, using a torque wrench, ensure the bolt is torqued to 33 lb-ft (45 N-m).
 - If a bolt is **NOT** present, **OR** a bolt is present but not fully seated install a new bolt and run down the bolt until it is fully seated. These are self-tapping bolts, so it is normal for no threads to be present if the bolt is not installed.
 - Install the bolt, and then torque the bolt to 33 lb-ft (45 N-m).
3. Reinstall the Quarter Window Lower Trim Finish Panel. Refer to *Quarter Window Lower Trim Finish Panel Replacement* in SI.

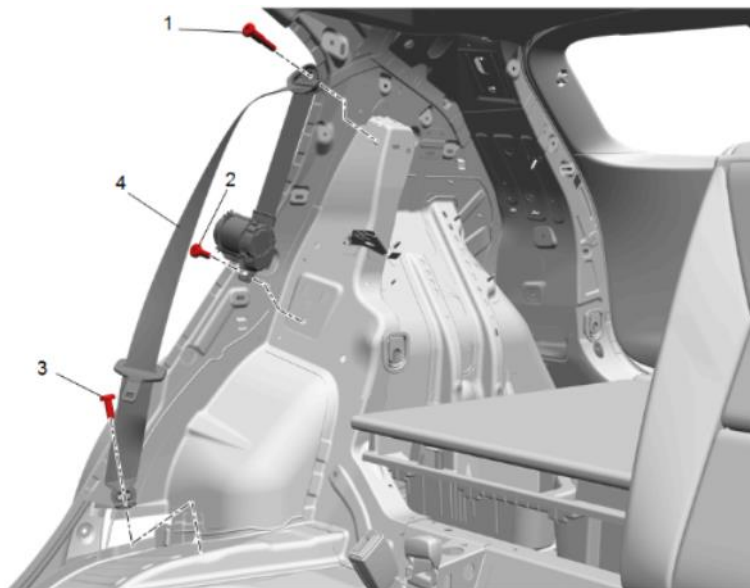
5081235

2. Check for the presence of a bolt at location (2), the seat belt retractor anchor, on **both** sides of the vehicle.
 - If a bolt is present, using a torque wrench, ensure the bolt is torqued to 33 lb-ft (45 N-m).
 - If a bolt is **NOT** present, **OR** a bolt is present but not fully seated, install a new bolt and run down the bolt until it is fully seated. These are self-tapping bolts, so it is normal for no threads to be present if the bolt is not installed.
 - Install the bolt, and then torque the bolt to 33 lb-ft (45 N-m).
3. Reinstall the Quarter Lower Rear Trim Panels. Refer to *Quarter Lower Rear Trim Panel Replacement* in SI.
