October 2021
FL900A
NHTSA #21V-689
Transport Canada #2021-545

Subject: Cascadia Drag Link Tapered Joint

Models Affected: Specific model years 2019-2021 Freightliner Cascadia vehicles manufactured April 2, 2018, through July 14, 2020.

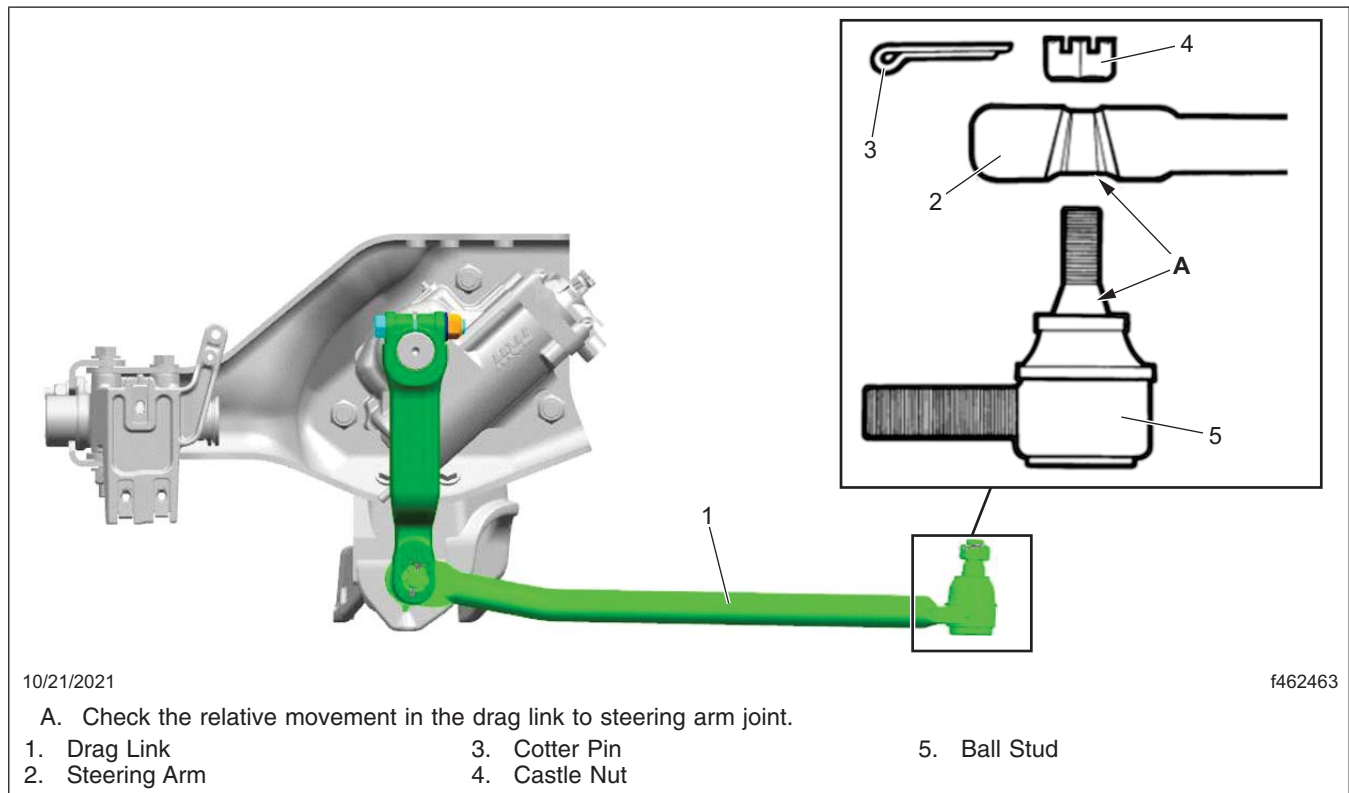
Fig. 1, Drag Link to Steering Arm Joint

1. Check the base label (Form WAR259) for a completion sticker for FL900 (Form WAR261) indicating this work has been done. The base label is usually located on the passenger door about 12 inches (30 cm) below the door latch. If a sticker is present, no work is needed. If there is no sticker, proceed with the next step.
2. Park the vehicle on a level surface, apply the parking brakes, and chock the rear tires.
3. Open the hood.
4. Using your DTNAConnect credentials, go to https://dtnacontent-dtna.prd.freightliner.com/content/dam/techlit/video/chassis/46_steering/Loose_Draglink_Unit32K_2.mp4 to watch a reference video that shows a drag link steering arm joint with movement present. Notice an audible knocking sound.
5. Observe the behavior of the drag link steering arm joint. See [Fig. 1](#).

5.2 While the steering wheel is being turned, check the behavior of the drag link to steering arm joint.

- The castle nut appears to be loose.
- The cotter pin is not in place.
- There is relative movement in the drag link to steering arm joint when the steering wheel is moved back and forth.

YES → Go to **Drag Link and Steering Arm Replacement** procedure.
