IMPORTANT SAFETY RECALL

NHTSA Safety Recall
No. 21V-722

CSN 833

Rotation Bearing Washer Inspection

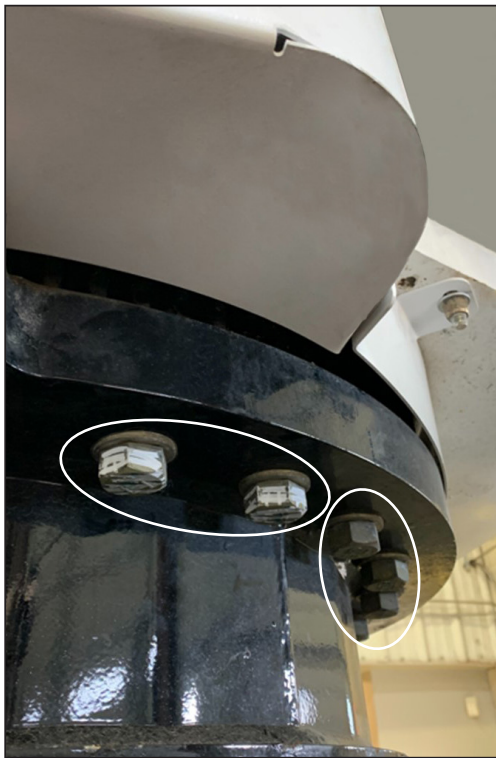
Figure 1 — Outer Race Rotation Bearing Cap Screws and Washers

1. Position the unit on a level surface, apply the parking brake, and turn off the engine. Remove the key from the ignition, and secure it following your employer's vehicle lockout/tagout procedure. Chock the wheels.
2. Locate the rotation bearing outer race mounting cap screws and washers under the top plate of the pedestal (refer to Figure 1).
3. Using a flashlight or work light, look closely at the washer shown as number 1 in Figure 2 to determine if the washer is overlapping the weld next to the pedestal wall (refer to Figures 3 and 4). Mark Figure 5 to indicate the inspection result for this washer.
