## **TECHNICAL INSTRUCTIONS**

### **SAFETY RECALL 21TA07**

#### **VEHICLE MAY LOSE MOTIVE POWER WHILE DRIVING**

#### **CERTAIN 2022 MODEL YEAR PRIUS AND PRIUS PRIME VEHICLES**

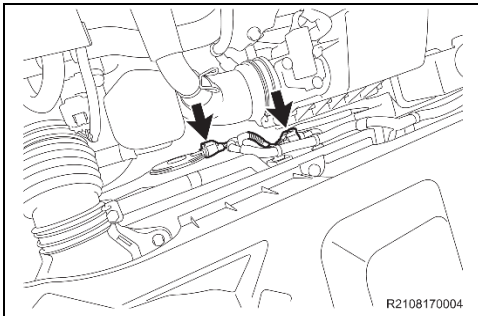
#### 1. DISCONNECT COOLING FAN

**If the cooling fans run during the Calibration update procedure, the battery voltage will be inconsistent and could cause damage to the control module(s).**

- a. Disconnect the 2 electrical connectors from the cooling fan on the radiator fan shroud.
