IMPORTANT SAFETY RECALL This notice applies to your vehicle. See attached serial number list.

NHTSA Safety Recall No. 21V-736

Customer Service Notice

Mounting Frame Inspection (Replaces SIL 809 and SIL 820)

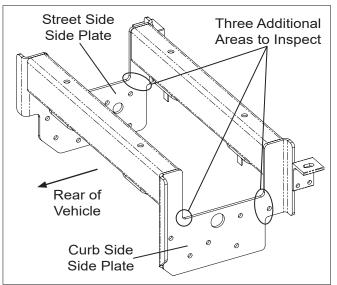
Figure 4 – Mounting Frame Additional Inspection

- 1. Keep the unit set up as in Inspection Procedure A step 1.
- 2. Use a wire brush to remove any paint and rust from the other three corners of the mounting frame (refer to Figure 4).
- 3. Using a flashlight, inspect the outer surface and the rounded corners of the other three corners of the mounting frame as shown in Figure 4 for the extent of any cracking in the steel plate.
 - If there is no cracking in any of these three areas, order the kit as specified on page 1, and install it before putting the unit back into service.
 - If there is cracking in any of these three areas, call 1-270-505-1532 to speak to Telecom Product Support or email Telecom.Product.Support@altec.com to obtain further direction on repair.
