CR220 – Side Stand Replacement

Hypermotard 950 SP Model Year 2019
Safety Recall Campaign SRV-RCL-21-011

Date: September 28, 2021
To: Dealer Principal, General Manager, Service Manager, North American Dealer Network
From: Richard Kenton, Technical Director
Eric Bradley, Technical Training and Publications Manager

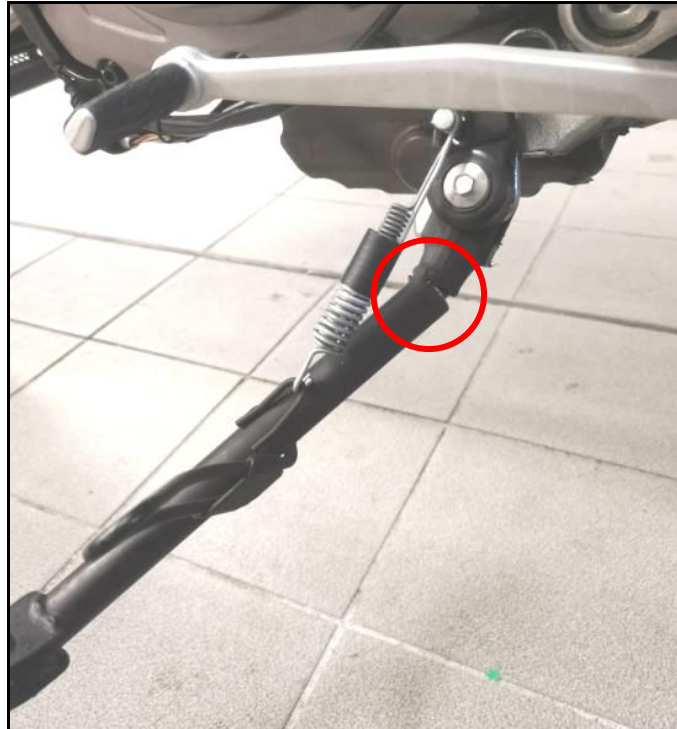
Ongoing product quality testing and field reports have identified a potential problem in the production process by the side stand supplier on a small batch of the above-mentioned motorcycles. There is a risk that the side stand could break at the weld that joins the side stand tube with the upper forged section, leading to an excessive inclination of the motorcycle when parked and, in rare cases, to a potential tip over.

For all involved vehicles, the side stand must be replaced with a new one with part no. 55610702BA. When replacing the side stand, you will also be required to replace the retaining pin part no. 82114632BB to ensure the proper installation of a new assembly.
