# Thor Motor Coach Recall Repair Instructions

Recall #	<b>21V-755 2021-598</b>		
Description/Title:	<b>18M Rize/Scope LP Hose</b>		
Affected Product Line(s):	<b>Certain model year 2022 18M Rize and Scope motorhomes</b>		
Service Campaign # :	<b>RC000243</b>	Released Date:	<b>11/12/2021</b>
Repair Code:	<b>TMCRC10104V</b>	Document Date:	<b>11/12/2021</b>
Time Allowed:	<b>1.3</b>	Document Revision:	<b>A</b>

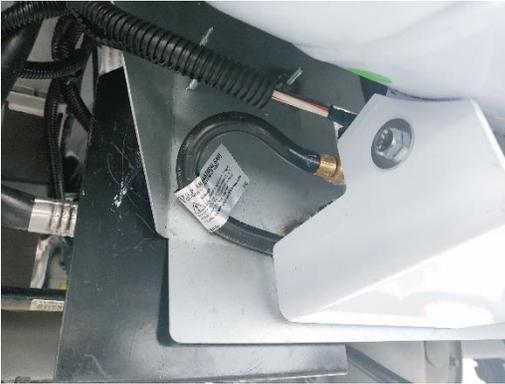
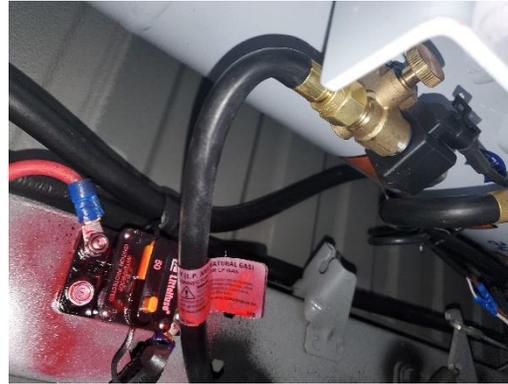
On certain model year 2022 Rize & Scope motorhomes, the LP hose between the solenoid valve and LP regulator was improperly installed at a 90-degree angle. In addition, the LP hose that was installed during production is too short and is causing the bend in the LP hose to become more prominent. Due to the bend in the line, the LP hose could rupture and possibly lead to a leak in the LP hose. This could cause a fire, which could result in serious injury or death.

*Examples of Improperly Installed LP Hose*

1. Remove the existing p-clamps.
2. Loosen the fittings where the hose goes into the tank and where the hose goes into the regulator.
3. Remove the LP hose.
4. Install the new, longer hose (54”) in the same way as the old one.
  - a. Ensure the hose sweeps where the fittings go into the regulator and tank.
  - b. Be sure to keep hose clear of any sharp edges.
5. Perform LP test to ensure everything is installed and working properly.
