EC22-002

ITB22-007

VOLUNTARY SAFETY RECALL CAMPAIGN 2014-2017 QX60 HYBRID; HYBRID POWERTRAIN CONTROL MODULE REPROGRAM

CAMPAIGN ID #: R21B4
APPLIED VEHICLES: 2014-2017 QX60 Hybrid (L50H)

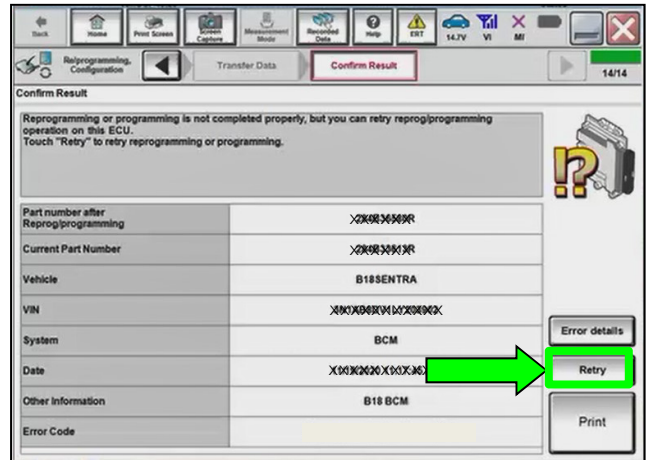
Figure 16

If reprogramming does not complete and the “!?” symbol displays as shown in Figure 16:

- Check battery voltage (12.0 – 15.5V).
- Ignition is ON, Engine is OFF.
- External Bluetooth® devices are OFF.
- All electrical loads are OFF.
- Select **Retry** and follow the on screen instructions.

NOTE: **Retry** may not go through on first attempt and can be selected more than once.

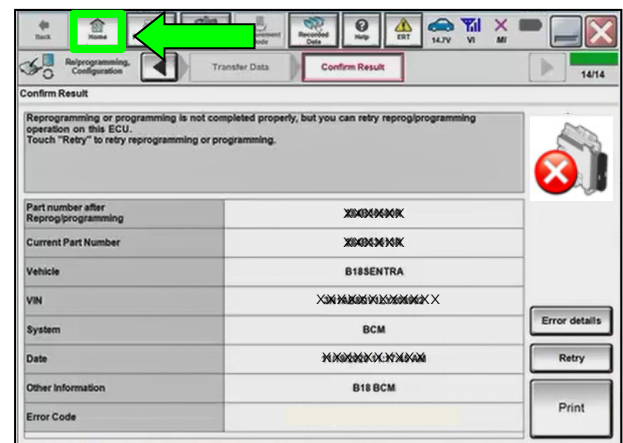
Figure 17

If reprogramming does not complete and the “X” symbol displays as shown in Figure 17:

- Do not disconnect the VI or shut down C-III plus if reprogramming does not complete.
- Check battery voltage (12.0 – 15.5V).
- CONSULT A/C adapter is plugged in.
- Ignition is ON, Engine is OFF.
- Transmission in Park.
- All C-III plus / VI cables are securely connected.
- All C-III plus updates are installed.
- Select **Home**, and then restart the reprogram procedure from the beginning.
