Service Bulletin

Bulletin #: 9152021

Subject:

Inform Aluma dealers and owners that have 8214HSTILT trailers and have front latch catch issues with the Rivet Nut coming loose from the front frame.

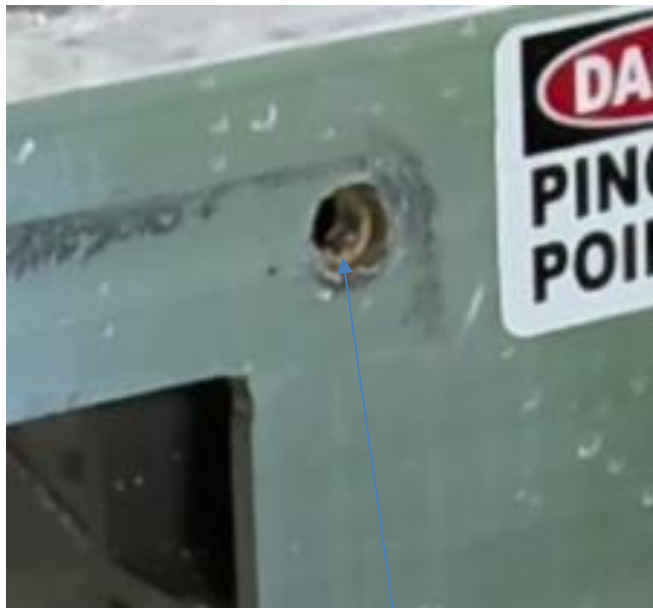
Figure 2

Rivet Nut shell

5. Using a drill with a 17/32" drill bit, drill out the two threaded Rivet Nut. Part of the Rivet Nut shell will remain in the front frame of the trailer. **See Figure 2**

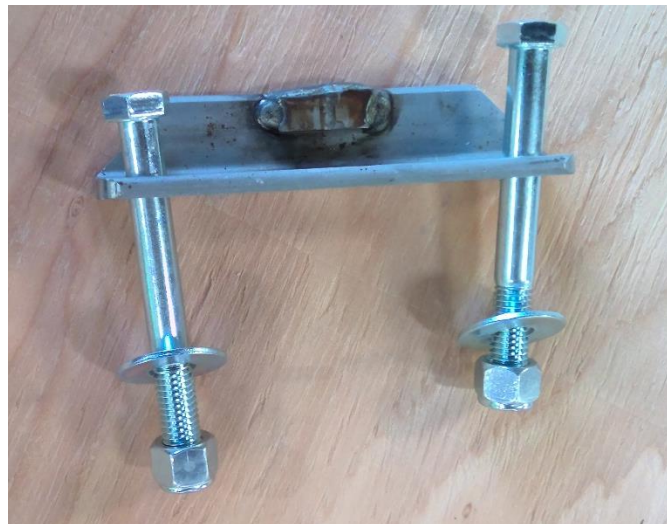
Figure 4

Items included from Aluma
for Bulletin 9152021

7. Reassemble using the new latch catch plate and provided hardware, of 2 - .5" X 4.5" stainless steel bolts, .5" Nylon Insert Lock Nuts, and .5" flat washer. Place both bolts through the latch catch and then into the holes you previously drilled out. Then place one washer on each bolt and then the Nylon Insert Lock Nuts. **See Figure 4**

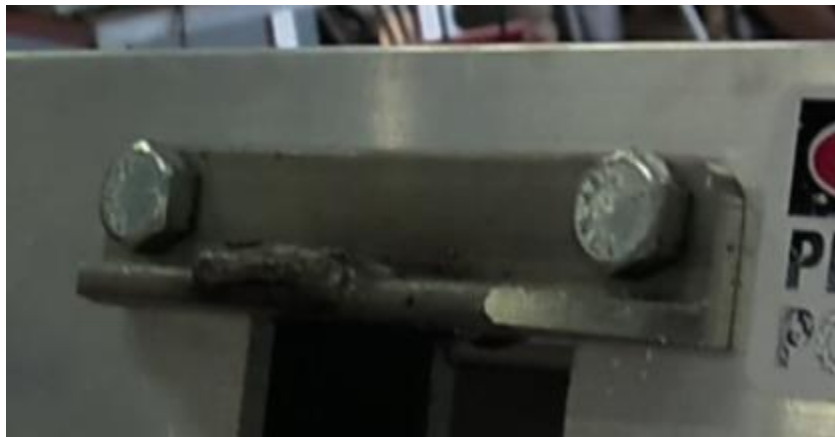
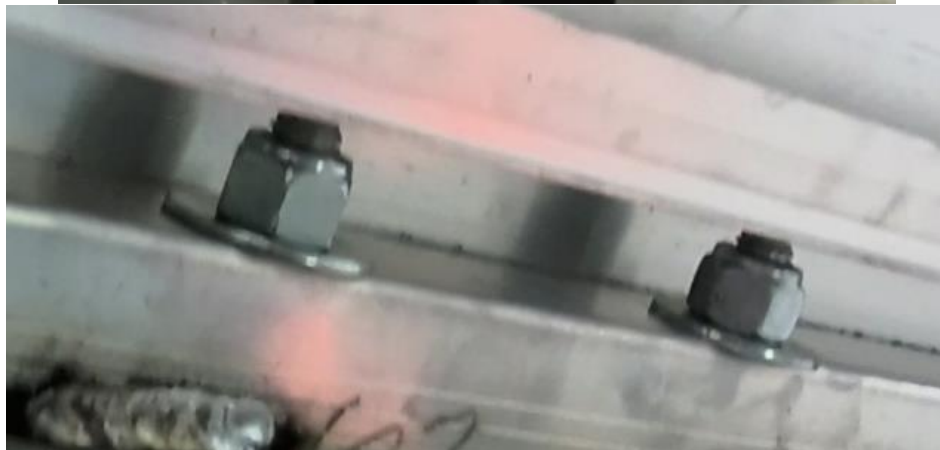
Photo of completed front and back of updates
