HUSQVARNA TECHNICAL BULLETIN HTB2110

OCTOBER 1, 2021

RECALL: THIS MODIFICATION HAS TOP PRIORITY AND MUST BE PERFORMED IMMEDIATELY TO ENSURE CUSTOMER SAFETY

CLUTCH SLAVE CYLINDER INSPECTION AND REPLACEMENT IF NEEDED

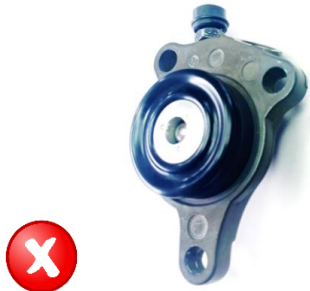
Husqvarna Motorcycles North America, Inc. has determined that a defect which relates to motor vehicle safety exists with certain 2018, 2019 and 2020 motorcycles listed above pertaining to the clutch slave cylinder. On affected motorcycles there is a possibility that the bellow style gasket can be damaged caused by deviations during assembly. Damage to the bellow gasket may affect the function of the clutch slave cylinder. This could result in the rider noticing a change in shifting behavior and the clutch becoming inoperable to the point where the clutch will not disengage when the clutch lever is pulled in. To ensure the highest level of safety, performance, reliability and customer satisfaction, it is necessary to replace the clutch slave cylinder on all affected motorcycles that have a bellow style gasket clutch slave cylinder mounted (Fig. 1).

The cause of the defect is due to design of the originally mounted clutch slave cylinder that has a bellow style gasket that can be damaged. To remedy this defect, a new clutch slave cylinder without the bellow style gasket must be installed on all affected motorcycles (Fig. 2).

Fig. 1 - Version with bellow style gasket
(p.n. 79432061144)

Some motorcycles might already have the new version clutch slave cylinder mounted from a customer replacement. Therefore it is first necessary to inspect the clutch slave cylinder to determine which version is installed. If the bellow style gasket clutch slave cylinder is mounted it must be replaced by the new version (p.n. 76132061044). If the new version is already mounted then you must reinstall the new style slave cylinder using a new gasket and o-ring on the slave cylinder and a new lock washer for the front sprocket to seal and remount the components properly.
