Dealer Operator/General Manager	Sales New Vehicles	Sales Used Vehicles	Business Manager (F&I)	Service	Parts & Accessories	Administration
Date: October 18, 2021		Source: Zero Motorcycles Customer Service Department

# Model Year 2020 Zero SR/F Rear Rotor Bolts Re-Torque Service Recall

## NHTSA Campaign Number: 21V-795

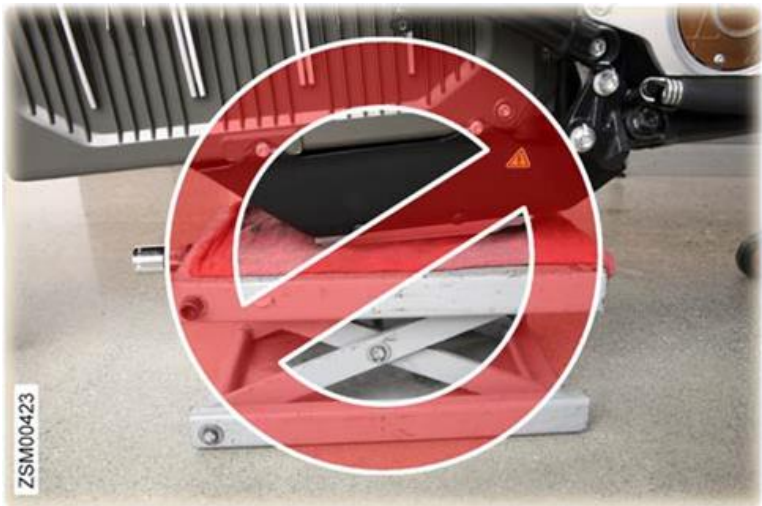
**CAUTION: Do not lift the Zero SR/F by placing a scissor jack or other lift under the controller carrier. Lifting the motorcycle in this manner could result in damage to the controller and other components.**

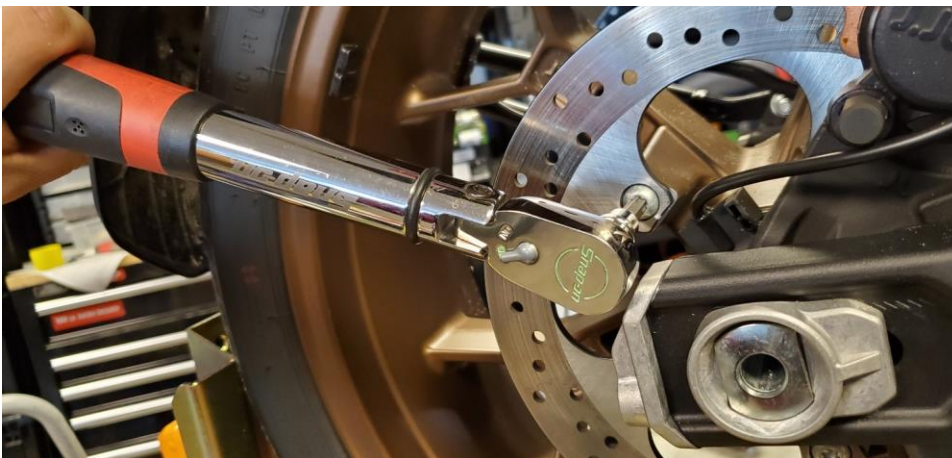
3. Using the T40 Star Drive Bit Socket and a Torque Wrench, re-torque the existing rotor bolts one at a time to 26 ft-lbs/36 Nm. The existing paint pen marks should reflect that the head of the bolt has rotated in this process.

4. If any of the rear rotor bolts is damaged or is removed first, it should be replaced. Remove such bolts one at a time and replace. Torque each bolt to the 26 ft-lbs/36 Nm.
