TO: Mercedes-Benz Dealer Principals, General Managers, Sales Managers, Service Managers, Parts Managers	FROM: Gregory Gunther, Department Manager, Vehicle Compliance and Analysis, Engineering Services
RE: <b>Recall Campaign Launch Notification</b> <b>Check All Seat Assemblies</b> <b>MY20-21 GLE-Class, GLS-Class and C-Class</b> <b>(167 and 205 platform)</b>	DATE: 11/24/2021

## Check All Seat Assemblies

Campaign No. 2021110010, November 2021

SUBJECT: **Model GLE-Class, GLS-Class and C-Class (167 and 205 platform)  
Model Year 2020-2021**

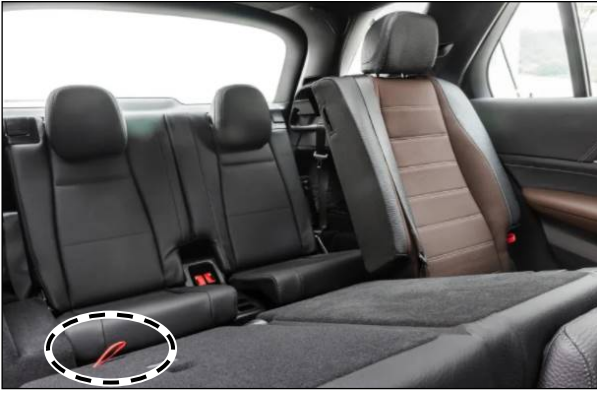
Figure 1

4. Check whether the switch for the seat backrest release (easy entry feature/seat release) and the emergency release strap (**figure 1**) are present at the second seat row.

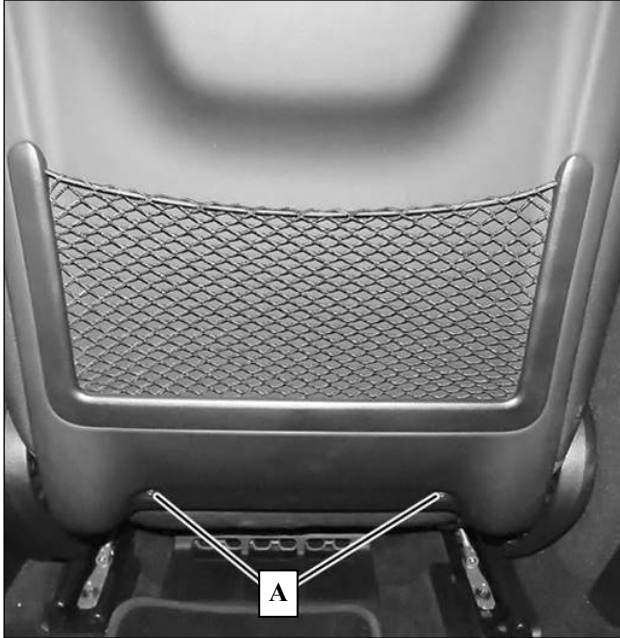
Figure 2

6. Check whether the threaded connections of the seat backrest trim (**A, figure 2**) at the front seats (driver and front passenger seat) are present and correctly attached.

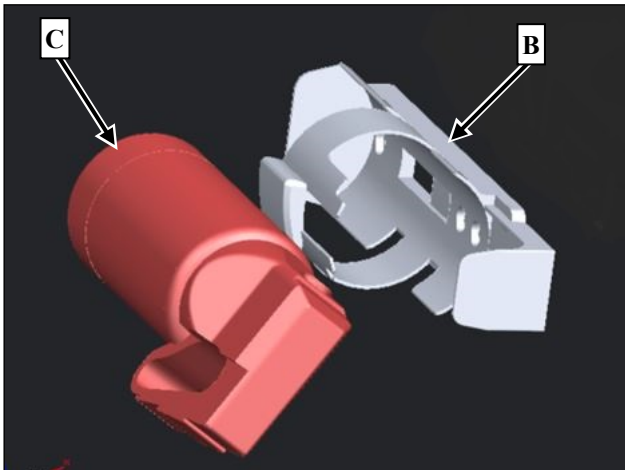
Figure 3

7. Check whether the fire extinguisher holder (**B**) at the driver's seat and fire extinguisher (**C**) are present (**figure 3**).

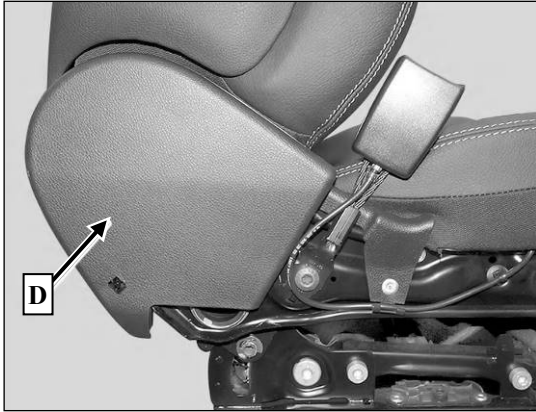
Figure 4

8. Check whether the side inner trims (**D, figure 4**) and side outer trims (**E and F, figure 5**) at the front seats (driver and front passenger seat) are present.

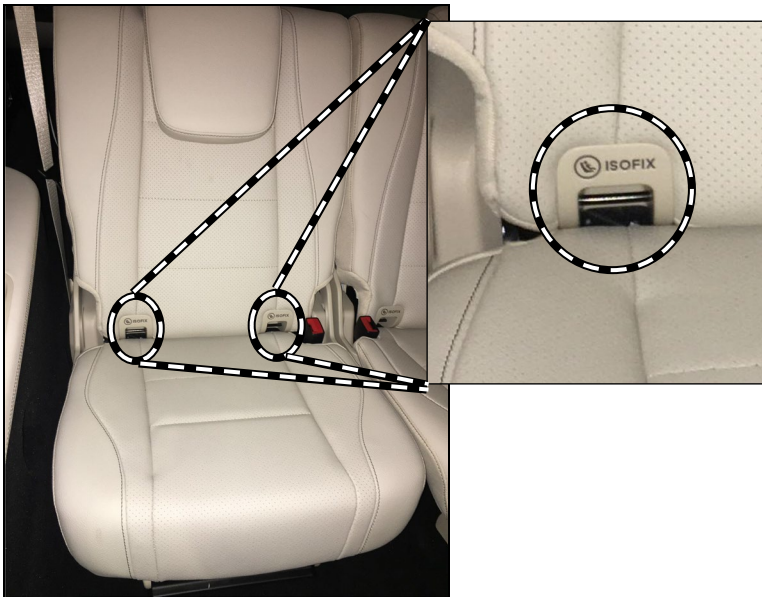
Figure 6

9. Check whether the covers for the child seat anchors at the second seat row are present and correspond to the correct equipment variant (**figure 6 - sample illustration**).

10. Check whether the covers for the child seat anchors at the third seat row are present and correspond to the correct equipment variant (figure 6 - sample illustration).

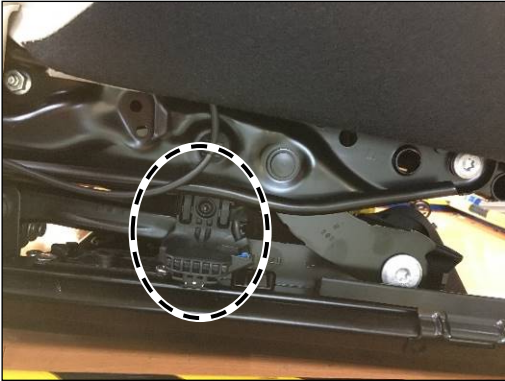
Figure 7

**i** The Hall sensors (figure 7) may **only** be installed in vehicles **with** code **494** (USA VERSION) or **460** (CANADA VERSION).

- i** The Hall sensor is located, in each case, on the inner side of the seat adjustment unit of the front seats.

**i** If the Hall sensors of the seat adjustment unit at the front seats have been installed in vehicles **without** code **494** (USA VERSION) or **460** (CANADA VERSION), the seat adjustment unit at the front seats must be replaced by the correct version in accordance with the vehicle equipment variant!

**i** If - in spite of code **494** (USA VERSION) or **460** (CANADA VERSION) - no Hall sensors and no associated cutout in the seat adjustment unit are present, the seat adjustment unit must be replaced by the correct equipment variant and the Hall sensor installed.
