Recall Campaign Bulletin

Campaign No. 2021110010, November 2021

SUBJECT: Model GLE-Class, GLS-Class and C-Class (167 and 205 platform)

Check All Seat Assemblies

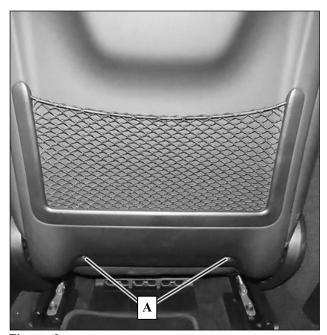
Figure 2

6. Check whether the threaded connections of the seat backrest trim **(A, figure 2)** at the front seats (driver and front passenger seat) are present and correctly attached.

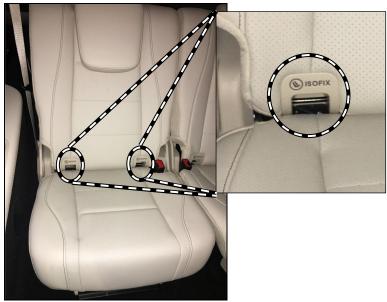
Figure 6

- **9.** Check whether the covers for the child seat anchors at the second seat row are present and correspond to the correct equipment variant (figure 6 sample illustration).
 - Li Depending on the equipment variant, ISOFIX or i-Size child seat anchors.
- **10.** Check whether the covers for the child seat anchors at the third seat row are present and correspond to the correct equipment variant (figure 6 sample illustration).
 - i Only for model 167.9.
 - Li Depending on the equipment variant, ISOFIX or i-Size child seat anchors.

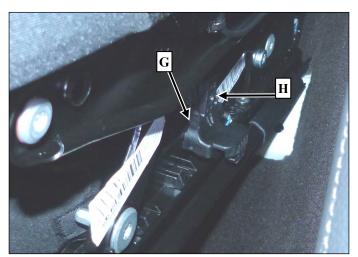
Figure 7

- 11. Check whether the cover of the seat belt guide for the lap belt of the second seat row is present.
 - i For basic data, see AR91.40-P-0683ME for model 167.
 - i For basic data, see AR68.30-P-4581LW for model 205.
- **12.** Check whether correct equipment variant of seat adjustment unit at the front seats is present.
 - The Hall sensors (figure 7) may **only** be installed in vehicles **with** code **494** (USA VERSION) or **460** (CANADA VERSION).

The Hall sensor is located, in each case, on the inner side of the seat adjustment unit of the front seats.

If the Hall sensors of the seat adjustment unit at the front seats have been installed in vehicles **without** code **494** (USA VERSION) or **460** (CANADA VERSION), the seat adjustment unit at the front seats must be replaced by the correct version in accordance with the vehicle equipment variant!

If - in spite of code **494** (USA VERSION) or **460** (CANADA VERSION) - no Hall sensors and no associated cutout in the seat adjustment unit are present, the seat adjustment unit must be replaced by the correct equipment variant and the Hall sensor installed.

- **1.2.** Place suitable pads behind the seat adjustment unit to protect the floor covering against damage/pressure marks caused by the seat rails of the seat adjustment unit when the front seat is tilted.
- **1.3.** Switch off ignition.
- 1.4. Clip Hall sensor (G, figure 7) into envisaged cutout in the seat adjustment unit.
- 1.5. Attach Hall sensor (G, figure 7) using screw (H, figure 7) to seat adjustment unit.
- Screw, Hall sensor to seat adjustment unit 3.5 [Hm].
- i Connect electrical connector.
