**TITLE: 2020 & 2021 W800 & W800 CAFE
IMPROPER TIGHTENING EXHAUST HOLDER NUTS**

RECALL

IMPORTANT SAFETY RECALL NHTSA RECALL NO. 21V-819

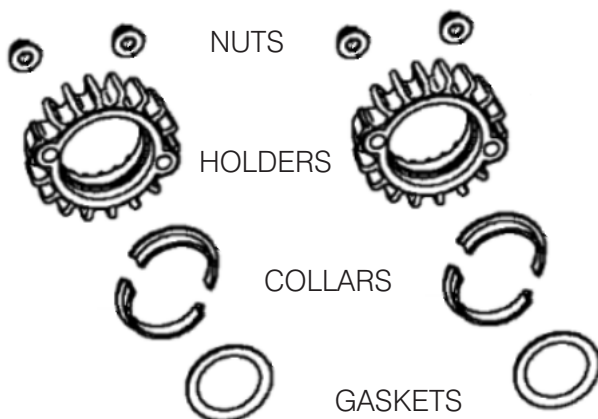
On the affected units, the exhaust pipe holder nuts that secure the exhaust pipe to the cylinder may not have been tightened correctly during assembly. Continued use of the vehicle with this condition could potentially result in the nuts and securing collars falling off and becoming a road hazard, increasing the risk of a crash.

Kawasaki has initiated a Recall campaign to repair all eligible units. The repair consists of replacing the exhaust pipe holder gaskets and exhaust pipe collars with new ones.
