## RECALL 21V829 REMEDY INSTRUCTIONS

Make(s): XLR BOOST Model(s): XLT25LRLE-79 Model Year(s): 2022	Repair Code: RC-003-01-00-004115 Allotted Time: .75 HRS. Inspection Code: N/A Allotted Time: N/A
	Concern: An incorrect 12V and 110V gauge wire was installed during manufacturing for the inverter. The 12V is missing a breaker as it the 110V.	Photo(s) Required: YES Prior Authorization Required: NO Part(s) Kit Number: 791429 Part(s) Return: N/A

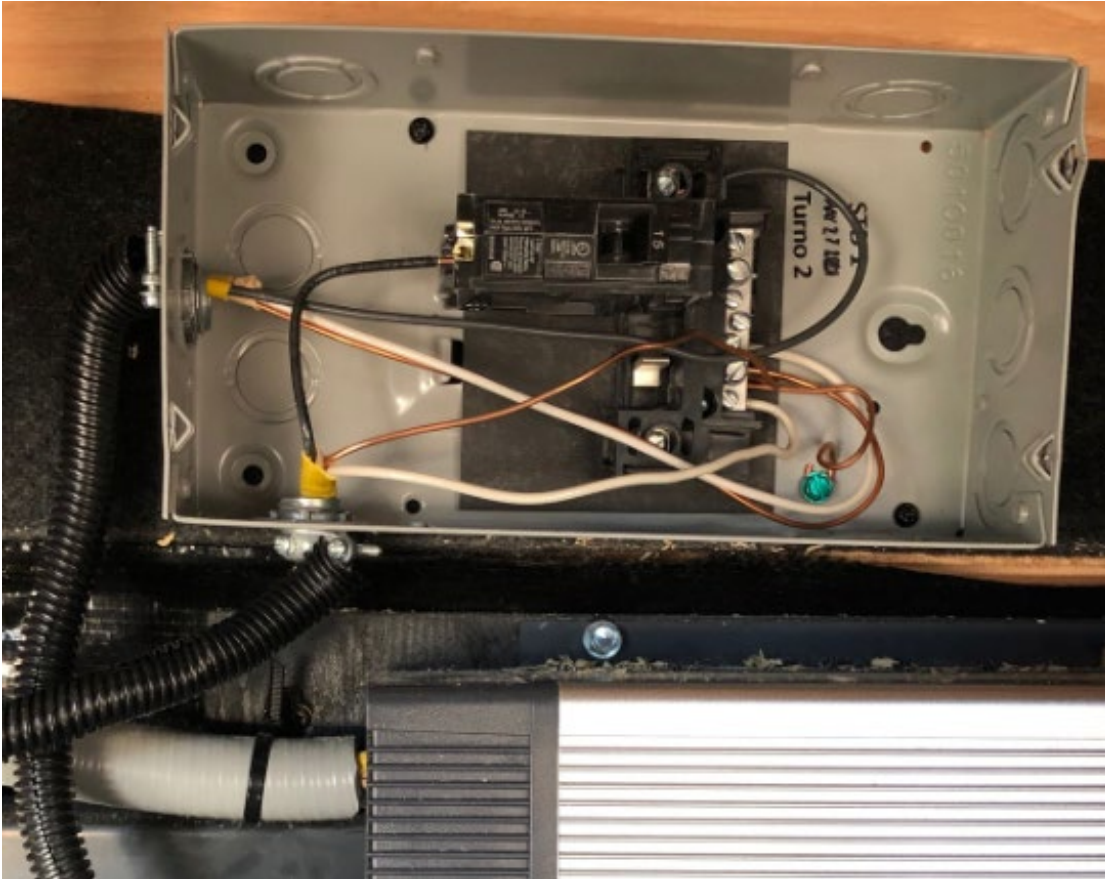
FIGURE 1

An incorrect 12V and 110V gauge wire was installed during manufacturing for the inverter. The 12V is missing a breaker as it the 110V.

- STEP 1: DIRECTLY ABOVE THE INVERTER, INSTALL THE SUBPANEL TO THE WALL (FIG. 1);
- STEP 2: INSTALL THE 15AMP BREAKER INTO THE SUBPANEL (FIG 1);
- STEP 3: REMOVE THE CORRESPONDING BREAKER "KNOCK-OUT" FROM THE SUBPANEL'S COVER;
  - NOTE: IT IS EXTREMELY IMPORTANT THAT YOU ONLY TAKE OUT THE "KNOCK-OUT" THAT CORRESPONDS WITH THE BREAKER LOCATION. IN THE EVENT YOU MISTAKENLY REMOVE THE WRONG "KNOCK-OUT" YOU WILL BE REQUIRED TO PROCURE AN APPROVED SUBPANEL "KNOCK-OUT" PLUG AND INSTALL IT IN THE SUBPANEL!
- STEP 4: LOCATE THE YELLOW 12 GAUGE 110V WIRE THAT IS WIRED INTO THE INVERTERS **"OUTPUT SIDE"** AND DISCONNECT THIS WIRE FROM THE INVERTER (FIG. 2);

STEP 6: USE THE 3’ 12/2 YELLOW WIRE FROM THE PARTS KIT, INSTALL A STRAIN RELIEF ON ONE END. FEED THE WIRE THROUGH A SEPARATE “KNOCK-OUT” ON THE SIDE OF THE SUBPANEL. ENSURE YOU LEAVE ENOUGH LENGTH OF WIRE TO CONNECT TO THE **“HOT LUG”**, GROUND BAR AND NEUTRAL BAR. THIS WILL BE THE **“LOAD SIDE WIRE”** (FIG. 1);

STEP 7: THE LOAD SIDE WIRE NOW NEEDS CONNECTED TO THE INVERTERS **“OUTPUT SIDE”**. ENSURE TO TRIM EXCESS WIRE AND ONLY STRIP A MINIMAL AMOUNT OF SHEATHING FROM THE BLACK AND WHITE WIRE, ENOUGH TO PROPERLY ENGAGE WITH THE INVERTER TERMINAL (FIG. 1);
