SIB 51 21 21

RECALL 21V-831: REAR LICENSE PLATE ILLUMINATION

MODEL

E-Series	Model Description	Production Date
G02	X4 Sports Activity Coupe	July 27, 2021 – October 19, 2021
F98	X4 M Sports Activity Coupe	July 28, 2021 – October 12, 2021

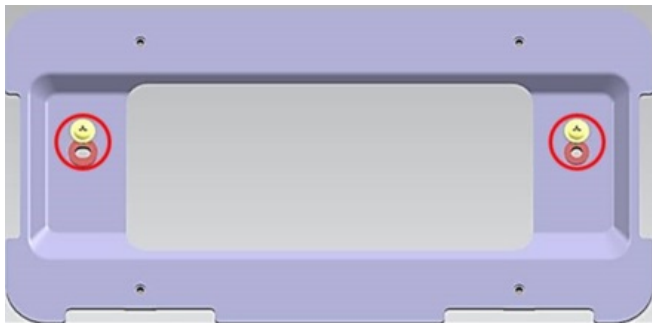
2. Inspect the 2 mounting screws of the rear license plate bracket as shown to the left.

Are both mounting screws installed ABOVE the traditionally used metal bushings?

Yes: No further correction is necessary.

No: Continue to step 3.

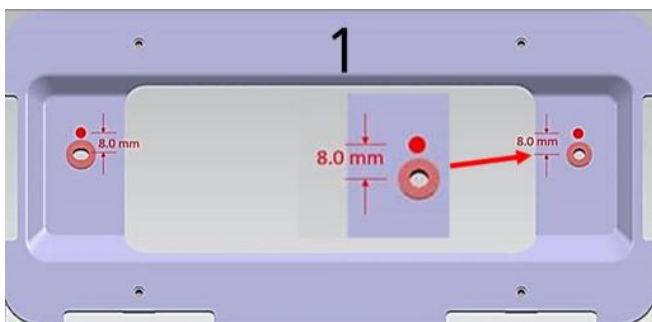
The position of the rear license plate bracket does not conform to federal lighting requirements.

4. Using a 5mm drill bit, drill 2 new holes exactly 8mm directly above the metal bushings as shown to the left.

5. Reinstall the rear license plate bracket using the 2 new holes, tightening to 1.12 Nm.

Note: The screw heads may now impact the metal bushings when tightened. This is OK.
