GROUP	MODEL
Safety Recall Campaign	2017-2018MY Optima (JF P/HEV) w/Nu 2.0L GDI HEV
NUMBER	DATE
SC218 (Rev 1, 01/24/2022)	November 2021

SAFETY RECALL CAMPAIGN

ENGINE INSPECTION/REPLACEMENT AND KSDS S/W INSTALLATION (SC218)

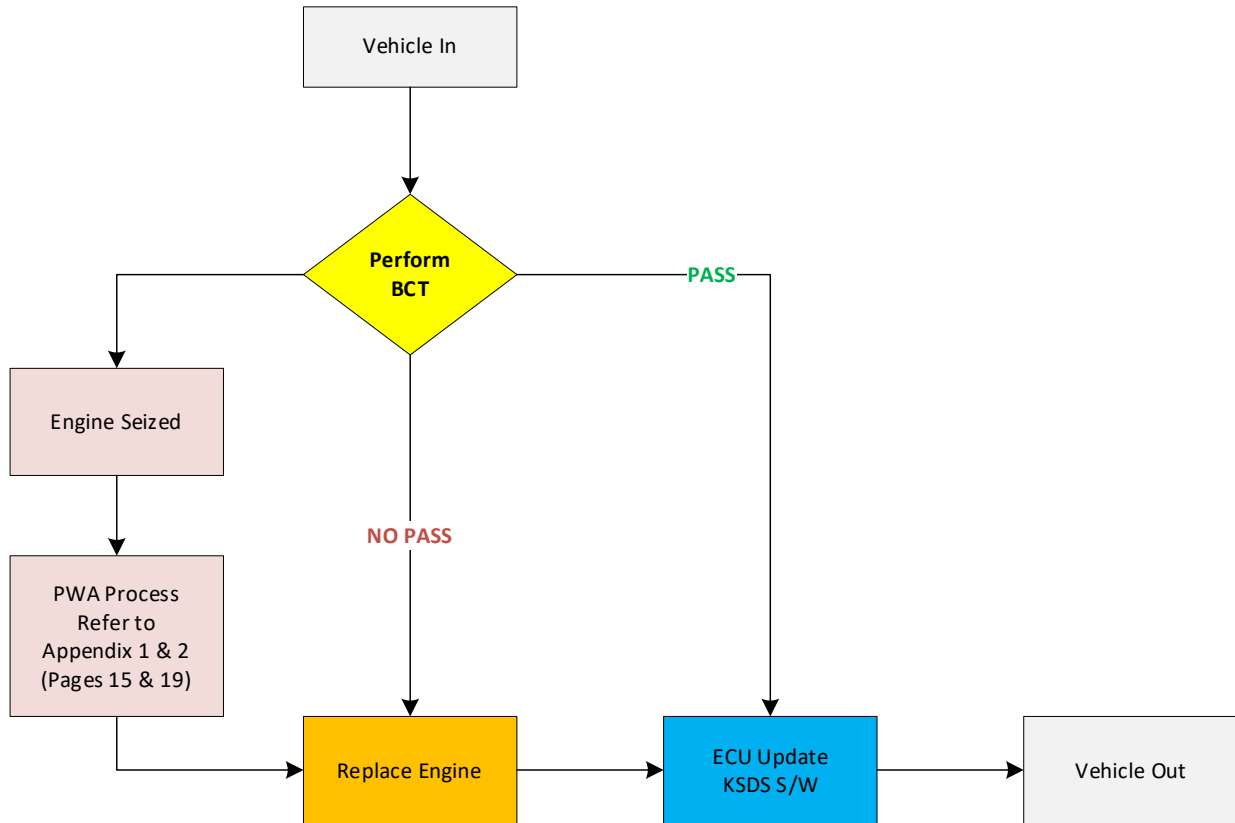
Flowchart:

Follow the flowchart below and refer to SST067 for BCT procedure. Be sure to apply the ECU Update (KSDS Software) after BCT or engine replacement.

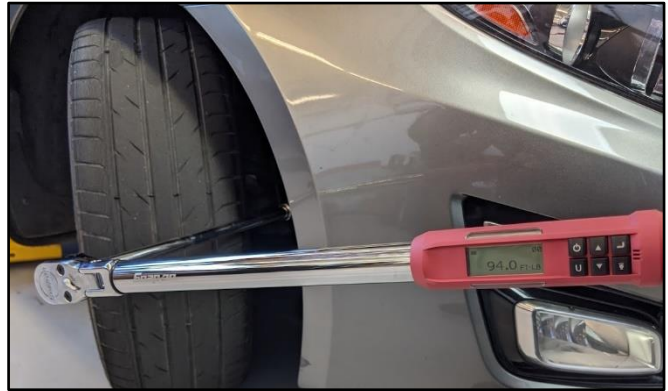
5. Show the engine being cranked and torque specification exceeding 94 lb.ft. torque.
