December 2021  
FL904 AB  
NHTSA # 21V-850 (School Bus)  
Transport Canada # 2021-669 (School Bus)

## **Subject: TBB Alternator Cable Loose**

**Models Affected: Specific model year 2020-2022 Thomas Built Buses EFX and HDX vehicles manufactured October 1, 2019, through August 19, 2021.**

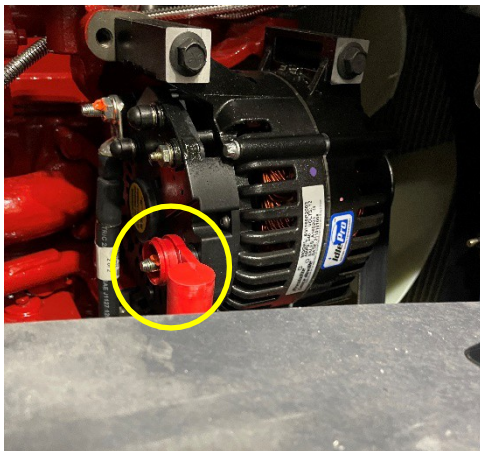
Fig. 6, With EFX engine cover repositioned, see the power cable connection circled in yellow (Right front of engine)

6. Tighten the alternator power cable-anchoring nut to the value shown in Fig, 7, and identified in Fig. 6 circled in yellow.
7. Connect the negative battery cable at the batteries, turn the main power disconnect switch to the ON position.
8. Start engine to check that the repair functions as intended.
9. Reverse the engine cover removal process, and latch the engine cover into place.
10. Unchock the tires, and release the EFX vehicle back into service.

Alternator Part Number	Torque Value <b>lbf·in</b>
TBB181725	90
TBB181726	90

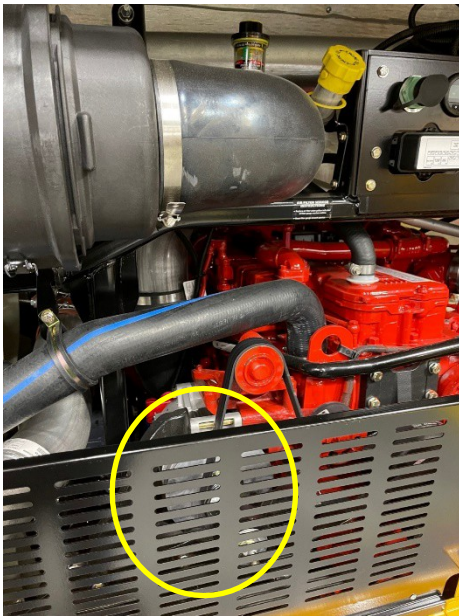
**Fig. 8, HDX Alternator location (yellow circle) is behind the belt guard (black). Access the power cable nut through the opening below the hose and above alternator**

11. Access the HDX alternator power cable securement nut through the rear engine door. See Fig. 8, Fig 9, and Fig. 10.

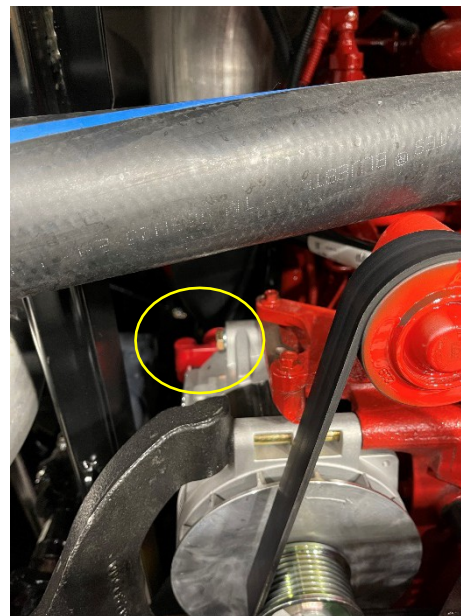
**Fig. 9, Yellow circle identifies the power cable nut on backside of alternator**

12. Tighten the alternator power cable-anchoring nut to the value shown in Fig, 11.

Alternator Part Number	Torque Value <b>lbf·in</b>
TBB179526	53
TBB181726	90

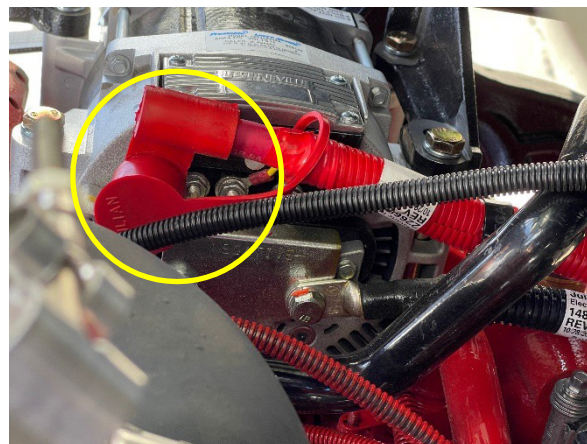
**Fig. 10, Power cable connection shown from the rear view of alternator. Remove the red protection cap to access the power cable nut**
