Safety Recall Code: 74E3

Passenger Occupant Detection System (PODS)

April 23, 2022

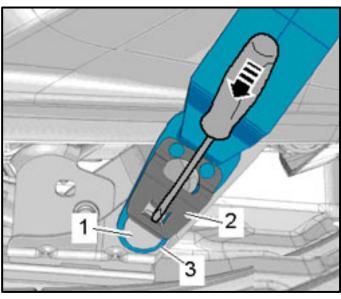
- The spring <2> can bend if removed incorrectly. Replace the three-point seat belt if the spring is bent or distorted. Damage to the seat belt is not covered under this action.
- Only move the spring <2> far enough to unlock the tab on the spring. Do not overextend the spring.

- Release the spring catches <2> by inserting a small screwdriver in the opening in the spring <arrow>.
- Slide the belt end fitting <3> downward and disengage at the pin <1>.
