RECALL 21V876 REMEDY INSTRUCTIONS

Make(s): CARGO MATE & CONTINENTAL CARGO
 Model(s): MANY, SEE BELOW
 Model Year(s): 2021 - 2022

Concern:
 The 2 5/16" coupler may have components only spot-welded to it by the coupler manufacturer. This condition may lead to trailer separation from the tow vehicle.

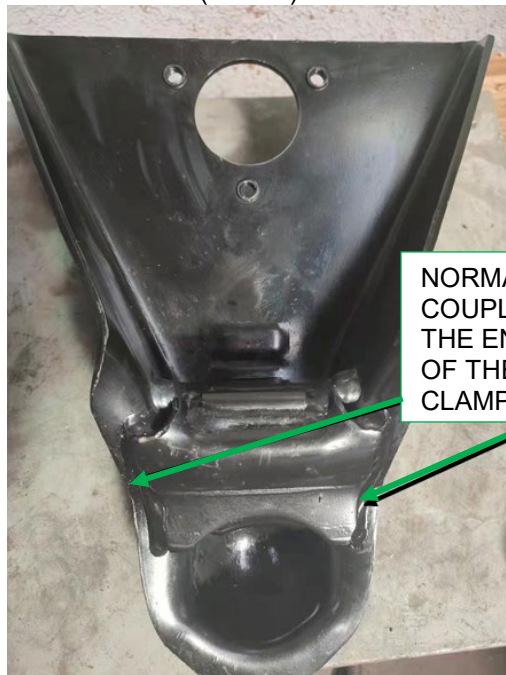
FIGURE 1 (GOOD)

NORMAL WELDS ON COUPLER UP THE ENTIRE LENGTH OF THE BOTTOM BALL CLAMP

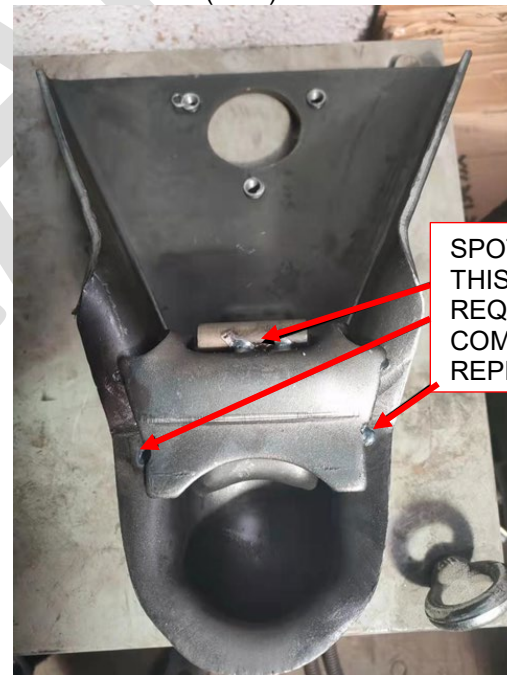
FIGURE 2 (BAD)

SPOT WELDS LIKE ON THIS COUPLER WILL REQUIRE A COMPLETE COUPLER REPLACEMENT.

IF THE COUPLE HAS SPOT WELDS LIKE FIGURE 2, THE COUPLE IN WHOLE NEEDS TO BE REPLACED. PHOTOGRAPH THE COUPLER'S MISSING WELDS (IF MISSING) PRIOR TO AND POST THE REMEDY. Contact Pacific Rim @ 360-859-3828 and order part number - CA-5400-B. Claims should be filed on Dealer
