January 2022  
FL907AB  
NHTSA #21V-882  
Transport Canada #2021-697

## Subject: Western Star Power Cable Studs

**Models Affected: Specific model years 2017-2019 Western Star 4700, 4900, 5700, and 6900 model vehicles manufactured September 12, 2016, through February 6, 2018.**

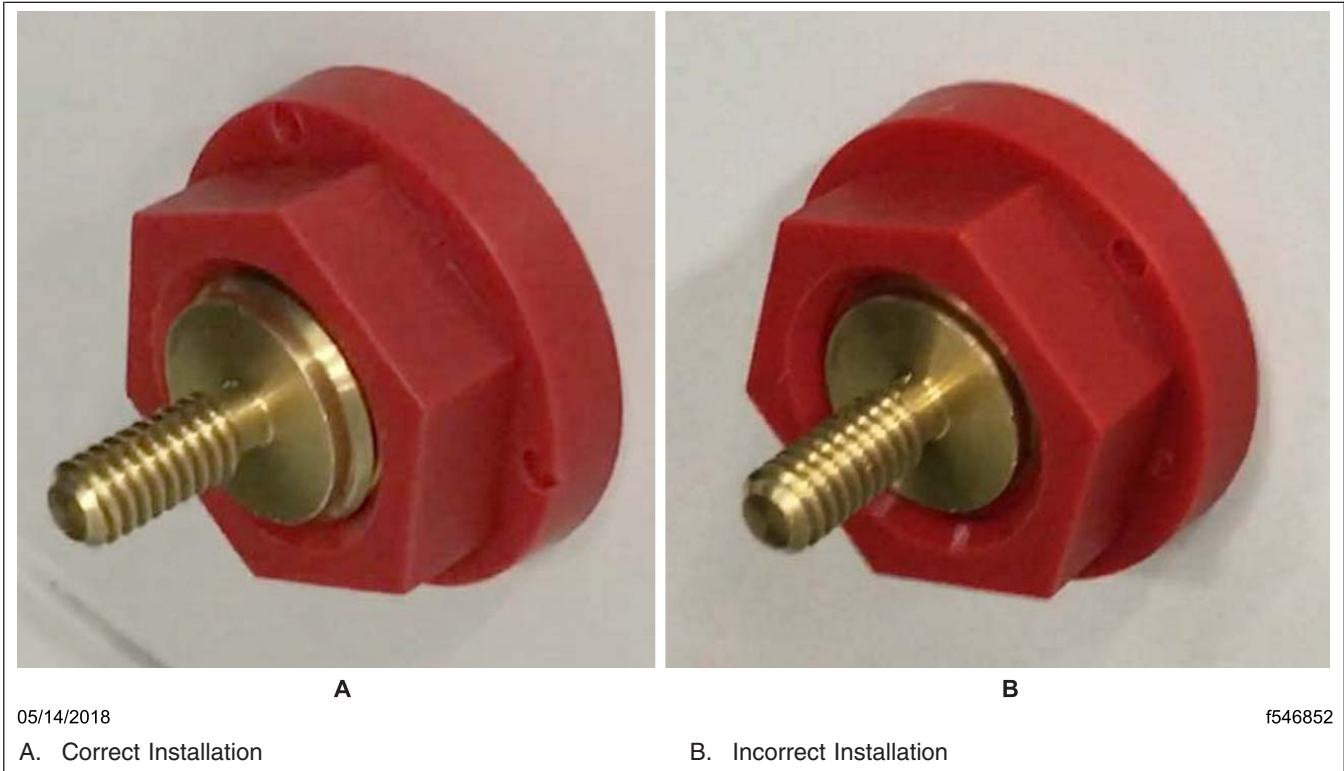
**Fig. 3, Installation Inspection**

On certain vehicles, the bulkhead pass through power cable studs with an attached gasket seal may not protrude through the bulkhead adequately. If improperly installed, the power cable studs may contact the bulkhead, resulting in potential arcing, which may increase the risk of a fire.

**IMPORTANT: Replacement studs must be installed with the plastic nut on the inside of the frontwall, regardless of how they were installed prior to this repair.**

12. Tighten the plastic nuts 80 to 98 lbf-in (904 to 1107 N-cm). Make sure at least one thread is exposed past the plastic nut. See [Fig. 3](#) and [Fig. 4](#).
