## IMPORTANT SAFETY RECALL

**NHTSA Recall Number:** 21V-884

## Mounting Frame Inspection

**Units Affected:** AT200A aerial devices built on Ford F450/F550 chassis from 2012 to 2016. Verify your unit is affected by reviewing the attached list or accessing Altec Connect.

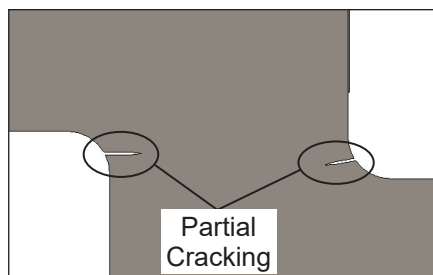
**Figure 9 — Partial Cracking Example**

5. If cracking is present, determine the extent of the damage as defined below.
- No cracking means no visible cracking at all in the plate (refer to Figure 8).
  - Partial cracking means a visible crack anywhere in the narrow section that extends only part way across the width or part way through the thickness of the plate (refer to Figure 9). Partial cracking may consist of one or more cracks.
  - Full cracking means a visible crack across the full width of the narrow section extending through the full thickness of the plate and causing the complete separation of the material (refer to Figure 10).

- If there is partial cracking, determine the extent of the cracking in each inspection area by measuring the length(s) of the cracking.
    - If the total length of cracking is less than  $\frac{3}{4}$ " in each inspection area, put the unit back into service. Order the reinforcement kit and install it within 60 days of the inspection, or schedule the installation of the reinforcement kit by Altec within 60 days of the inspection.

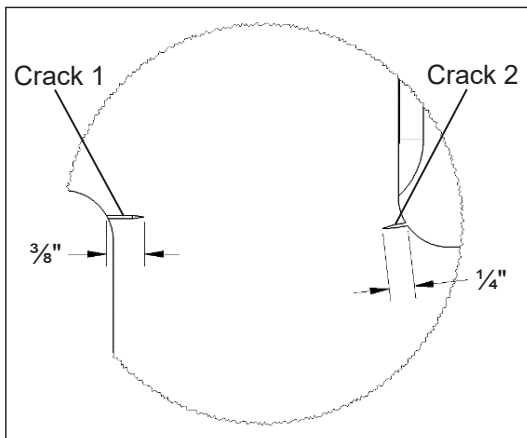
**Figure 11 — Partial Cracking, Example 1**

- Example 1: Inspection found no cracks in Areas A and C, a  $\frac{1}{2}$ " long crack in Area B, and two cracks in Area D (refer to Figure 11). The total length of cracking in Area D is the sum of the lengths of the two cracks,  $\frac{3}{8}$ " +  $\frac{1}{4}$ " =  $\frac{5}{8}$ ". Since the total length of cracking is less than  $\frac{3}{4}$ " in each inspection area, put the unit back into service, and install the reinforcement kit within 60 days of the inspection.

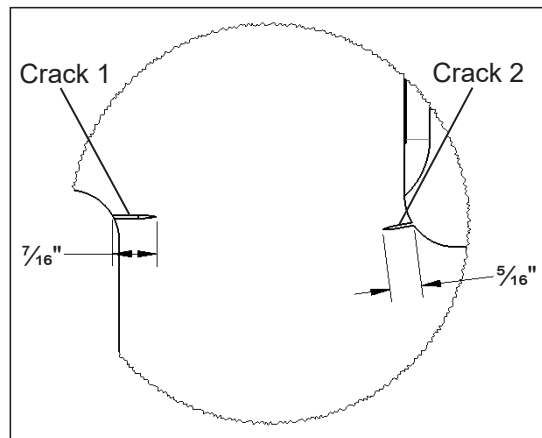
**Figure 12 — Partial Cracking, Example 2**

- Example 2: Inspection found no cracks in Areas A, B, and C, and two cracks in Area D (refer to Figure 12). The total length of cracking in Area D is the sum of the lengths of the two cracks,  $\frac{7}{16}$ " +  $\frac{5}{16}$ " =  $\frac{3}{4}$ ". Since the total length of cracking is  $\frac{3}{4}$ " in this area, the unit must be taken out of service. The vehicle can still be driven, but the aerial device cannot be used until the mounting frame is repaired.

- If the total length of cracking in any inspection area is  $\frac{3}{4}$ " or more, take the unit out of service. Order and install the reinforcement kit, or schedule the installation of the reinforcement kit by Altec. The vehicle can still be driven, but the aerial device cannot be used until the mounting frame is repaired.

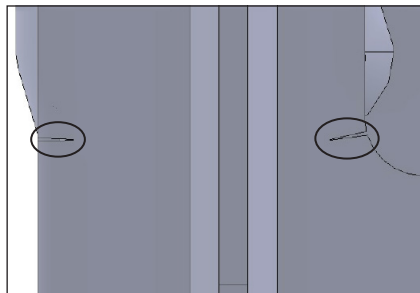
**Figure 19 — Partial Cracking Example**

- **No cracking** means no visible cracking at all in the plate (refer to Figure 18).
- **Partial cracking** means a visible crack anywhere in the narrow section that extends only part way across the width or part way through the thickness of the plate (refer to Figure 19). Partial cracking may consist of one or more cracks.
- **Full cracking** means a visible crack across the full width of the narrow section extending through the full thickness of the plate and causing the complete separation of the material (refer to Figure 20).
- **Terminated cracking** means a crack in Area E that extends from the inside corner in the lower edge of the side plate toward the mounting hole or all the way to the mounting hole (refer to Figure 21). If there is cracking extending in any other direction in Area E, include it in the partial cracking assessment for Area C.

- If there is partial cracking, determine the extent of the cracking in each inspection area by measuring the length(s) of the cracking.
    - If the total length of cracking is less than  $\frac{3}{4}$ " in each inspection area, put the unit back into service. Order the reinforcement kit and install it within 60 days of the inspection, or schedule the installation of the reinforcement kit by Altec within 60 days of the inspection.

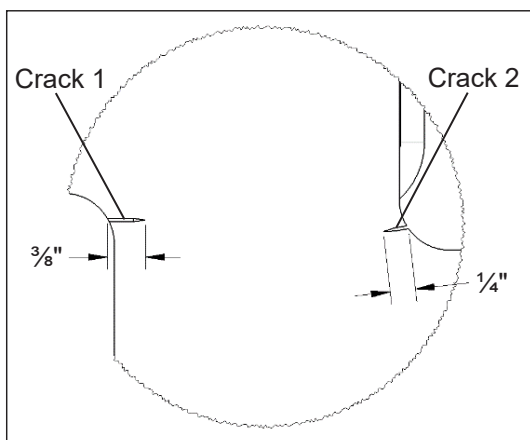
**Figure 22 — Partial Cracking, Example 1**

- Example 1: Inspection found no cracks in Areas A and C, a  $\frac{1}{2}$ " long crack in Area B, and two cracks in Area D (refer to Figure 22). The total length of cracking in Area D is the sum of the lengths of the two cracks,  $\frac{3}{8}$ " +  $\frac{1}{4}$ " =  $\frac{5}{8}$ ". Since the total length of cracking is less than  $\frac{3}{4}$ " in each inspection area, put the unit back into service, and install the reinforcement kit within 60 days of the inspection.

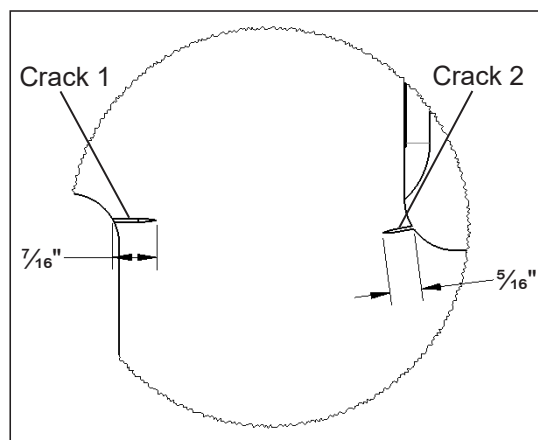
**Figure 23 — Partial Cracking, Example 2**

- Example 2: Inspection found no cracks in Areas A, B, and C, and two cracks in Area D (refer to Figure 23). The total length of cracking in Area D is the sum of the lengths of the two cracks,  $\frac{7}{16}$ " +  $\frac{5}{16}$ " =  $\frac{3}{4}$ ". Since the total length of cracking is  $\frac{3}{4}$ " in this area, the unit must be taken out of service. The vehicle can still be driven, but the aerial device cannot be used until the mounting frame is repaired.

- If the total length of cracking in any inspection area is  $\frac{3}{4}$ " or more, take the unit out of service. Order and install the reinforcement kit, or schedule the installation of the reinforcement kit by Altec. The vehicle can still be driven, but the aerial device cannot be used until the mounting frame is repaired.
