Recall Service Bulletin

APPLIES TO: This Recall service bulletin applies to certain 2020, 2021, and 2022 model year, K1 and K2 model motor home chassis built within VDM range of January 2, 2019 – September 13, 2021.

NHTSA/TC Id: 21V-776

CONDITION: Certain rear suspension mounting fasteners that attach the rear drive axle to the rear suspension may not have been tightened to their proper value.

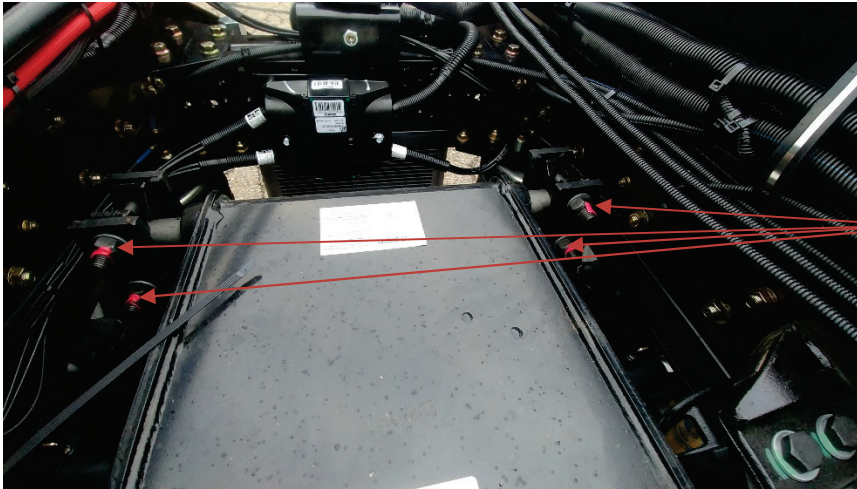
6. Inspect four upper torque box clamp fasteners for torque marks, if none are present or appears shifted from original position, please note on repair order.

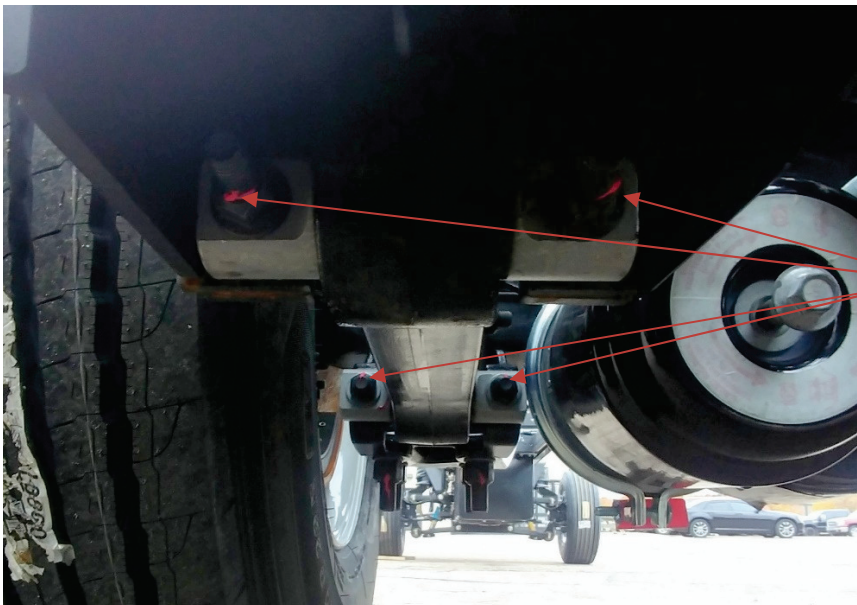
7. Inspect eight lower control arm fasteners for torque marks, if none are present or appears shifted from original position, please note on repair order.

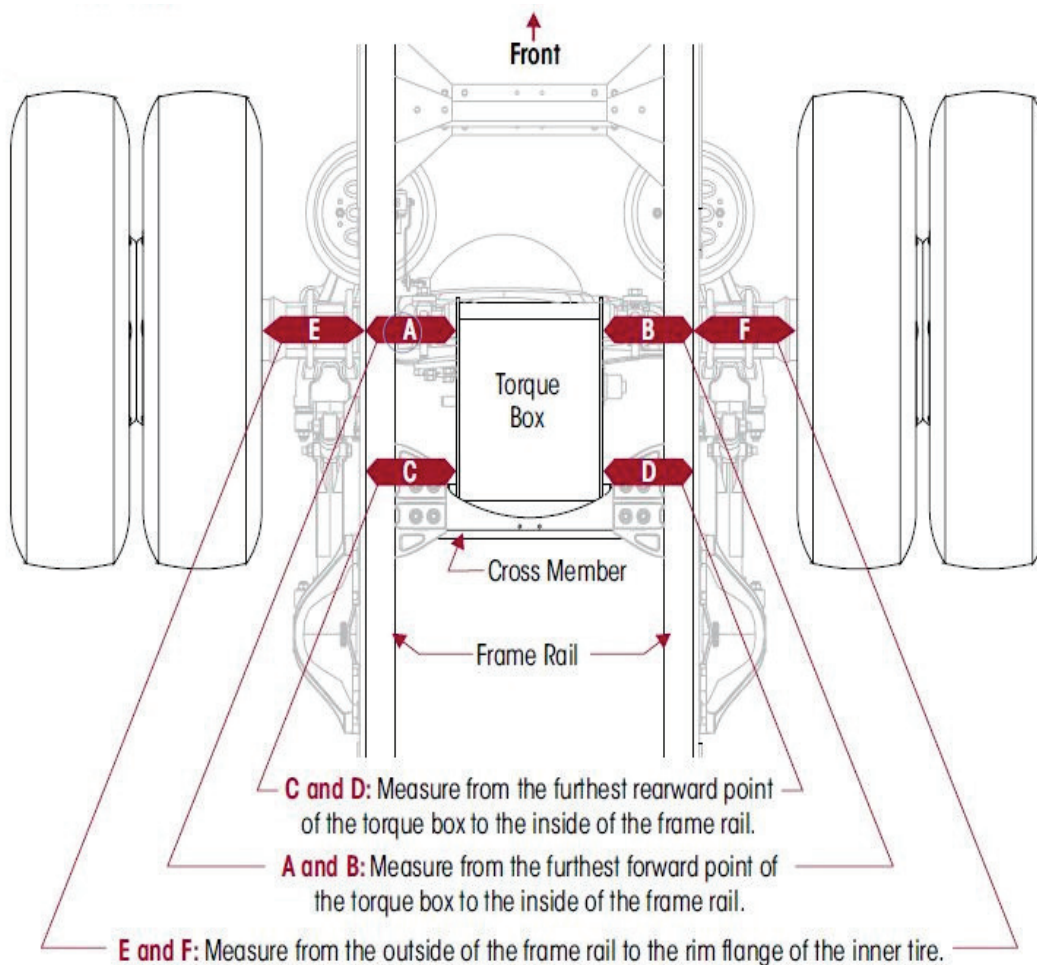
8. If no torque marks are present, visually inspect fasteners and holes for any damage such as side loading, elongated holes etc. that would require additional replacement of fasteners and/or components.
9. Using the below diagram, measure torque box lateral alignment and write down measurements for reference.

10. Measurements A, B, C and D will be used to determine if the torque box is centered and aligned in the frame. Measurements E and F will determine if axle is centered within the frame.
11. Calculate the difference between A & B, C & D, and A & C. If the calculated difference for all of these is $\frac{1}{4}$ " or less, the torque box alignment is within specifications, apply proper torque to bolts and mark the bolt/nut and continue to step 13.
12. If any of the calculated measurements are greater than $\frac{1}{4}$ ", the torque box must be aligned to the frame before proceeding. The steps to accomplish this are as follows.

Caution, if calculated measurements are greater than $\frac{1}{4}$ ", thoroughly inspect torque box fasteners and components for potential damage due to shifted torque box. Please contact Spartan RV Chassis Customer and Product Support if damage is present.

12d. Using a pry bar or similar tool, center the torque box within the frame rails. Measurements A & B, C & D, and A & C should all be within $\frac{1}{4}$ ". This will center the torque box and ensure parallelism within the frame.

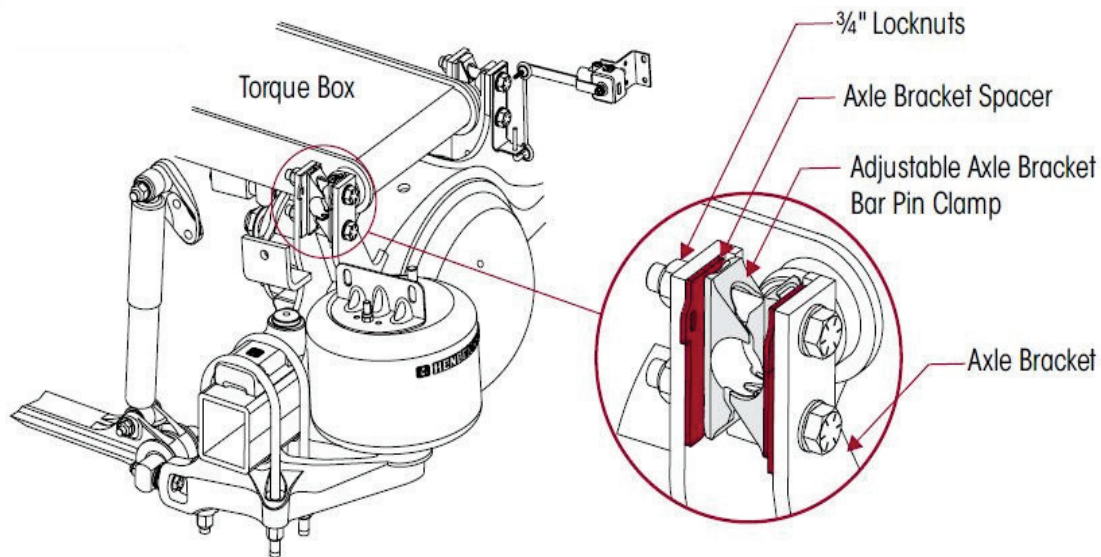
Warning, the drive axle has one (1) axle bracket with adjustable bar pin clamps and four (4) axle bracket spacers, and one (1) axle bracket with non-adjustable bar pin clamps. The bar pin clamp pairs may be changed from side to side but must not be mixed. All four (4) spacers must be used with the adjustable bar pin clamps, which are thinner than the non-adjustable bar pin clamps. Torque box connections must be tightened in the proper sequence and follow proper torque values. Failure to do so can result in the deformation of parts, loss of clamp force, bolt failure, loss of the axle's alignment, loss of vehicle control, property damage, or personal injury.

- 14a. Use the measurements from E and F to determine which direction the axle needs to be moved to center the axle under the vehicle.
- 14b. Loosen the torque box to axle clamp fasteners. The fasteners may already be loose from step 12. Do Not loosen the torque box to cross-member fasteners.
- 14c. Using a pry bar or equivalent tool, move the axle in the direction required to center the axle under the vehicle. Measurements E and F should be within a 1/4" of each other.

- 14d. Tighten the axle bracket clamp locknuts in the proper sequence. Tighten the lower clamp locknut first, then the upper clamp locknut. Tighten the locknuts to 290-310 LB-FT.
