TECHNICAL INSTRUCTIONS

SAFETY RECALL 21TA08

SECOND-ROW OUTBOARD SEAT BELT COULD TEAR IN A CRASH

CERTAIN 2022 MODEL YEAR SIENNA VEHICLES CONVERTED FOR WHEELCHAIR ACCESSIBILITY BY THE BRAUN CORPORATION (BraunAbility)

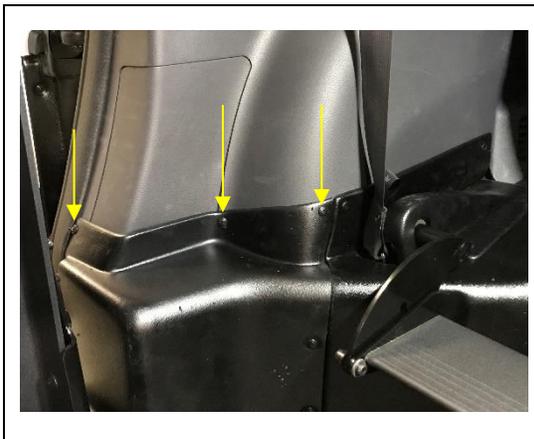
Note: You may need to remove the screws, shown below, to loosen the BraunAbility lower quarter trim panel enough to remove the Toyota quarter trim front lower cover

- a) Remove the rear door scuff plate.
- b) Disconnect the rear door opening trim weatherstrip
- c) Remove the quarter trim front lower cover
