Safety Recall

Code: 87H4

Subject A/C Drain Tube

Release Date January 28, 2022

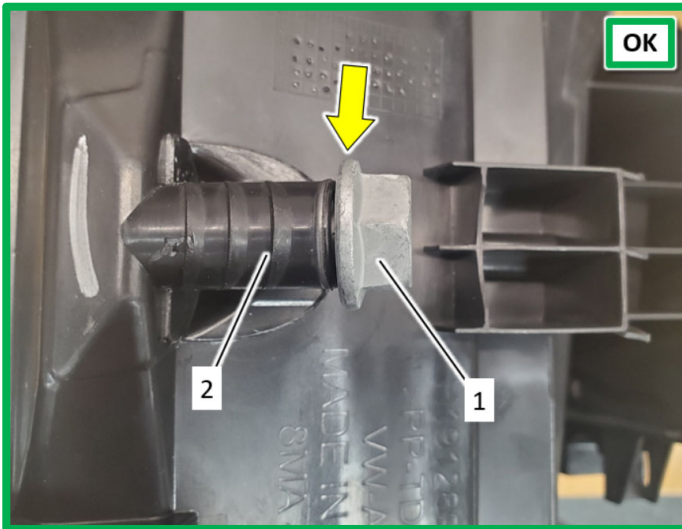
Inspect the evaporator drain tube:

- Use ONLY shouldered bolt, part number N-106-978-01, for the inspection.
- Insert bolt <1> into the evaporator housing drain tube <2>.
- If the bolt can be fully inserted up to the bolt's shoulder <arrow>:
 - REMOVE THE BOLT.
 - The evaporator drain tube is OK.
 - **Proceed to Section D.**

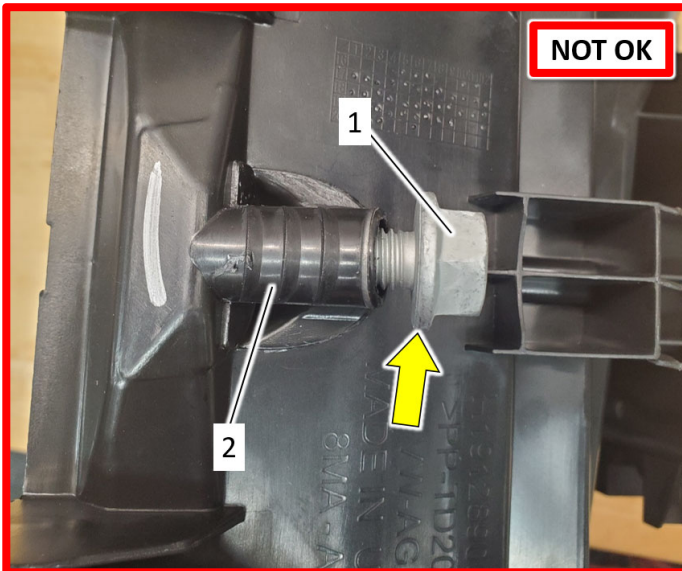
- If the bolt cannot be fully inserted into the evaporator housing up to the bolt's shoulder <arrow>:
 - REMOVE THE BOLT.
 - The evaporator housing drain tube is blocked.
 - The airbag control module must be replaced.
 - The evaporator housing must be reworked.
 - **Proceed to Section C.**

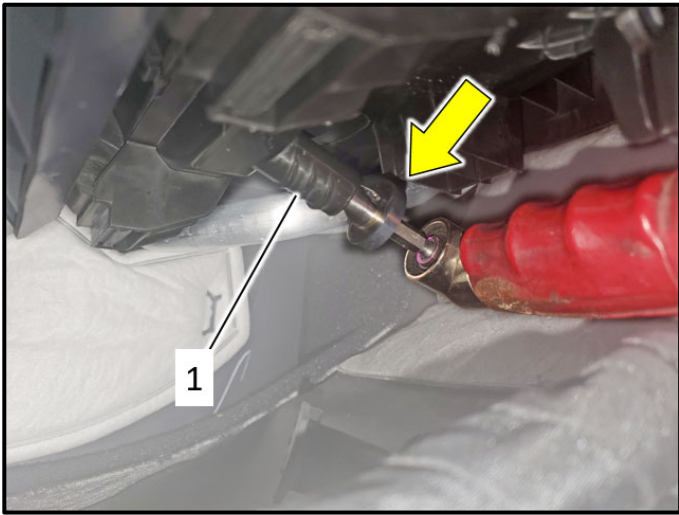
The intention of drilling is to remove the blockage where the tube meets the housing.

DO NOT drill on an angle. Doing so could damage the inside wall of the drain tube.

- Place the drill bit inside the evaporator drain tube <1> and drill until the stop <arrow> makes contact with the drain tube.
- When removing the drill bit, **DO NOT** reverse the direction of the drill.

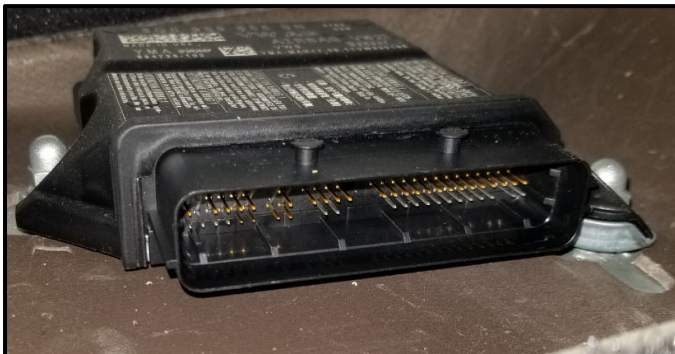
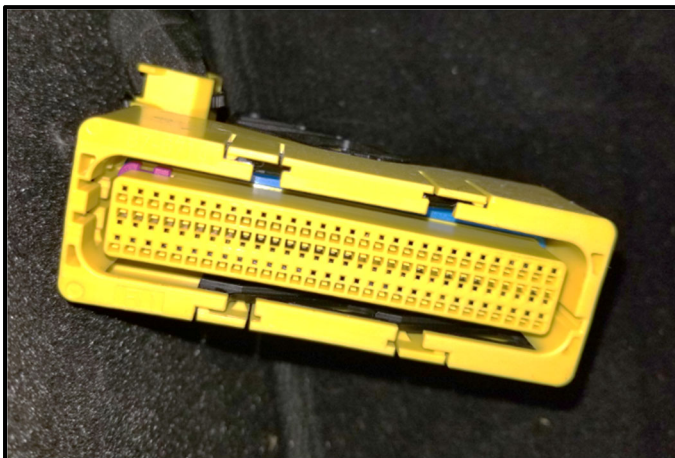
- Disconnect the connector in the front passenger footwell by releasing the connector safety catch and opening the locking clip <5> on the connector <arrow>.
- Remove the nuts <1 and 4>.
- Carefully lift the airbag control module <2> from the threaded pins and remove it toward the passenger side.
- When replacing the airbag control module:
 - Inspect the pins on the old airbag control module for corrosion.
 - Inspect the airbag control module connector for signs of corrosion or moisture.
- If only moisture is found:
 - Use compressed air to dry out connector and connector housing.
- If corrosion is found:
 - The pins in the connector must be inspected and replaced.
 - The connector cap must be replaced.

- U.S. dealers: Provide a photo and submit a campaign authorization request for consequential damage.
- Canadian dealers: Create a VTA WEB ticket and attach photos of the corrosion.

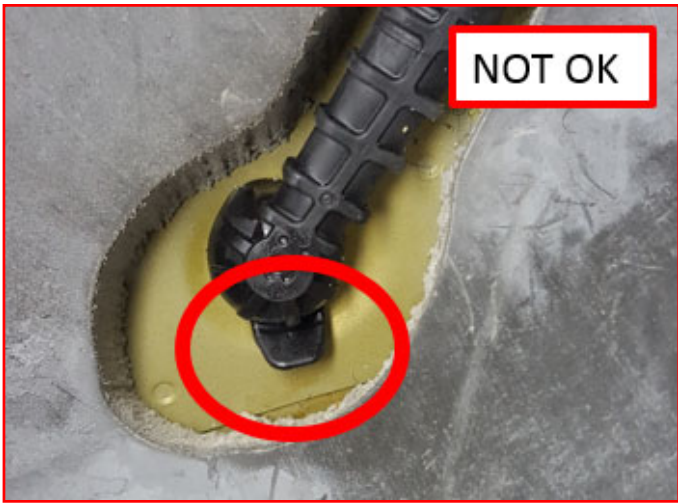
- The connection at the body can come loose when removing the hose from the evaporator housing.
- Inspect the evaporator drain tube installation at the body.
- If the tab <circle> is not installed into the body and the drain tube is not twisted, the drain tube must be reinstalled correctly/fully.

If tube is to be reinstalled, spray water on the body or the drain tube to aid in installation.
