Recall Campaign Bulletin

Campaign No. 2021120004, December 2021

SUBJECT: **Model GLE-Class (167 platform)**
Model Year 2021
Electric Heater Ground Bolting

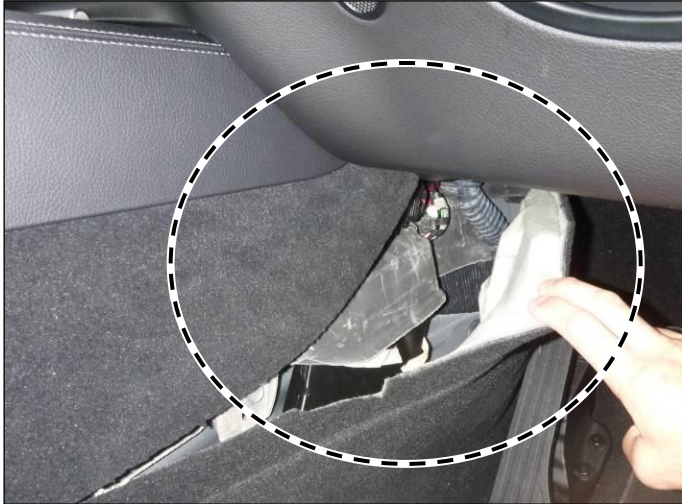
Figure 1

1. Slide front passenger seat backward to the end position.
2. Detach front right floor covering until area around ground connection of PTC booster heater is accessible (**Figure 1**).

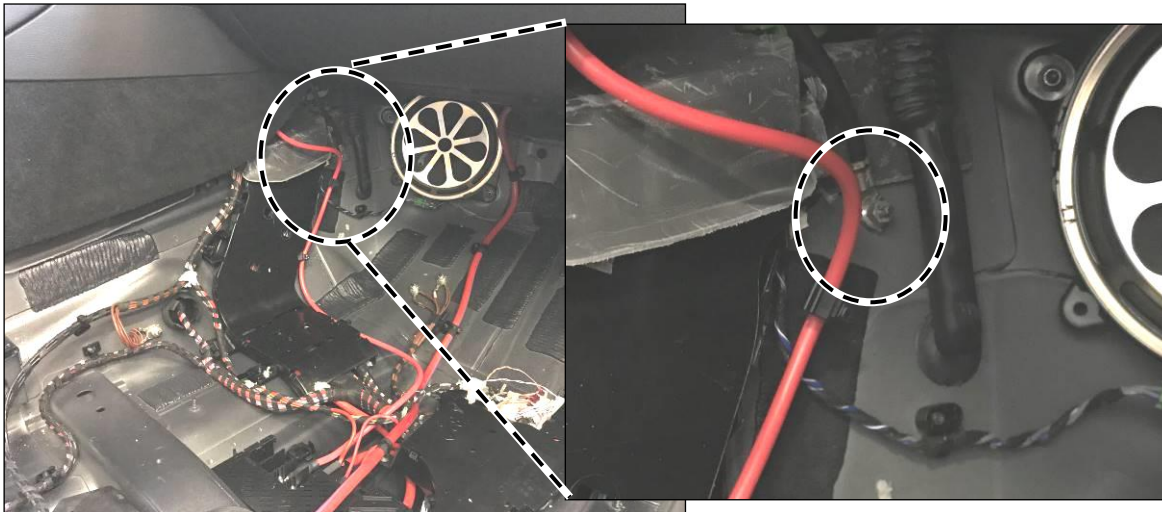
Figure 2

3. Check for scorch marks in area of ground connection of PTC booster heater (**Figure 2**).
4. Check ground connection of PTC booster heater as to whether loose or tightened with correct torque (**Figure 2**).

i **Figure 2** shown with removed floor covering!

i The torque of the ground connection **must** be **Nm** 10!

- a. **Scorch marks present** in the area of the ground connection:
Carry out **work procedure**.
- b. **Scorch marks not present** in the area of the ground connection:
End measure.

1. Install new PTC booster heater.

i If further component parts in the area of the ground connection have been damaged, new component parts must also be installed!
