TO: Mercedes-Benz Principals, General Managers, Sales Managers, Service Managers, Parts Managers	FROM: Anthony Washington, Department Manager, Regulations and Certifications
Re: Recall Campaign Launch Notification Model 907 (Sprinter) Model Years 2021 Tighten Spring Loaded Rear Step	DATE: February, 2022

Campaign No. 2022010007, February, 2022

SUBJECT: **Model 907 Sprinter, Model Year 2021**
Tighten Spring Loaded Rear Step

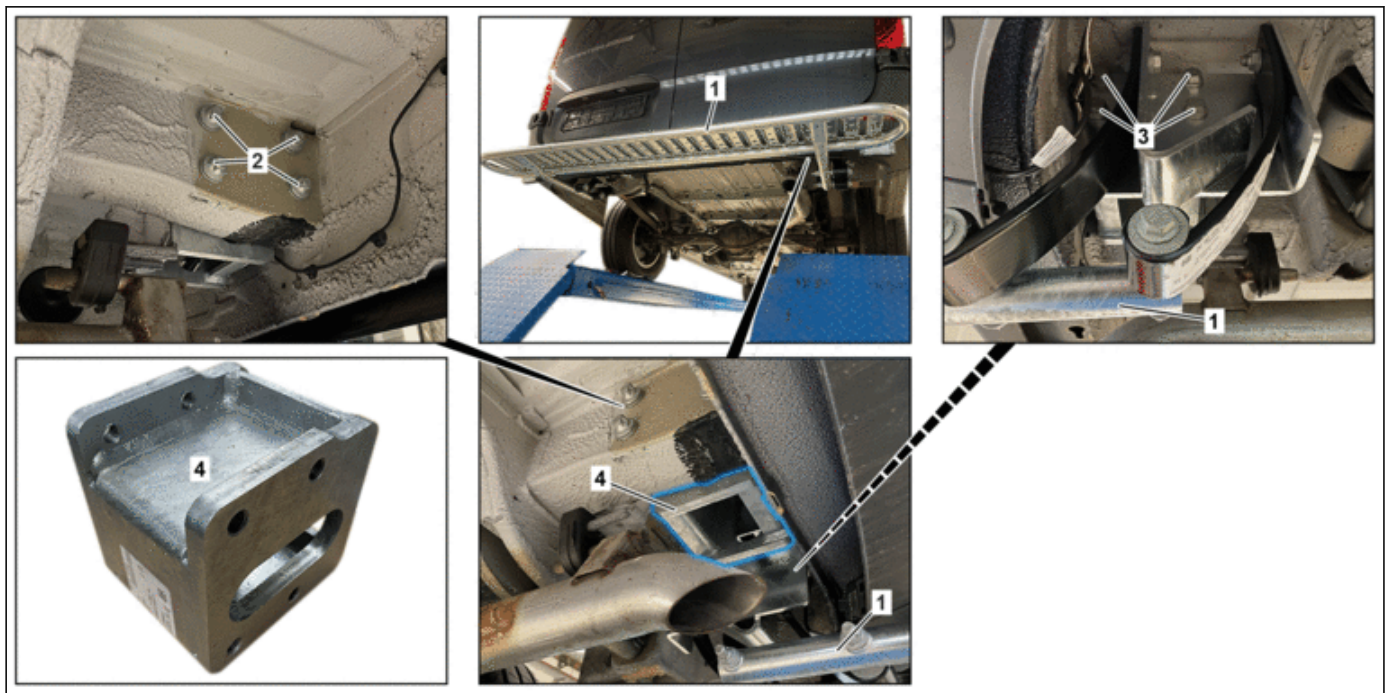
D88.30-A047-79

MBAG has determined that on certain Mercedes-Benz Sprinter vehicles with a spring-loaded rear step, certain bolt fasteners on the step assembly were not tightened to the required torque. Should the affected bolt fasteners loosen during vehicle operation, the rear step could separate from the vehicle. As a result, the step might become a road hazard which could increase the potential risk of a crash for following traffic.

3	Support spring-mounted step (1).

WS 000 588 11 62 00 Major assembly mount		WS01.00-P-0092B
4	Replace mounting support (4) of spring-mounted step (1).

To do so, remove screw/bolts (2, 3). Replace screws (2, 3) too.

5	Install in the reverse sequence.

Number	Designation	Model 907, 910
BA88.30-Z-1001-03KTS	Screw/nut, sprung running board to longitudinal member	94Nm
