GROUP	MODEL		
	Safety Recall Campaign	2020-2021MY Rio (SC)		
	NUMBER	DATE		
	SC223	January 2022		
SAFETY RECALL CAMPAIGN

# SUBJECT: BRAKE MASTER CYLINDER REPLACEMENT (SC223)

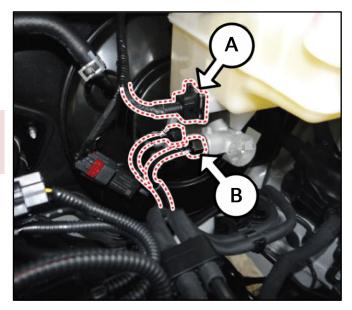
- Do <u>not</u> spill brake fluid on the vehicle as it may damage the paint. If brake fluid comes in contact with the paint, wash off immediately with water.
- Disconnect the brake fluid level switch connector (A) and disconnect the brake tube (B) from the master cylinder by loosening the tube flare nut.

Tightening torque for Flare Nut: ABS: 10.1 - 12.3 lb.ft (13.7 - 16.7 N.m) ESC: 13.7 - 16.6 lb.ft (18.6 - 22.6 N.m)
