Technical Service Bulletin

GROUP RECALL	NUMBER 22-01-001H
DATE JANUARY 2022	MODEL(S) Accent (HC)

SUBJECT: BRAKE MASTER CYLINDER REPLACEMENT (RECALL 213)

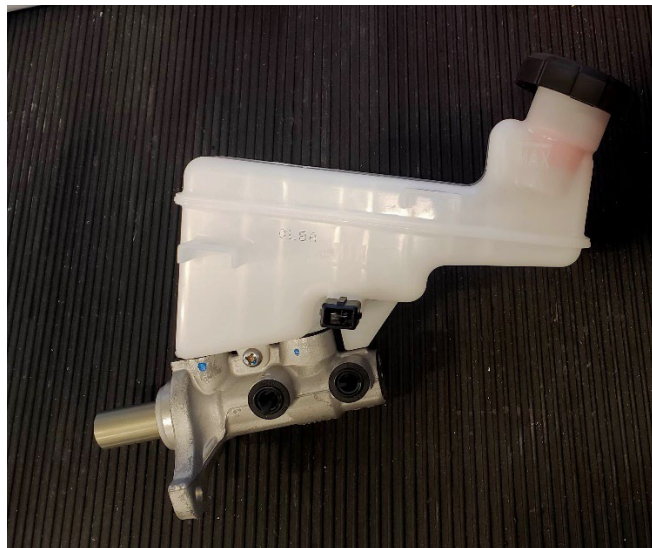
Description: This bulletin describes the procedure to replace the brake master cylinder on certain 21MY Accent (HC) models. The brake master cylinder in the subject vehicles may have been produced with sharp edges on one of the master cylinder's secondary inner cup seal seats, resulting in premature wear of the inner cup seal. Worn inner cup seals could reduce hydraulic pressure applied by the master cylinder resulting in reduced braking function at the wheels. The driver may experience longer brake pedal travel, change in pedal feel, and extended stopping distance, increasing the risk of a crash.
