Dealer Operator/General Manager	Sales New Vehicles	Sales Used Vehicles	Business Manager (F&I)	Service	Parts & Accessories	Administration
Date: December 13, 2021		Source: Zero Motorcycles Customer Service Department

Model Year 2022 Zero SR/F/S Rear Brake Pads Recall

NHTSA Campaign Number: 21V-940

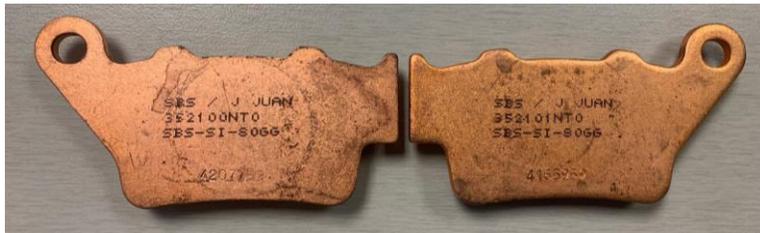
- 25-08149 - REAR BRAKE PADS SET SBS-SI-80GG - The correct rear brake pads have a copper backing and are marked with the 35100NT0/35101NT0 manufacturer part numbers and SBS-SI-80GG surface treatment number.

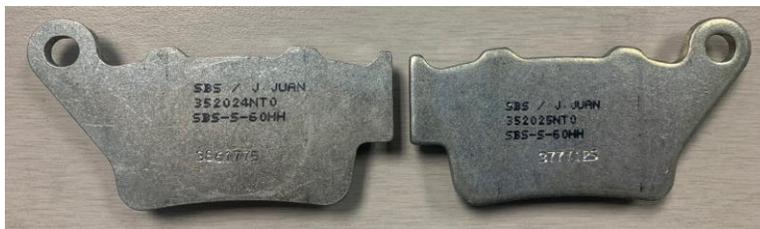
CAUTION: The incorrect rear brake pads have a silver backing and are marked with the 352024NT0/ 352025NT0 manufacturer part numbers and SBS-S-60HH surface treatment number. See image below of the incorrect brake pads. Be sure to mark them or destroy them to avoid future use.
