February 2022
FL914A
NHTSA #21V-946
Transport Canada #2021-739

Subject: Western Star 4900 Steering Column Pinch Bolt

Models Affected: Specific model years 2021-2022 Western Star 4900 model vehicles manufactured October 28, 2020, through November 1, 2022.

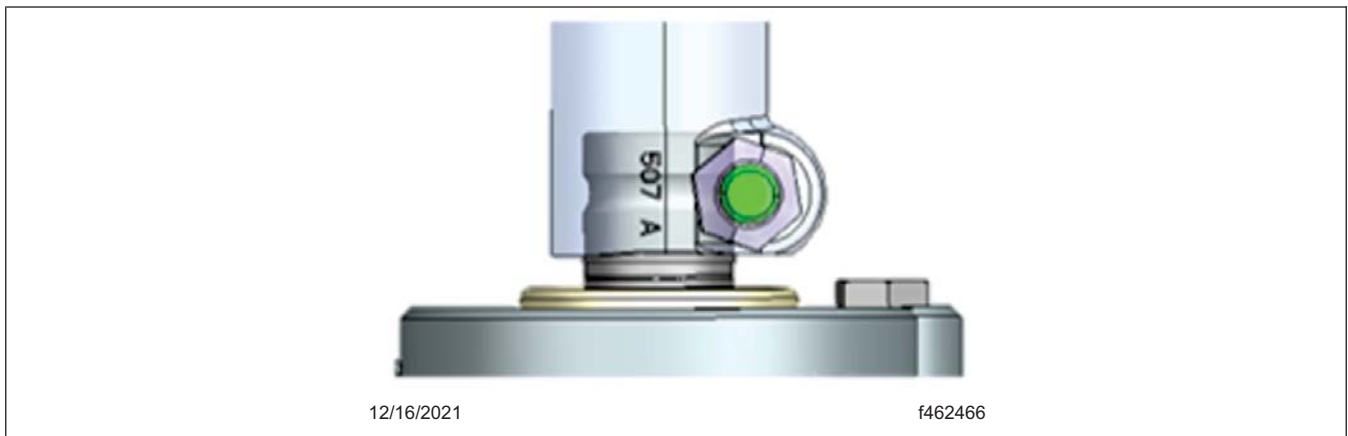
Fig. 2, Steering Shaft Installed Correctly

4. Start the vehicle. With the engine idling, turn the steering wheel so the pinch bolt is accessible at the top of the steering shaft.
5. Inspect the steering shaft to steering gear attachment. The steering gear input shaft must be seated completely into the steering shaft. For correct installation, see [Fig. 2](#). For a displaced steering shaft, see [Fig. 3](#).

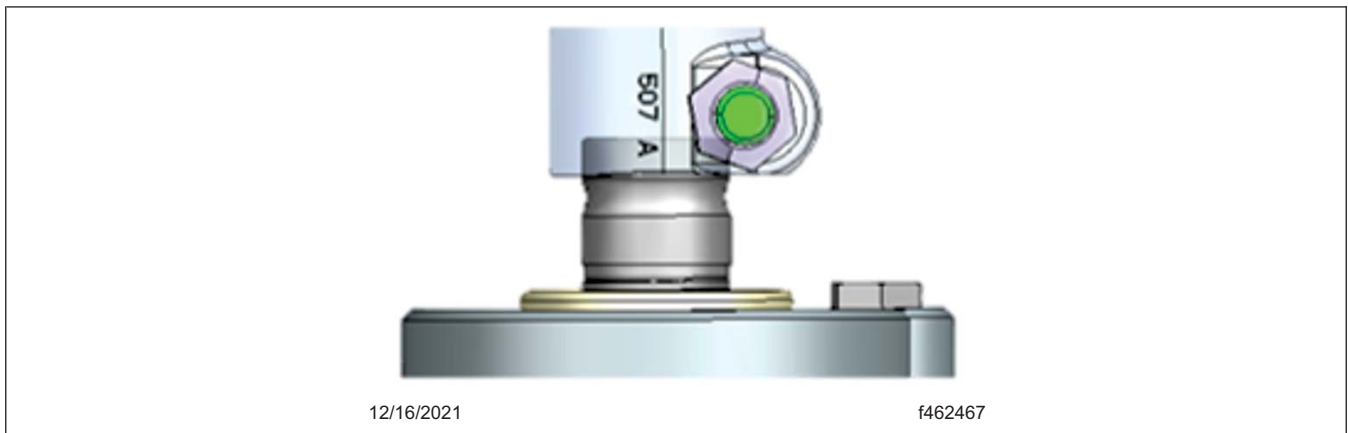
Fig. 3, Steering Shaft Lifted or Displaced

On certain vehicles, the steering shaft may not have been properly installed. An improperly installed steering shaft may separate from the steering gear, resulting in a loss of steering control. A loss of steering control may lead to a vehicle crash.

1. Remove and discard the pinch bolt and nut on the steering gear side of the steering shaft.
2. Slide the steering shaft down so it is completely seated on the steering gear input shaft.

3. Install the new pinch bolt and nut. Tighten the pinch bolt 30 to 35 lbf-ft (41 to 47 N-m).
4. Apply a blue torque seal after the required torque has been set.
