Safety Recall

Code: 90S9

Subject	Gateway Control Module																												
Release Date	January 18, 2022																												
Affected Vehicles

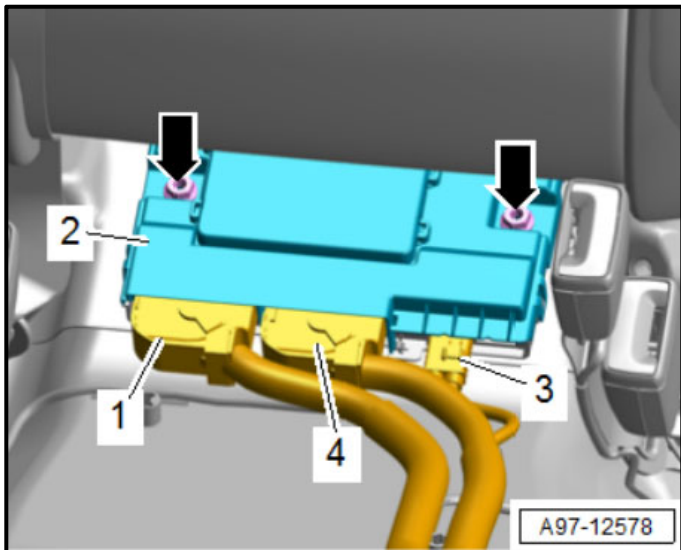
Unbolt gateway control module:

The electrical connectors remain connected.

- Remove and discard the nuts <arrows>.

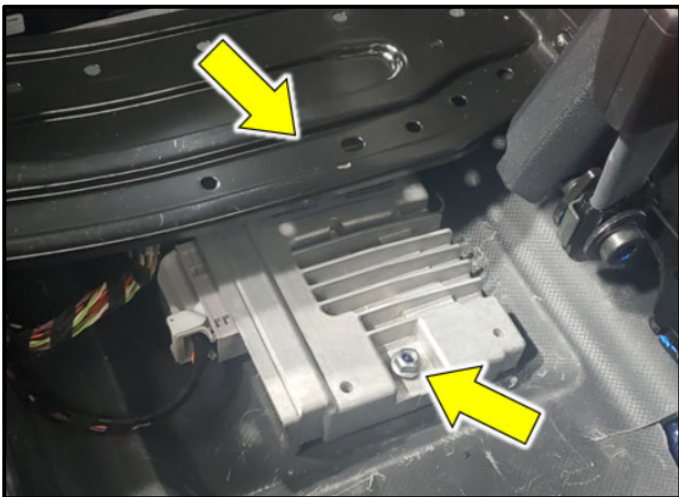
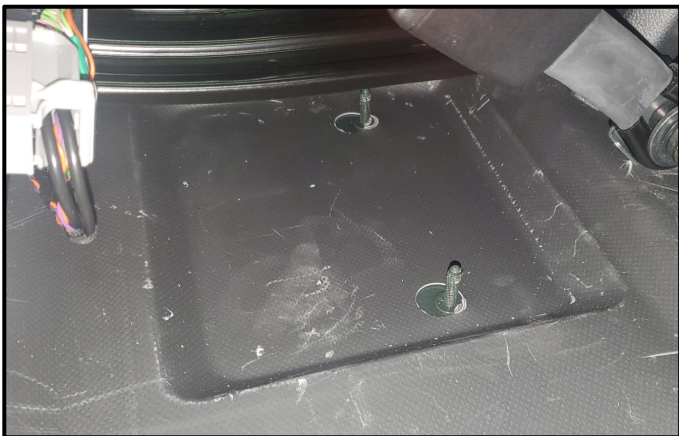
- Inspect the recessed well that the gateway was in.
- If any liquid or traces of liquid are present:
 - Take photos showing liquid or traces of liquid are present.
 - The gateway control module must be replaced.
 - The connector pins must be inspected and any corroded pins replaced.

- U.S. dealers: Upload photos showing evidence of liquid to Doc-It for review. Contact Audi Warranty for authorization.
- Canadian dealers: Create an ATA WEB ticket and attach photos of evidence of liquid for review.

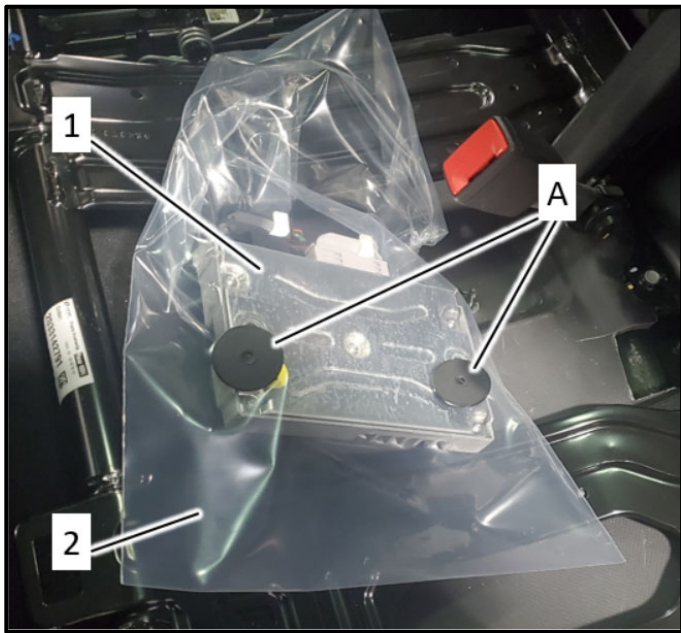
Install cover over gateway control module:

- Place the gateway control module <1> into protective cover <2>.
- The gaskets <A> will be placed over the studs on the floor.

It's also possible to install the cover onto the studs first, then install the gateway control module into the cover.

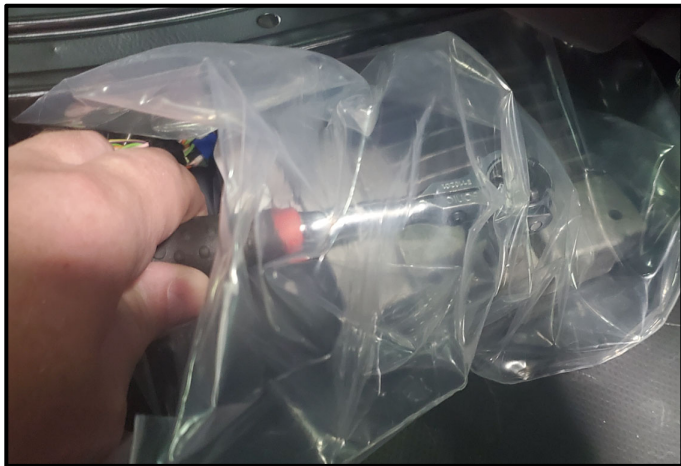
Reinstall gateway control module:

- The gateway must be fastened with new nuts.
- Tightening the nuts must be performed inside the protective cover, as shown.
- Torque the new nuts to 5 Nm.

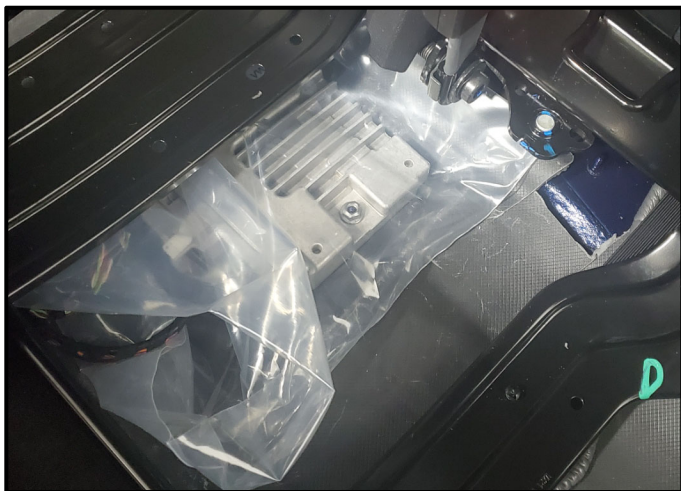
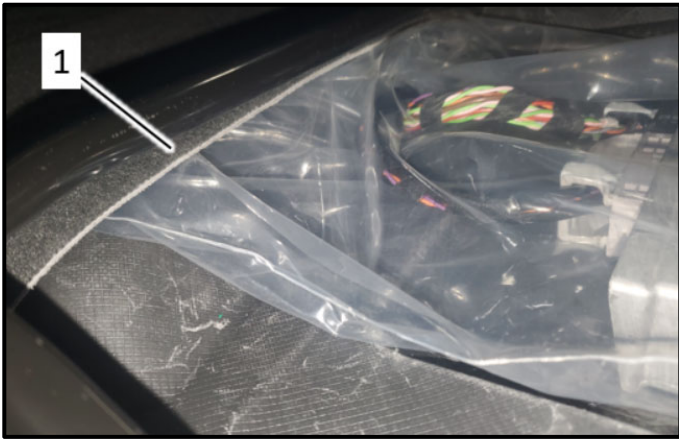
Final positioning of protective cover:

- Smooth out the protective cover and place the open end of the cover under the carpet <1>.

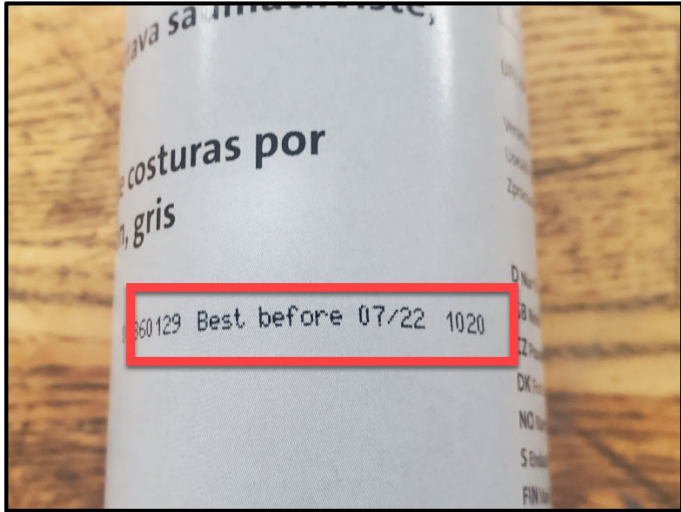
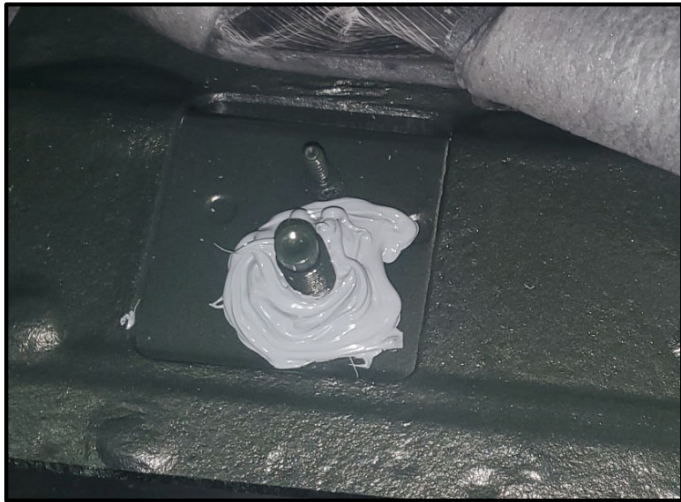
Apply sealant:

- Apply sealant around stud as shown.
- Ensure the base of the stud is fully encapsulated with sealant.
- Reposition floor insulation in its original position.
- Bring seat back to its original position.
