Safety Recall

Code: 90S9

Subject	Gateway Control Module																									
Release Date	July 22, 2022																									
REVISION SUMMARY	Added examples of incorrect gateway cover installation NOTE: Updated areas in this document are indicated by an orange bar in the right margin																									
Affected Vehicles

Subject: Safety Recall 90S9 – Gateway Control Module

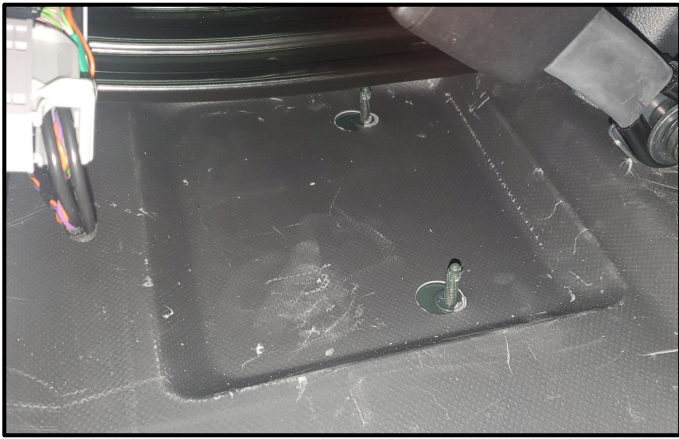
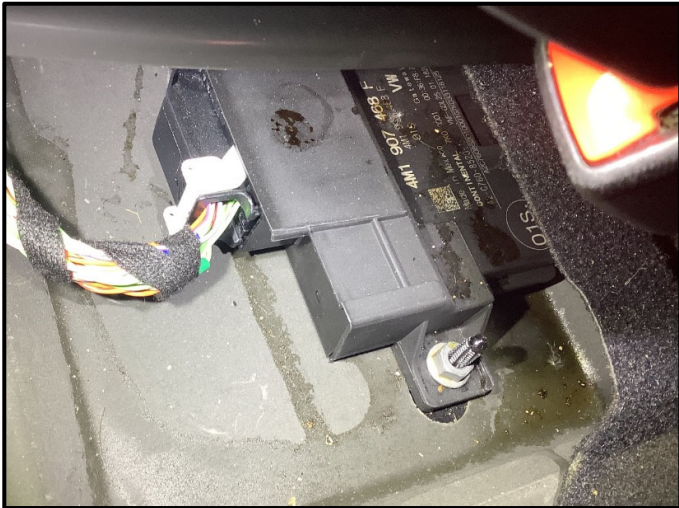
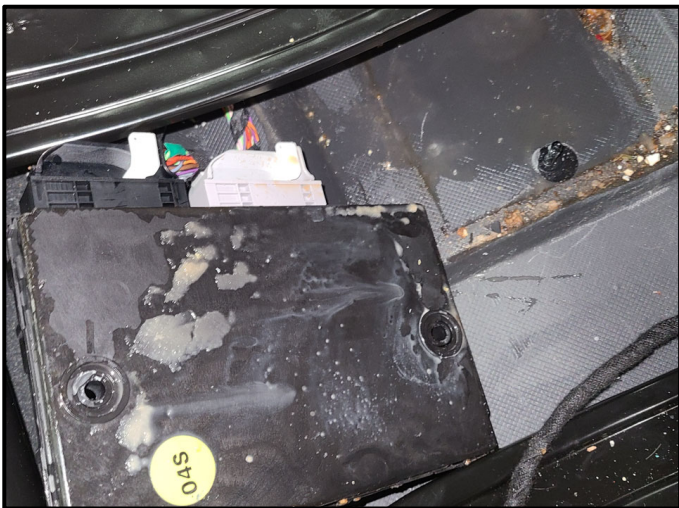
- Inspect the recessed well that the gateway was in.
- If any liquid or traces of liquid are present:
 - Take photos showing liquid or traces of liquid are present.
 - U.S. Dealers - Upload photos to Doc-It.
 - Canada Dealers - Upload photos to an ATA WEB Ticket
 - The gateway control module must be replaced.
 - The connector pins must be inspected and any corroded pins replaced.

If liquid is found on gateway, it is not necessary to contact Audi Warranty.
 If photos are not uploaded to Doc-It (U.S. Dealers) or to an ATA WEB Ticket (Canadian dealers), the claim for the gateway control module will be cancelled.

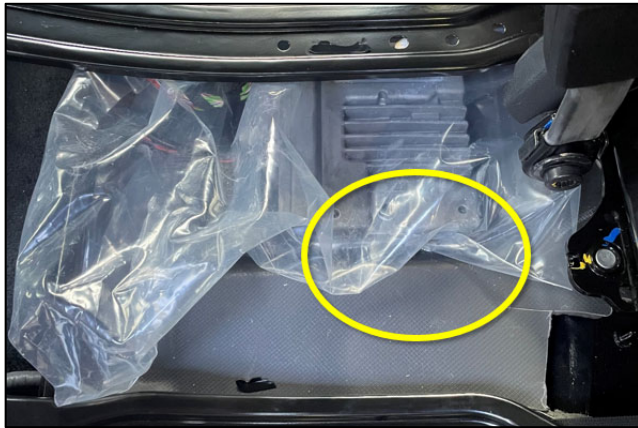
Ensure the cover is installed correctly. If the cover is folded under the gateway, it's possible to pinch the cover and create a puncture in the cover. Pay very close attention to how the cover is installed and also ensure the bolts are torqued correctly. Below are examples of covers that were not installed correctly, which can result in liquid entering the cover and damaging the gateway.

Cover folded under the gateway.

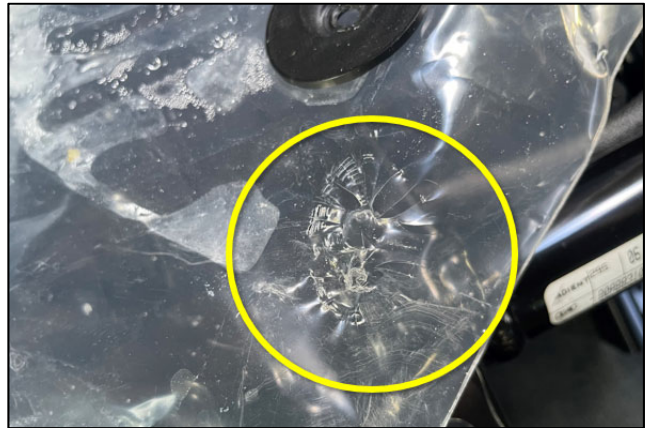
Cover pinched, resulting in puncture.

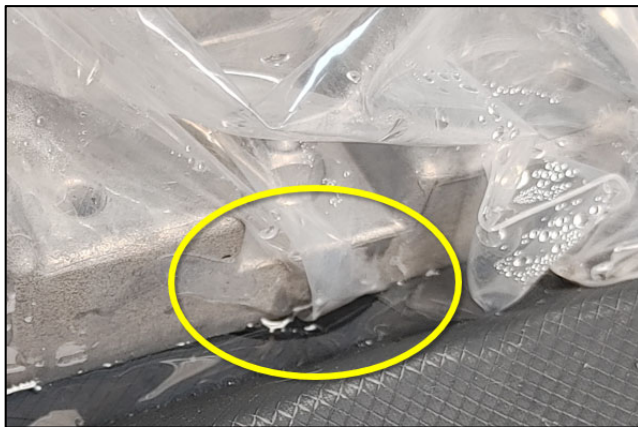
Cover folded under the gateway.

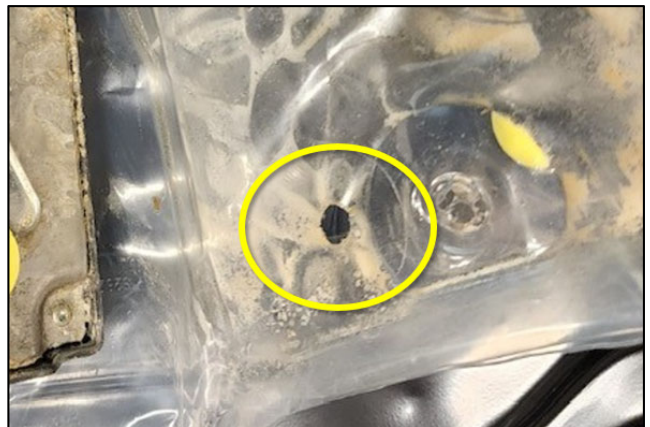
Cover pinched, resulting in puncture.

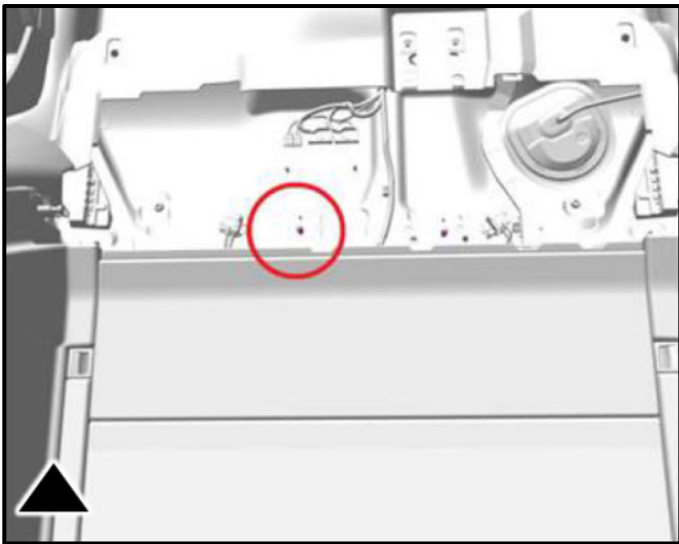
- The stud and area requiring sealant shown <circle>.

Prep area for sealant:
