# Safety Recall

Date	Number	Release	Page
12.2021	SC0433	01	1(9)

## Park Brake Control Valve MRU, TE

## Subject: BENDIX® PP-1® & PP-8™ PARK CONTROL VALVE WEAR AND REPLACEMENT NOTICE

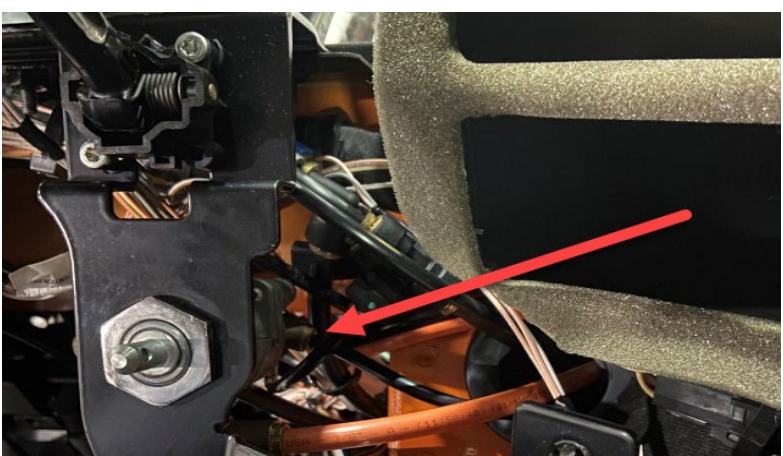
10. With all the panels removed, locate the park brake control valve (PP1) vent line. The vent line is directly opposite the yellow push pull button.
