PRODUCT CAMPAIGN BULLETIN

APPLICABILITY: 2020 MY Ascent

NUMBER: WRL-21R

SUBJECT: Front Axle Housings

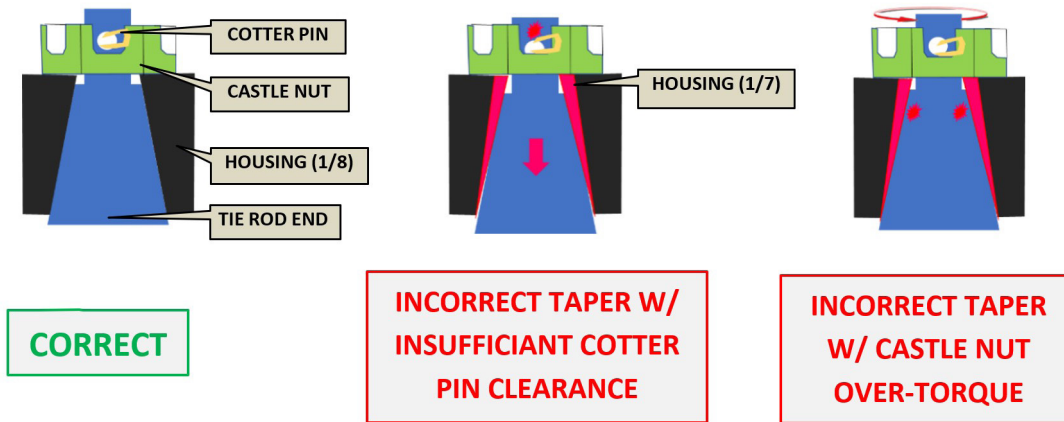
Axle Housing/Tie rod End Mounting Description:

The affected vehicles may be equipped with front axle housings that may have been manufactured with improperly tapered tie rod mounting holes. Over time, this condition may cause the tie rod end to separate from the axle housing, increasing the risk of a crash.

For all potentially affected vehicles, Subaru retailers will replace left front and right front housings, tie rod ends, and all related hardware with new parts at no cost to the customer.

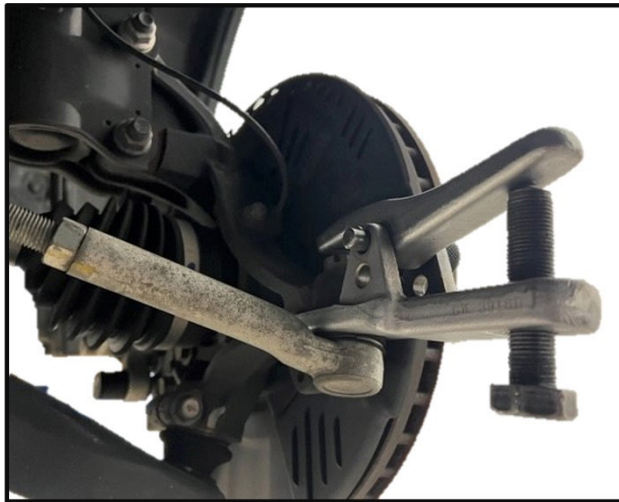
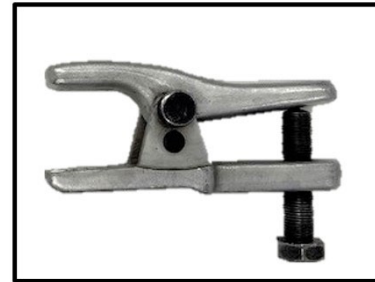
Tip 2: Even with usage of a recommended ball joint separator tool (shown below), there can be difficulty separating the tie rod end from the axle housing. This is caused by possible deformation of housing/tie rod from exceeded torque limits during installation. **ALWAYS** use eye protection when attempting to apply this method. If there is difficulty found when removing/separating the tie rod end with the axle housing, follow the procedures outlined on the next page.

OTC Ball Joint Separator **16-6297** shown above is available through the Subaru Dealer Equipment website: subaruretailersolutions.com
