## PRODUCT CAMPAIGN BULLETIN

**APPLICABILITY:** 2019-20MY Ascent  
 2020MY Legacy 2.4L (turbo models)  
 2020MY Outback 2.4L (turbo models)

**SUBJECT:** CVT Chain Guide Breakage

**NUMBER:** WRK-21R  
**DATE:** 07/05/22  
**REVISED:** 07/06/22  
**NHTSA ID:** 21V-955

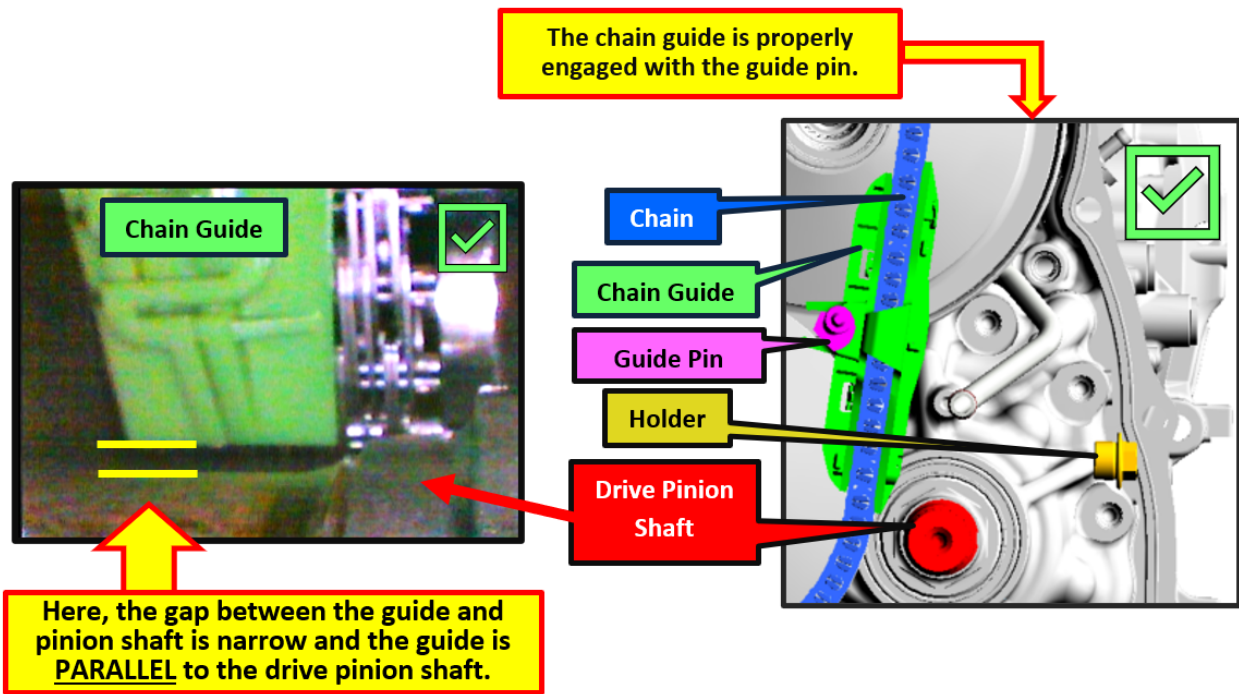
**CORRECT GUIDE POSITIONING:**

**STEP 3E:** Inspect the position of the lower end of the chain guide rail and the drive pinion shaft.
