PRODUCT CAMPAIGN BULLETIN

APPLICABILITY: 2019-20MY Ascent
 2020MY Legacy 2.4L (turbo models)
 2020MY Outback 2.4L (turbo models)

SUBJECT: CVT Chain Guide Breakage

NUMBER: WRK-21R
DATE: 07/05/22
REVISED: 07/08/22
NHTSA ID: 21V-955

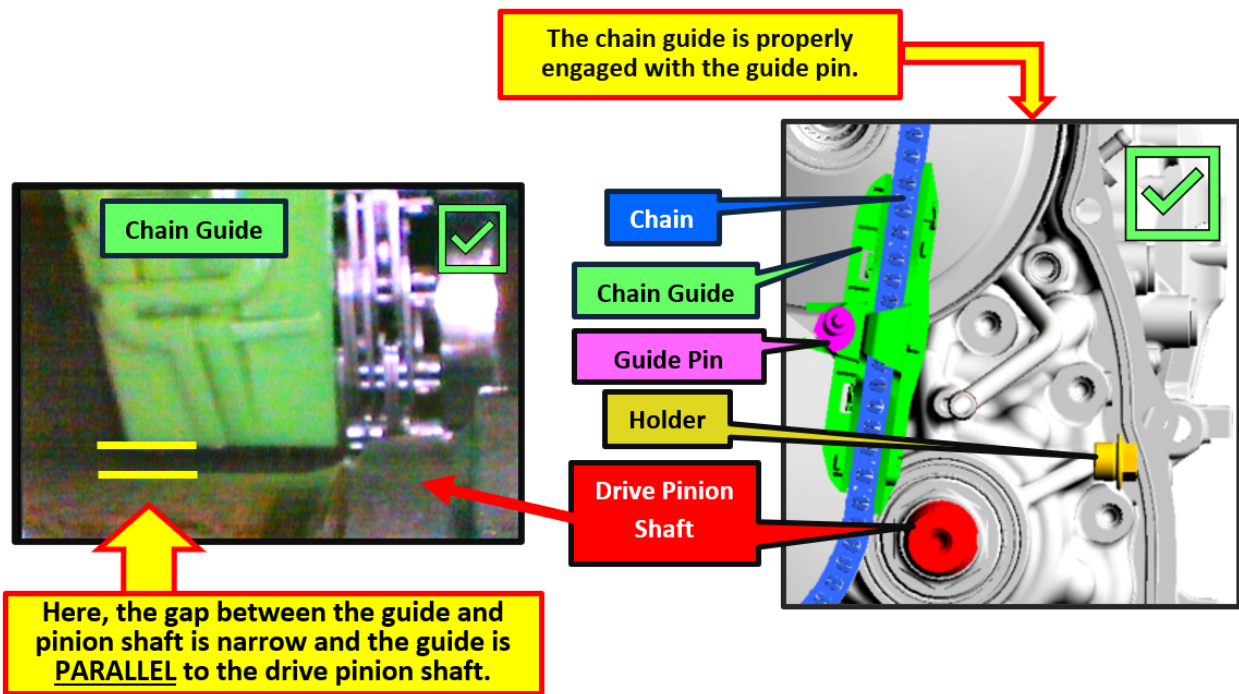
CORRECT GUIDE POSITIONING:

STEP 3E: Inspect the position of the lower end of the chain guide rail and the drive pinion shaft.

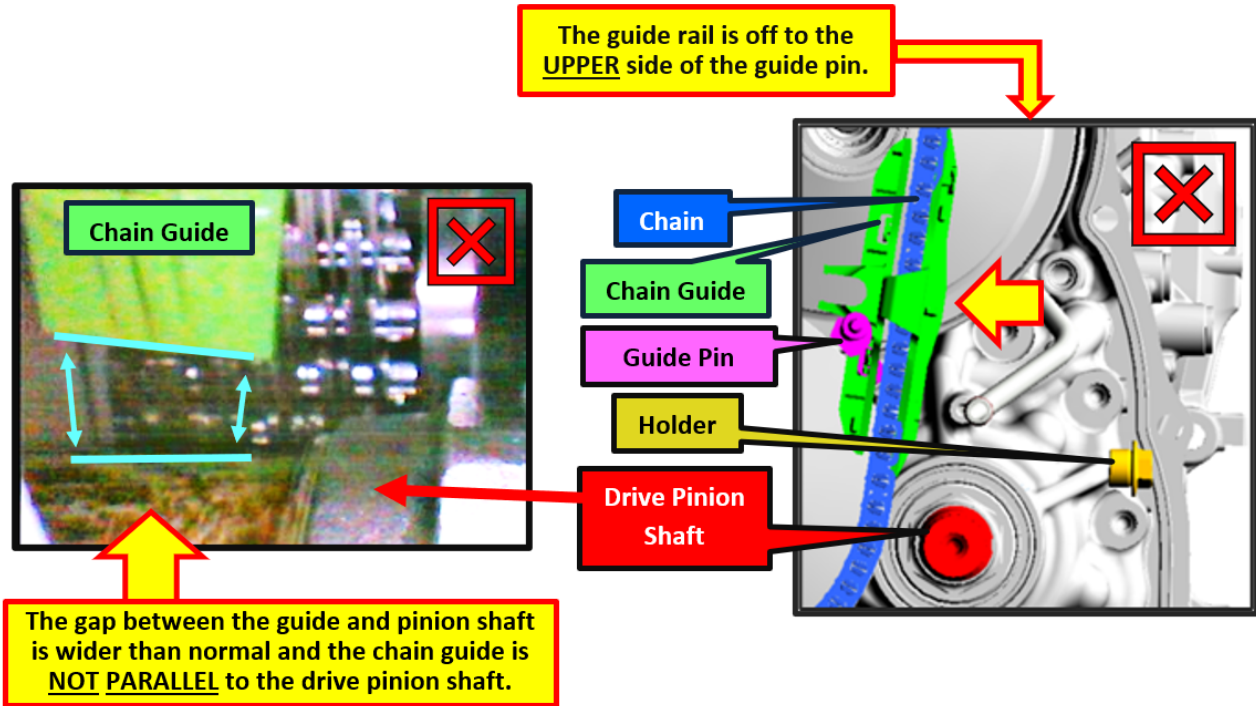
INCORRECT GUIDE POSITIONING 1:

Due to an improper program in the transmission control module (TCM), the CVT chain may slip, resulting in breakage of the chain guide. If the chain guide breaks, fragments of the guide could inhibit the shift select mechanism. If the vehicle continues operation with the drive chain slipping, over time the CVT drive chain could break.

STEP 4A: Replace the CVT assembly.
