PRODUCT CAMPAIGN BULLETIN

APPLICABILITY: 2019-20MY Ascent
 2020MY Legacy 2.4L (turbo models)
 2020MY Outback 2.4L (turbo models)

SUBJECT: CVT Chain Guide Breakage

NUMBER: WRK-21
DATE: 07/05/22
NHTSA ID: 21V-955

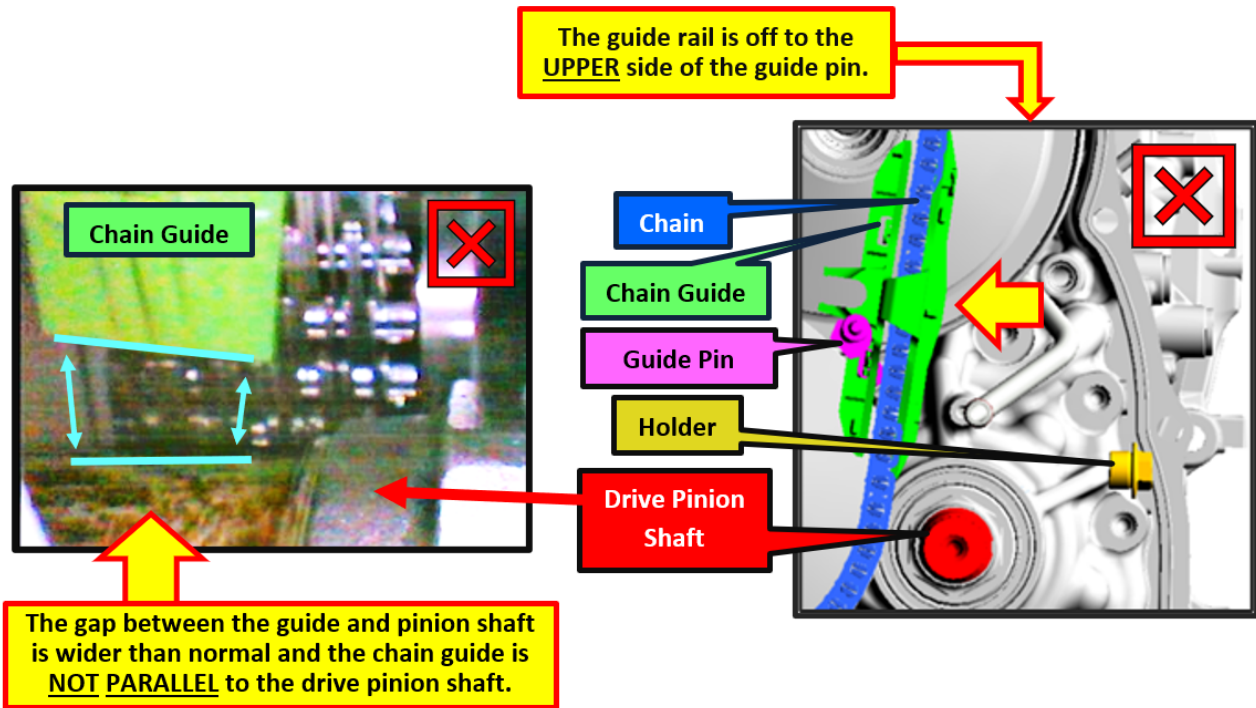
INCORRECT GUIDE POSITIONING 1:

Due to an improper program in the transmission control module (TCM), the CVT chain may slip, resulting in breakage of the chain guide. If the chain guide breaks, fragments of the guide could inhibit the shift select mechanism. If the vehicle continues operation with the drive chain slipping, over time the CVT drive chain could break.

STEP 4A: Replace the CVT assembly.
