## For Subaru Field Service Engineer Use ONLY

**Applicability:** 2019-20MY Ascent  
2020-21MY Legacy & Outback

**Number:** WRK-21

**Subject:** TR690 Chain Guide Inspection / TCM Reprogramming

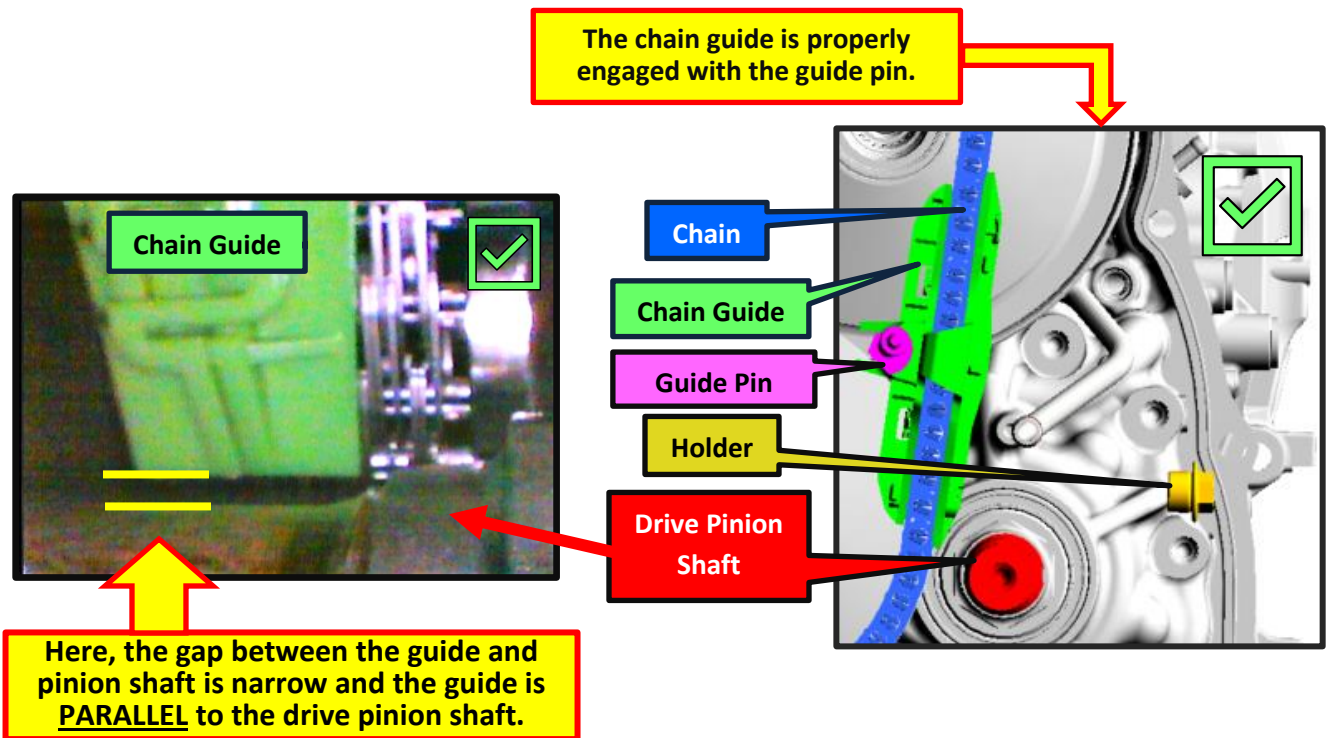
**CORRECT GUIDE POSITIONING:**

**STEP 8E:** Inspect the position of the lower end of the chain guide rail and the drive pinion shaft.

Result	Next step
<b>CORRECT POSITION</b>	Proceed to <b>STEP 10</b>
<b>INCORRECT POSITION 1 OR 2</b>	Proceed to <b>STEP 9</b>
