For Subaru Field Service Engineer Use ONLY

Supplemental work procedures for 2019MY Ascent updated with the PAK file released April 12th, 2022.

STEP 1-A: Reprogram the Transmission Control Module (TCM) with the **TEMPORARY** PAK file.

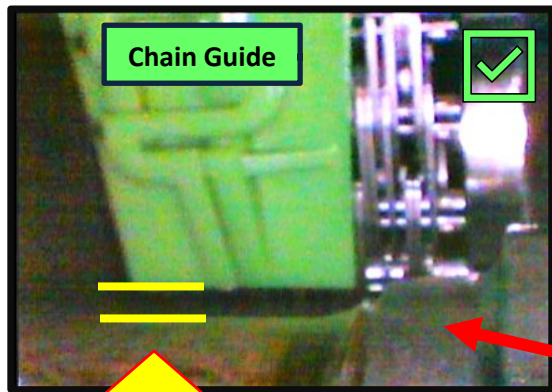
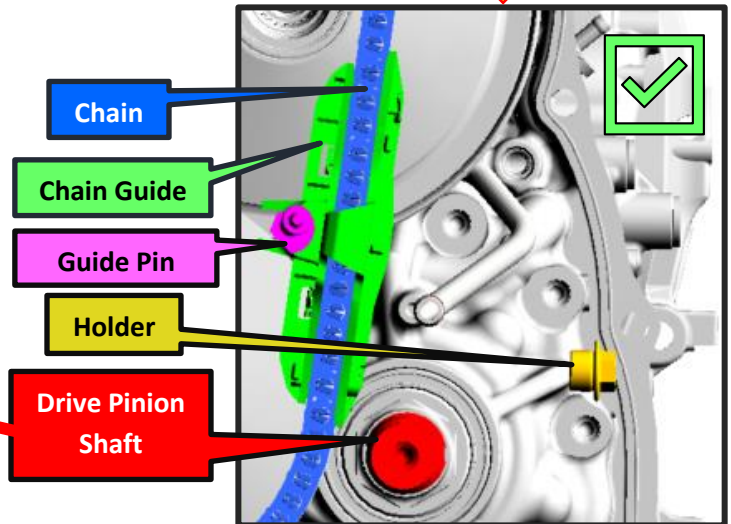
CORRECT GUIDE POSITIONING:

The chain guide is properly engaged with the guide pin.

Here, the gap between the guide and pinion shaft is narrow and the guide is **PARALLEL** to the drive pinion shaft.

Result	Next step
CORRECT POSITION	Proceed to STEP 5
INCORRECT POSITION 1 OR 2	Proceed to STEP 4
