Applicability: 2019-20MY Ascent
2020MY Legacy & Outback

Number: WRK-21

Subject: TR690 Chain Guide Inspection / TCM Reprogramming

Date: 5/3/22

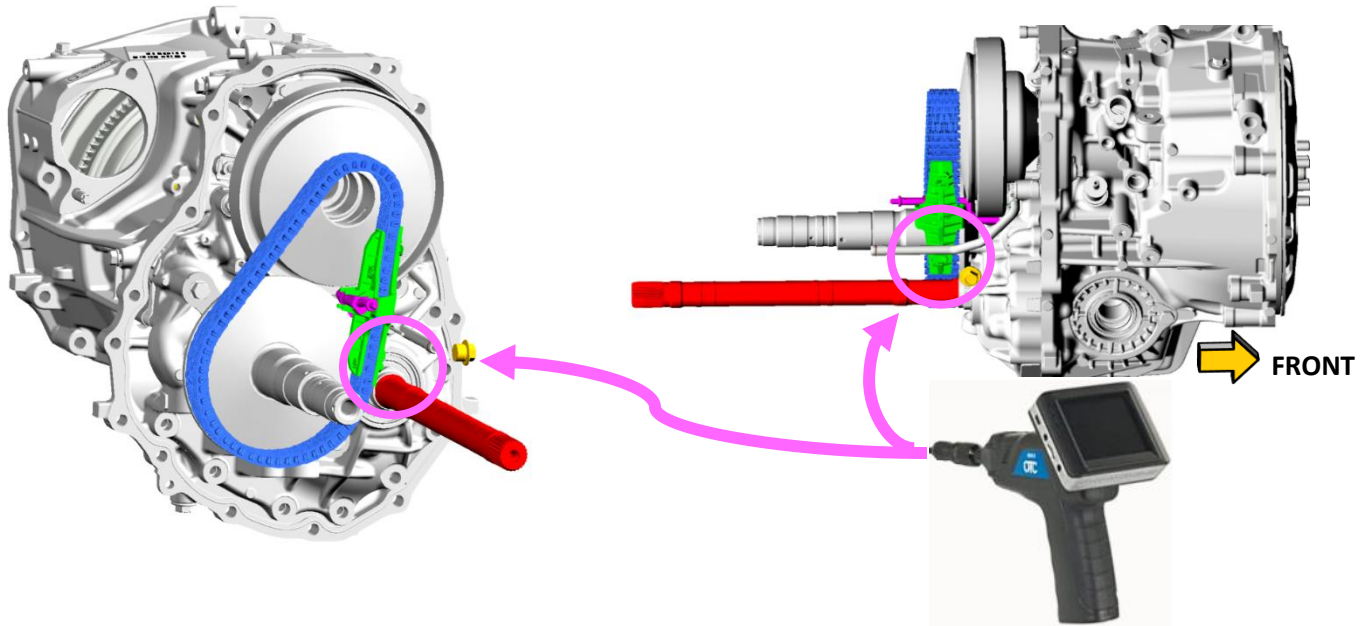
STEP 3E: Inspect the position of the lower end of the chain guide rail and the drive pinion shaft.

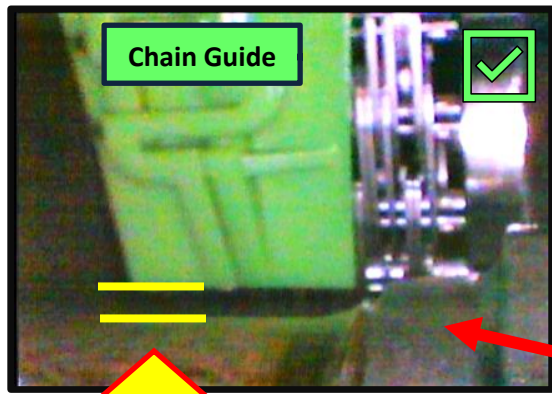
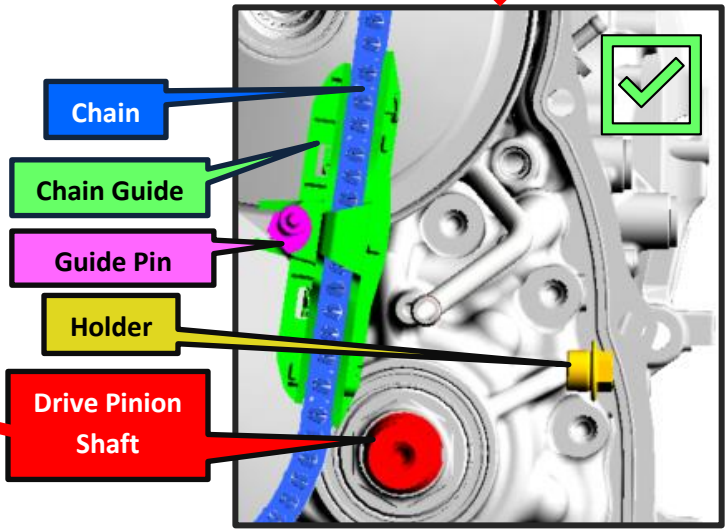
CORRECT GUIDE POSITIONING:

The chain guide is properly engaged with the guide pin.

Here, the gap between the guide and pinion shaft is narrow and the guide is PARALLEL to the drive pinion shaft.

Result	Next step
CORRECT POSITION	Proceed to STEP 5
INCORRECT POSITION 1 OR 2	Proceed to STEP 4
