RECALL CAMPAIGN BULLETIN

RS21-008

NTB21-112

VOLUNTARY SAFETY RECALL CAMPAIGN 2022 FRONTIER; DRIVER SIDE REAR SEAT BELT BUCKLE BRACKET BOLT INSPECTION

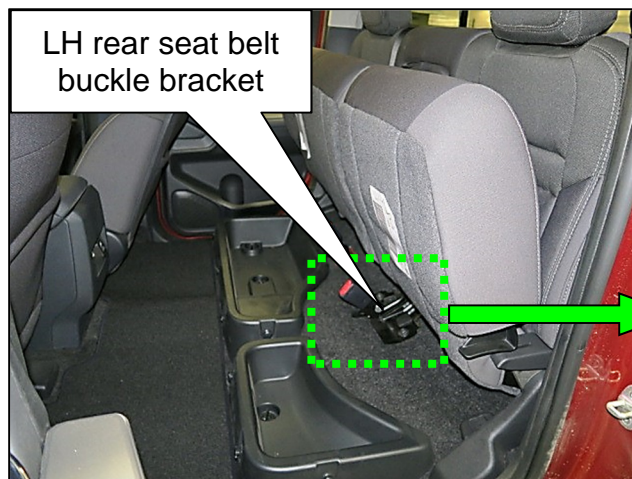
Figure 1

1. Open both rear passenger doors and lift both rear seat cushions to the upright and locked position, as shown in Figure 1.
2. Locate the LH rear seat belt buckle bracket bolts (Figure 1 and Figure 2).

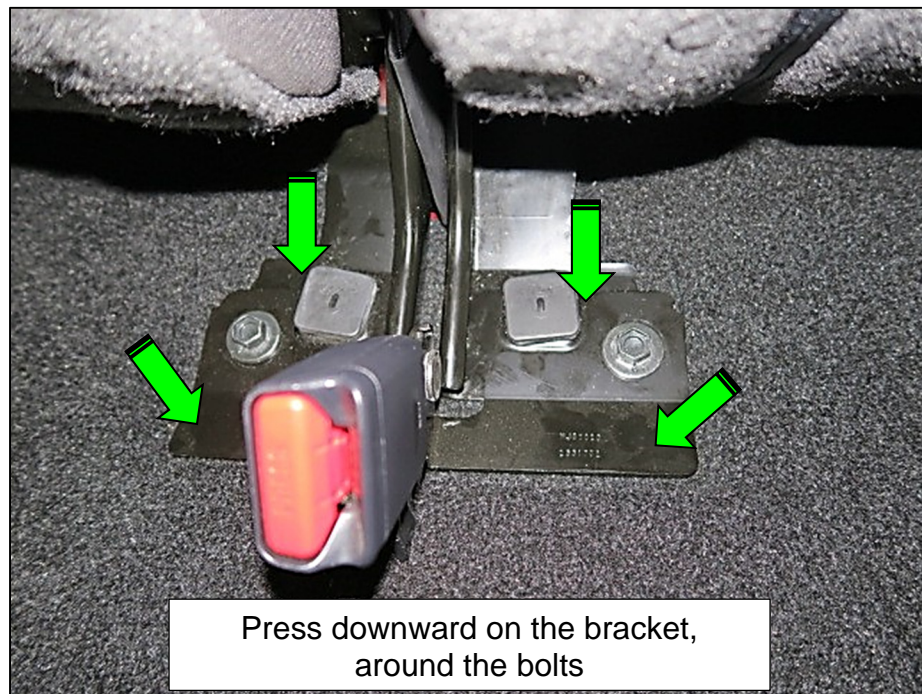
Figure 3

3. Use the following steps to inspect both the seat belt buckle bracket bolts to determine if the bolts are fully seated.
 - a. Visually inspect each bolt to determine if the bolts are flush with the seat belt buckle bracket.
 - b. Attempt to turn the bolt washers by hand.
 - c. Check for bracket looseness by pushing downward on the seat belt buckle bracket around each bolt (Figure 3).

4. If one or both bolts:
 - Is not flush with the bracket, either bolt washer turns by hand, or the bracket has movement around either one of the bolts, they are not fully seated; proceed to step 5 on page 4.
 - Is flush, washers do not turn and the bracket does not move, both bolts are fully seated and the inspection is complete; skip to step 9 on page 5.
