**SUBJECT: NEW VEHICLE DEMONSTRATION / DELIVERY HOLD -  
 Safety Recall 21S56 – Supplement #4**

Certain 2021 - 2022 Model Year F-150 Vehicles Equipped with Crew Cab, 145" Wheelbase, 4x4, 302a & Above Option Package, and One-Piece Aluminum Driveshaft  
 Loose/Sagging Underbody Insulators

In some of the affected vehicles, underbody insulators may loosen and contact the aluminum driveshaft, resulting in marking or scoring of the driveshaft. Over time, the aluminum driveshaft may fracture, which can result in loss of motive power while driving, unintended vehicle movement while the vehicle is in park if the parking brake is not applied, and secondary damage to surrounding components. A fractured driveshaft may also contact the ground which may cause loss of control of the vehicle while driving. A fractured driveshaft increases the risk of injury or crash.

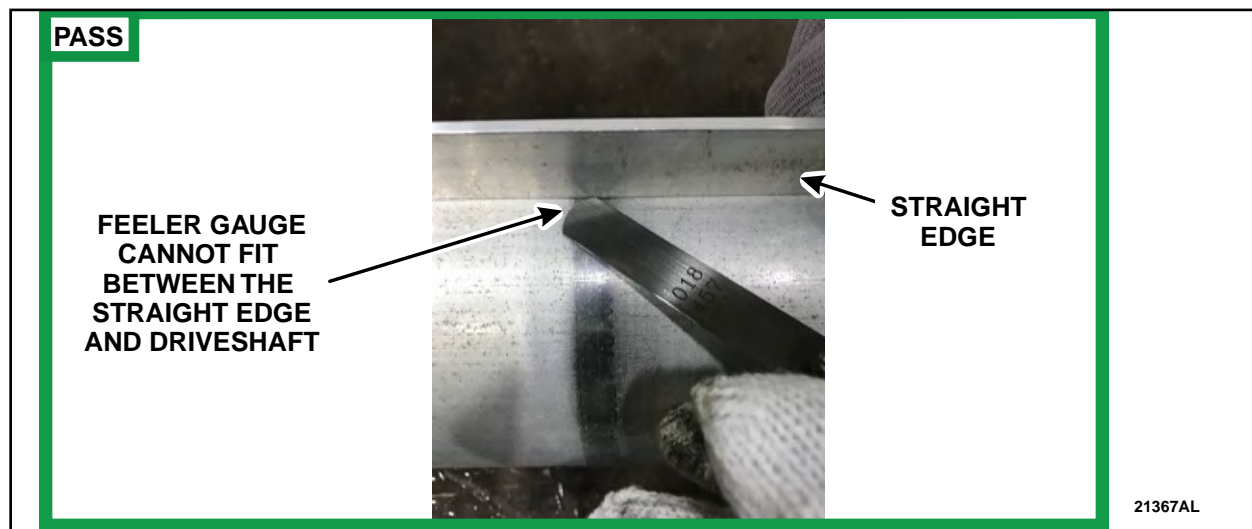
**FIGURE 3**

**Yes – Does not pass inspection. Contact the SSSC and provide a picture of the driveshaft with the feeler gauge fitting between the straight edge and wear mark. Once approved, rear driveshaft replacement will be required, but do not install at this time. Proceed to step 14.**

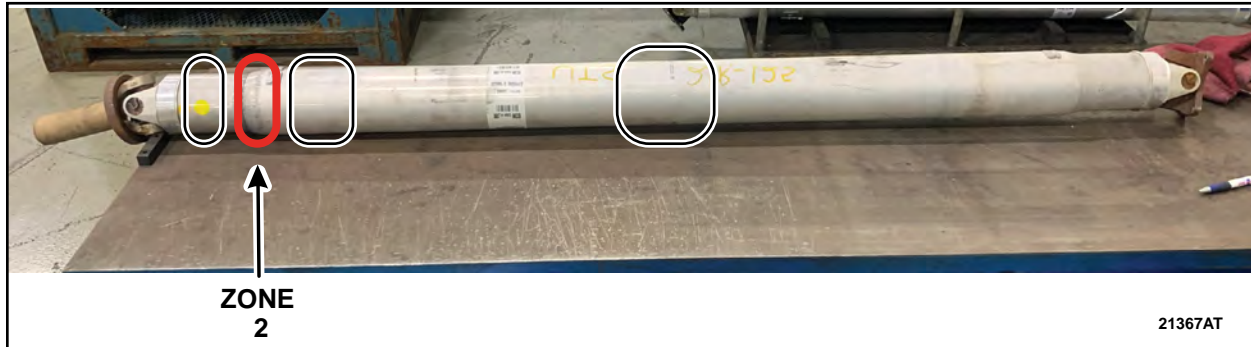
**FIGURE 5**

**Yes – Does not pass inspection. Proceed to step 13.**

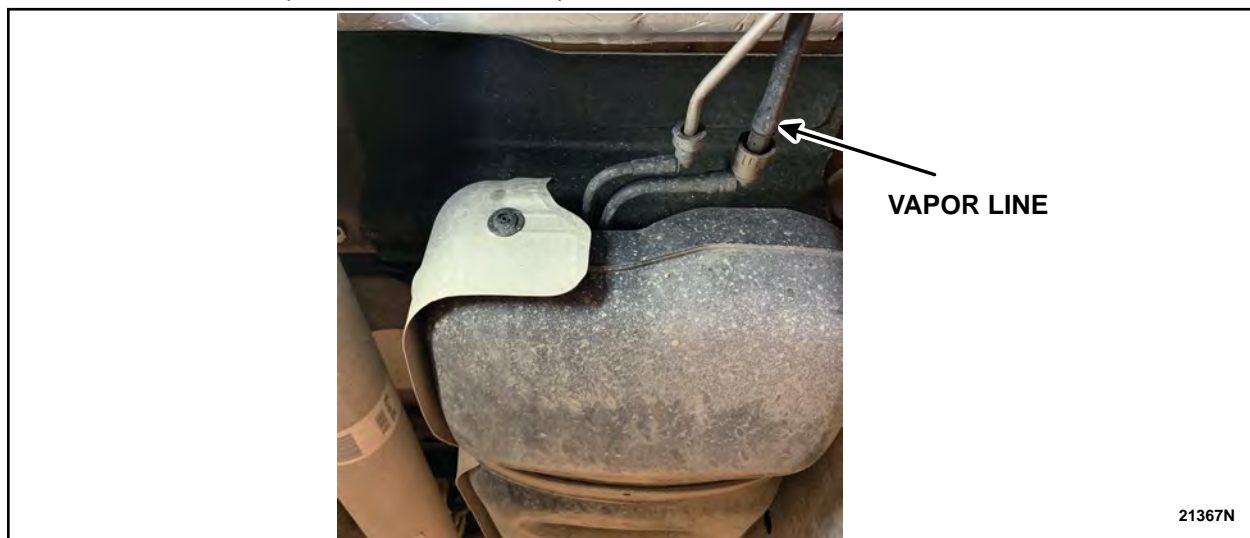
**FIGURE 11**

Yes – Does not pass inspection. Replace the damaged line. Please follow WSM procedures in Section 310-01, then proceed to step 17.
