**SUBJECT: NEW VEHICLE DEMONSTRATION / DELIVERY HOLD -  
 Safety Recall 21S56 – Supplement #3**

Certain 2021 - 2022 Model Year F-150 Vehicles Equipped with Crew Cab, 145" Wheelbase, 4x4, 302a & Above Option Package, and One-Piece Aluminum Driveshaft Loose/Sagging Underbody Insulators

**REASON FOR THIS SAFETY RECALL**

In some of the affected vehicles, underbody insulators may loosen and contact the aluminum driveshaft, resulting in marking or scoring of the driveshaft. Over time, the aluminum driveshaft may fracture, which can result in loss of motive power while driving, unintended vehicle movement while the vehicle is in park if the parking brake is not applied, and secondary damage to surrounding components. A fractured driveshaft may also contact the ground which may cause loss of control of the vehicle while driving. A fractured driveshaft increases the risk of injury or crash.

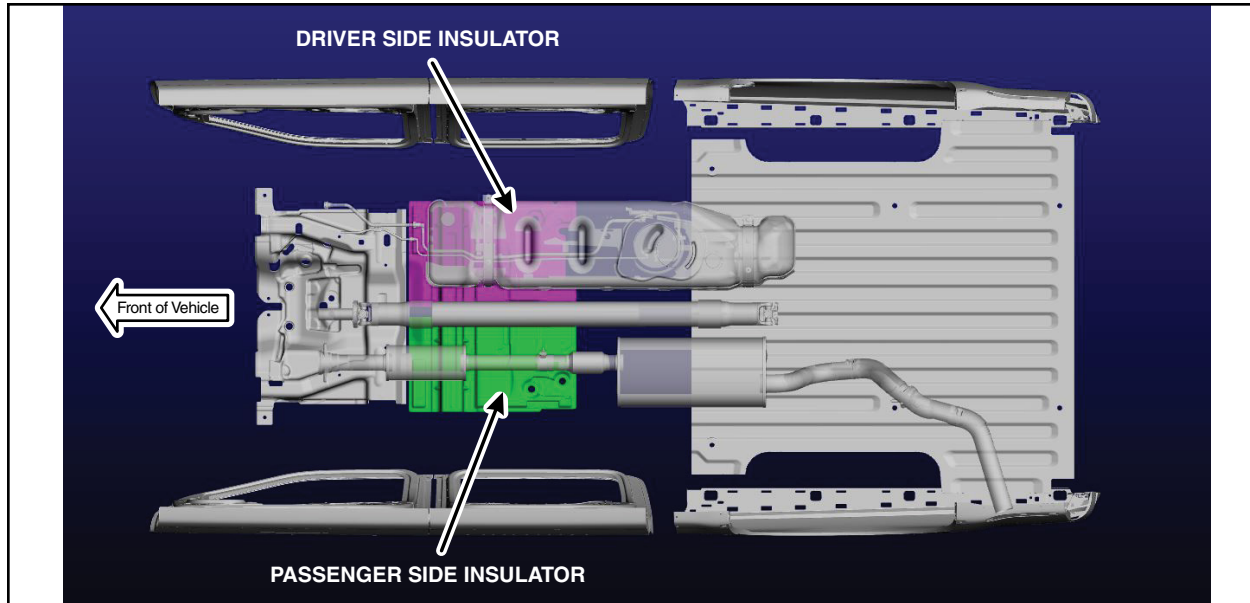
**FIGURE 1**

**NOTE:** The passenger side insulator is located directly above the exhaust.

Dearborn Truck Plant Build Date - Design change that removed underbody insulators from production

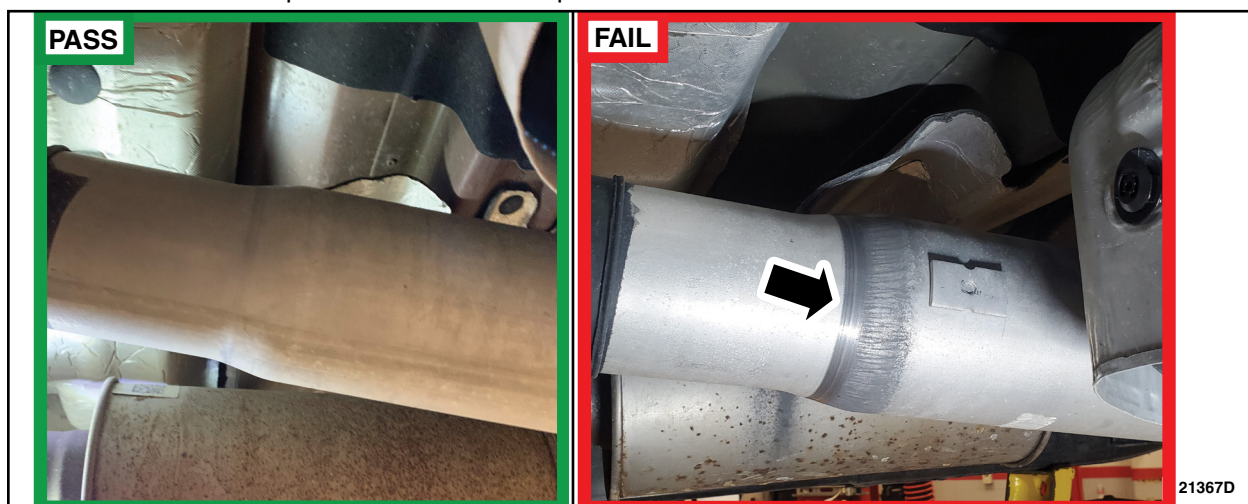
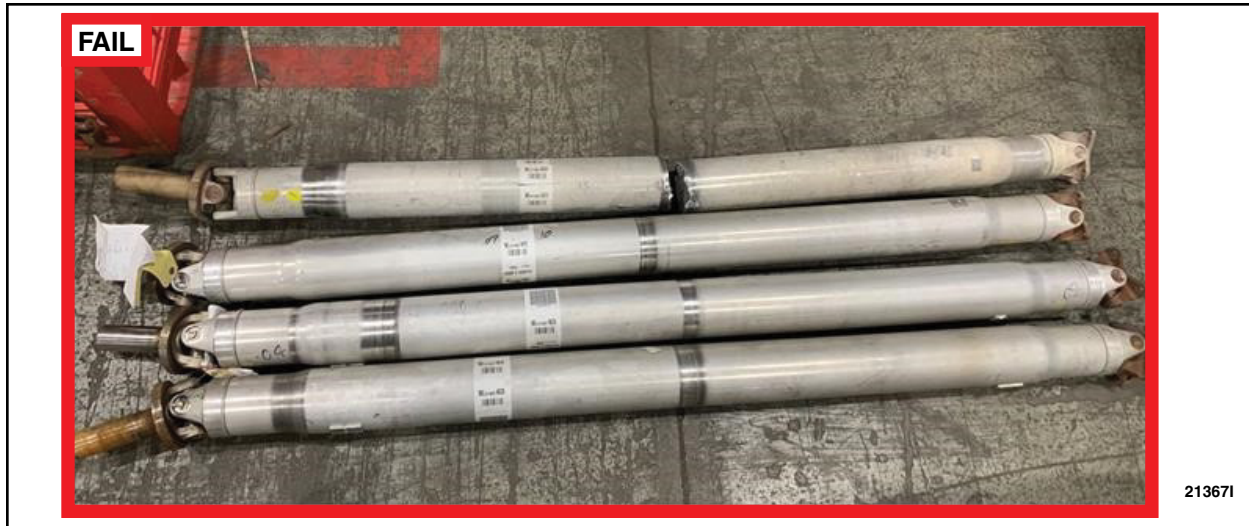
FIGURE 2

- Inspect the rear driveshaft for any marks caused by the passenger side insulator. Are there any marks present on the driveshaft due to contact from the insulator? See Figures 2 and 3.

Yes – Does not pass inspection. Contact the SSSC and provide a picture of the driveshaft with the marks. Once approved, rear driveshaft replacement will be required, but do not install at this time. Proceed to step 10.  
No – Passes inspection. Proceed to step 10.

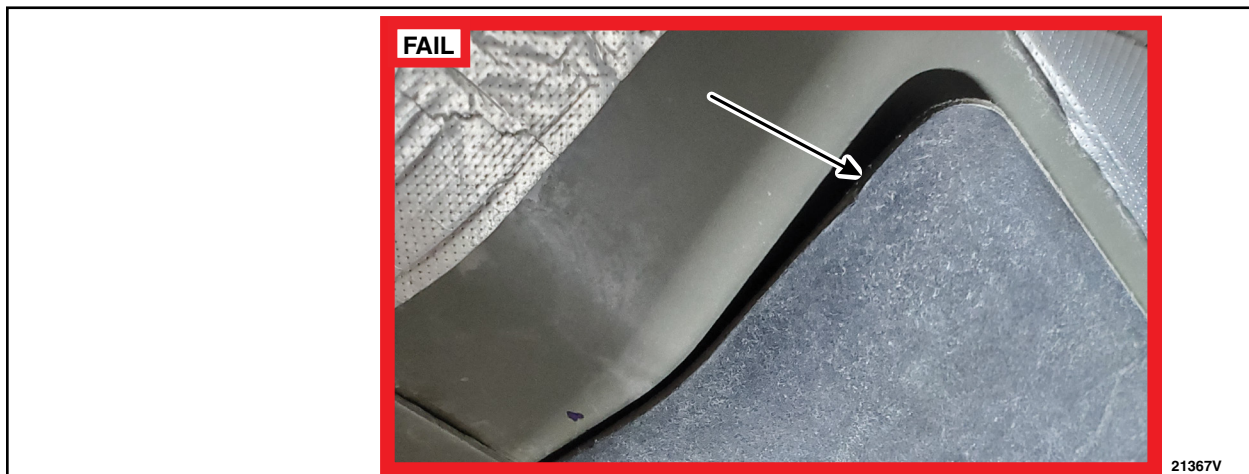
FIGURE 4

Yes – Does not pass inspection. Proceed to step 11.

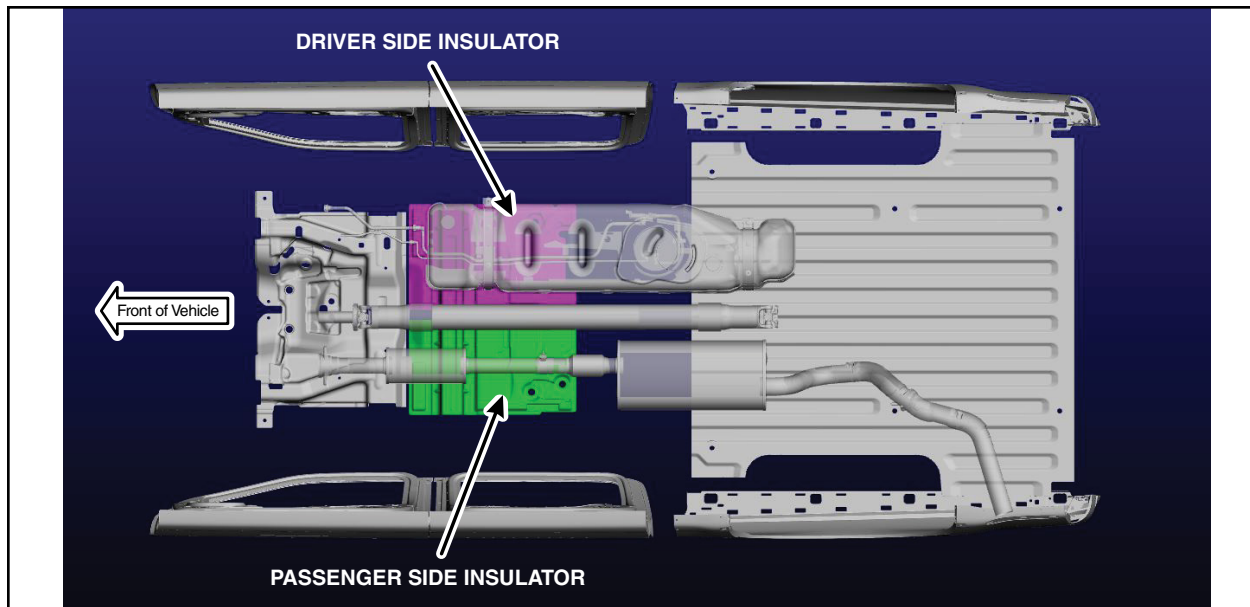
**FIGURE 1**

**NOTE:** Insulators are highlighted for illustration purposes only.

Dearborn Truck Plant Build Date - Design change that removed underbody insulators from production

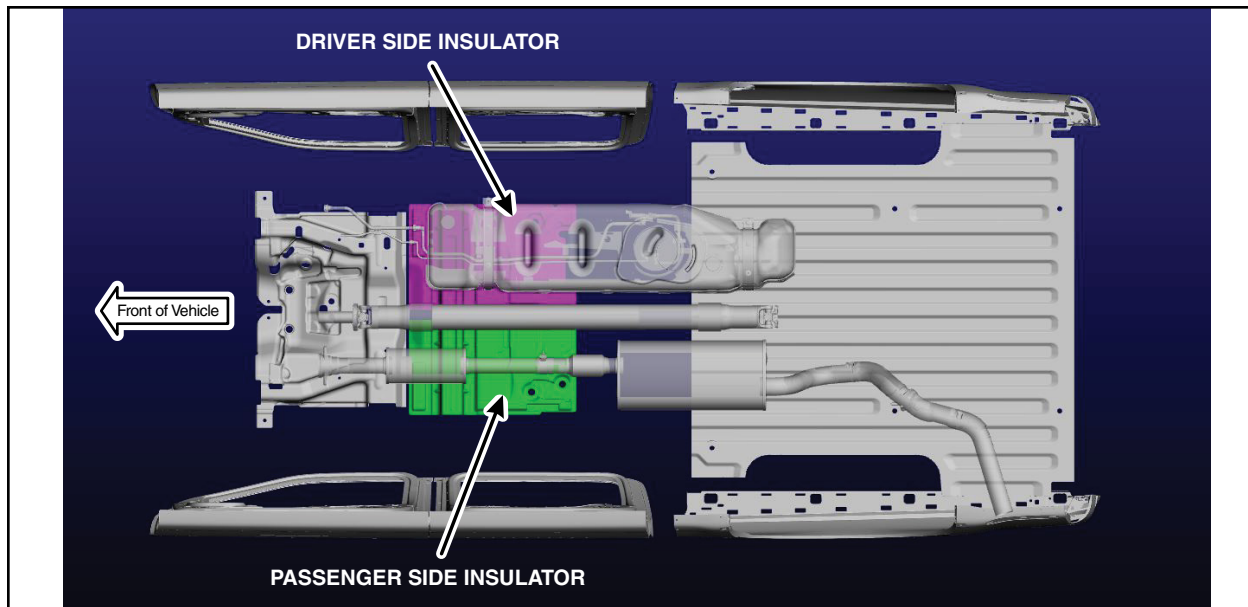
**FIGURE 1**

**NOTE:** Insulators are highlighted for illustration purposes only.

Dearborn Truck Plant Build Date - Design change that removed underbody insulators from production

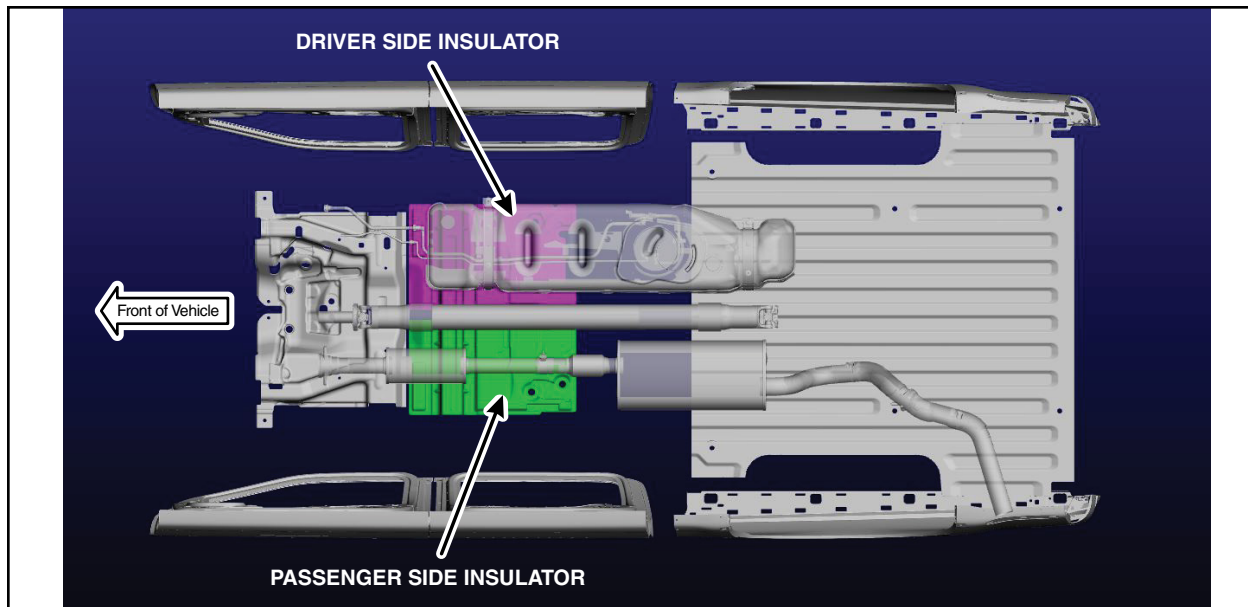
**FIGURE 1**

**NOTE:** Insulators are highlighted for illustration purposes only.

Kansas City Build Date - Design change that removed underbody insulators from production
