**SUBJECT: NEW VEHICLE DEMONSTRATION / DELIVERY HOLD -
 Safety Recall 21S56 – Supplement #1**

Certain 2021 - 2022 Model Year F-150 Vehicles Equipped with Crew Cab, 145”
 Wheelbase, 4x4, 302a & Above Option Package, and One-Piece Aluminum Driveshaft
 Loose/Sagging Underbody Insulators

In some of the affected vehicles, underbody insulators may loosen and contact the aluminum driveshaft, resulting in marking or scoring of the driveshaft. Over time, the aluminum driveshaft may fracture, which can result in loss of motive power while driving, unintended vehicle movement while the vehicle is in park if the parking brake is not applied, and secondary damage to surrounding components. A fractured driveshaft may also contact the ground which may cause loss of control of the vehicle while driving. A fractured driveshaft increases the risk of injury or crash.

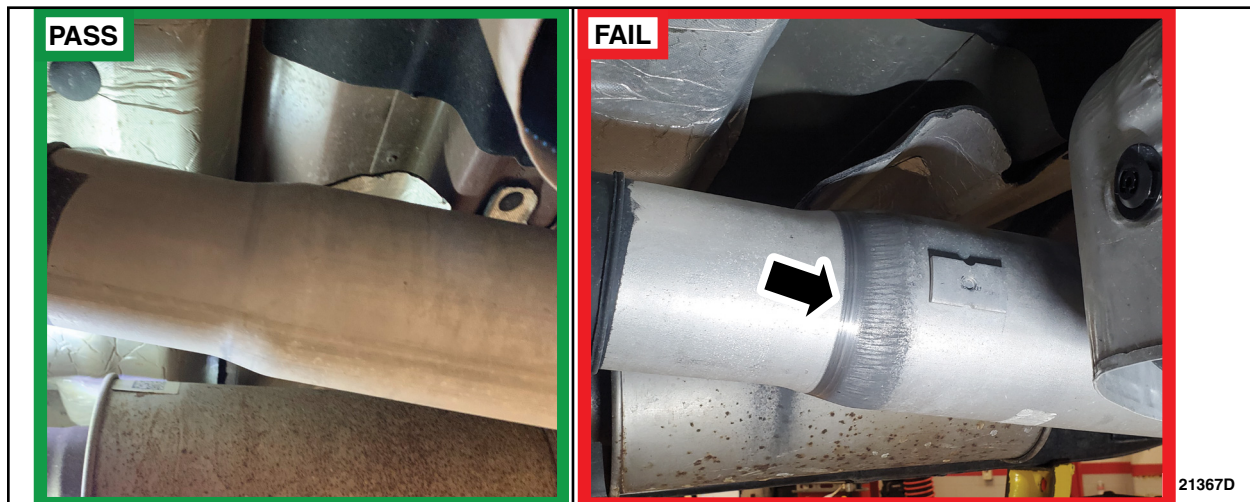
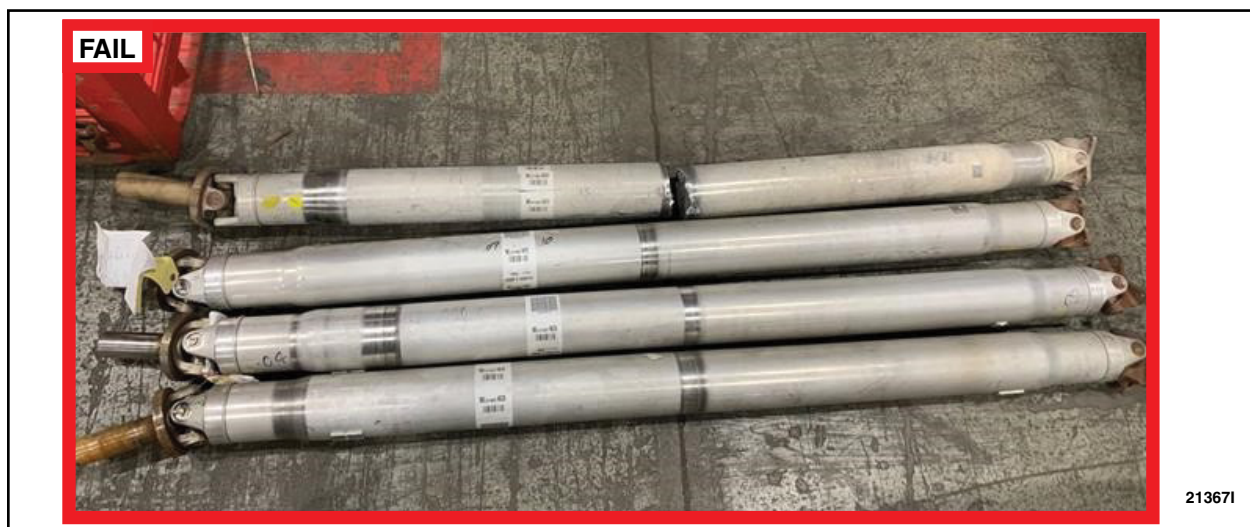
4. Inspect the rear driveshaft for any marks caused by the passenger side insulator. Are there any marks present on the driveshaft due to contact from the insulator? See Figures 2 and 3.

Yes – Does not pass inspection. Contact the SSSC and provide a picture of the driveshaft with the marks. Once approved, rear driveshaft replacement will be required, but do not install at this time. Proceed to step 5.

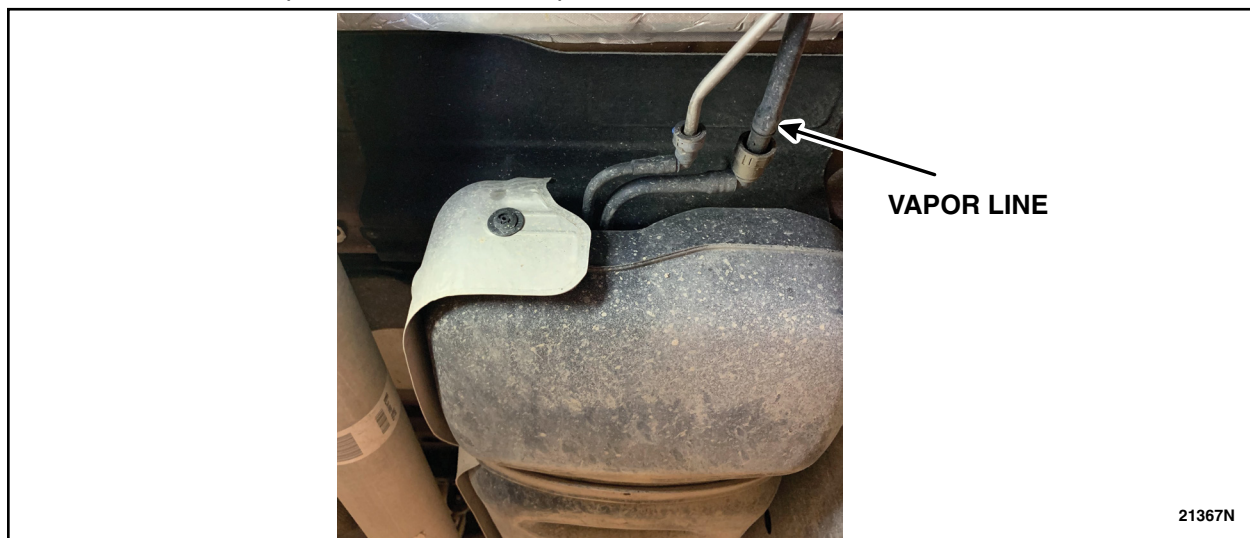
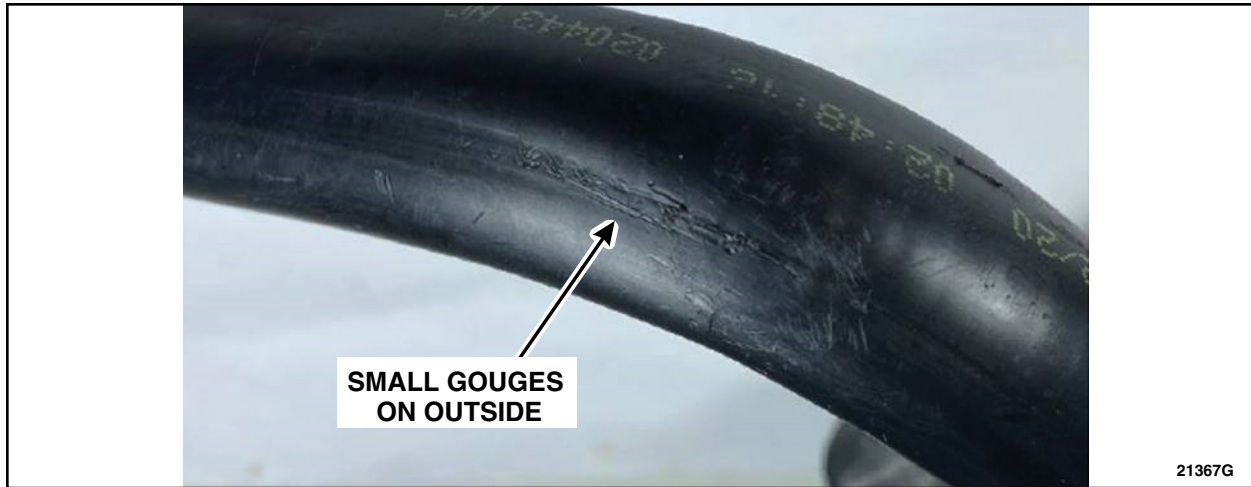
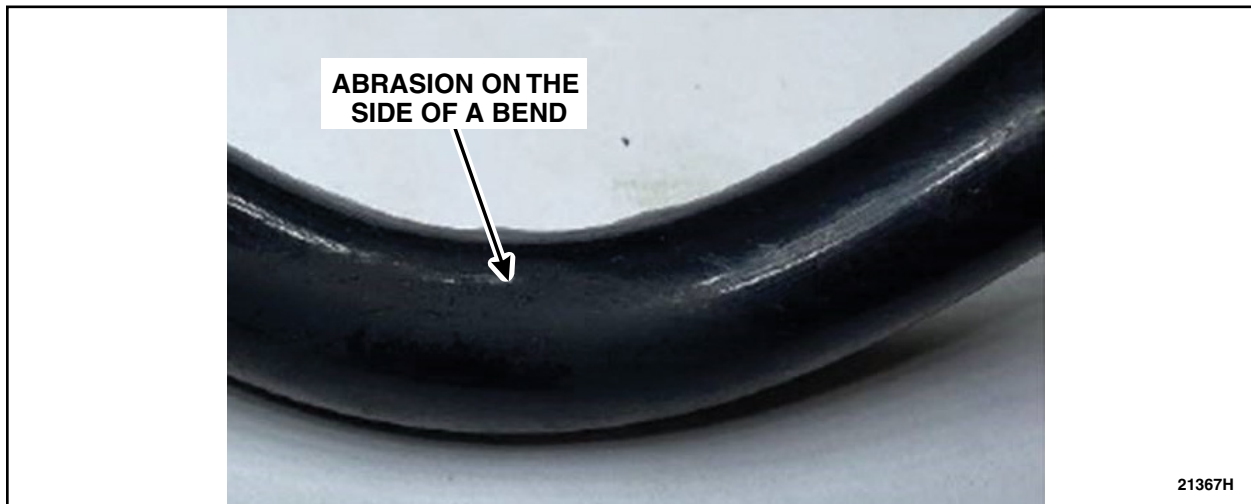
6. Remove the fuel tank to gain access to the vapor line. Please follow WSM procedures in Section 310-01.
7. Inspect the vapor line for any damage caused by the driver side insulator. Is there any damage to the line? See Figures 5 through 7.

Yes – Does not pass inspection. Replace the damaged line. Please follow WSM procedures in Section 310-01, then proceed to step 8.

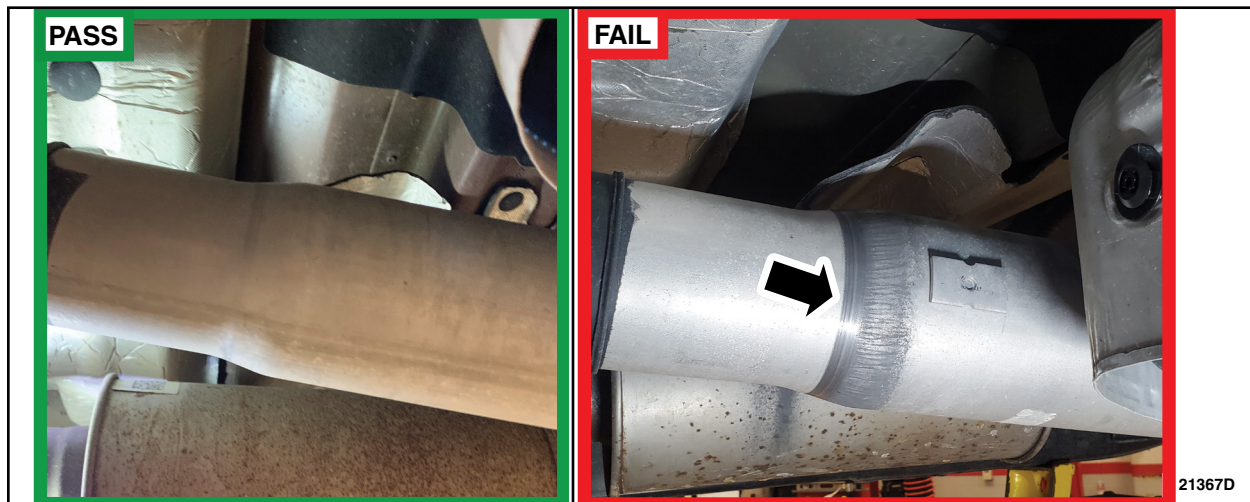
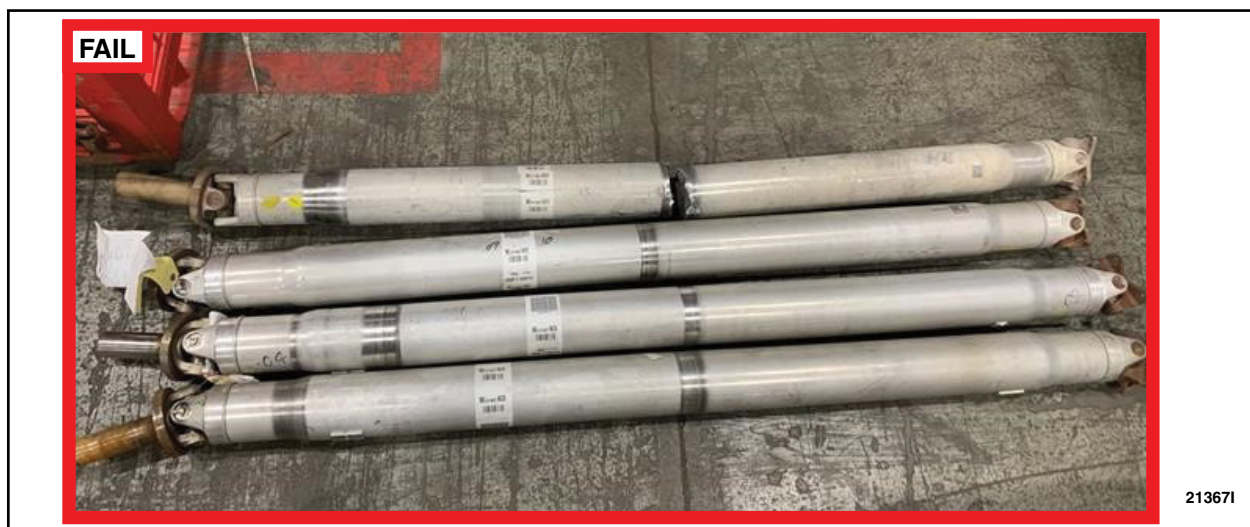
3. Inspect the rear driveshaft for any marks caused by the passenger side insulator. Are there any marks present on the driveshaft due to contact from the insulator? See Figures 2 and 3.

Yes – Does not pass inspection. Contact the SSSC and provide a picture of the driveshaft with the marks. Once approved, rear driveshaft replacement will be required, but do not install at this time. Proceed to step 4.

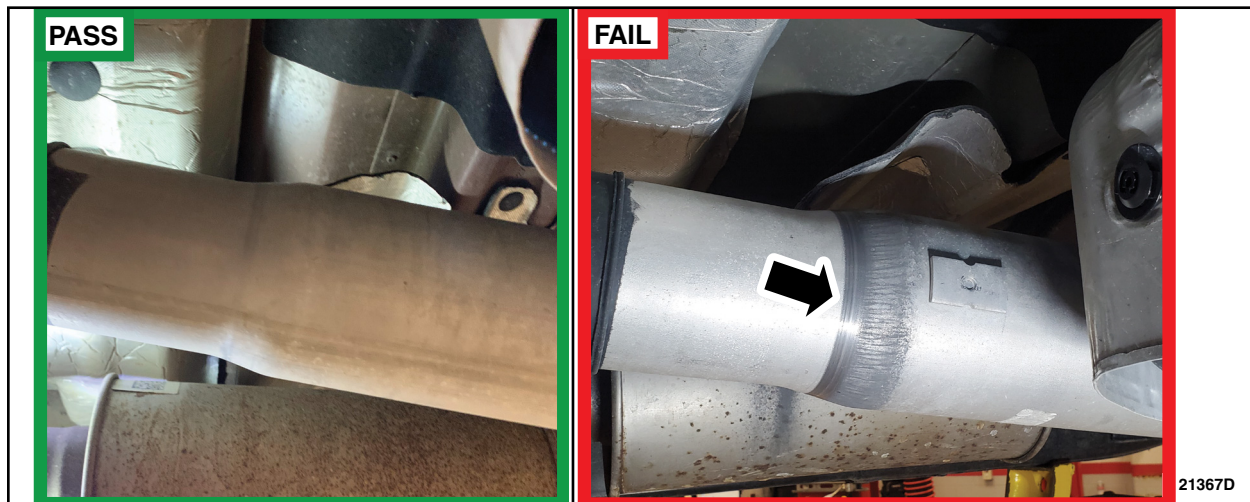
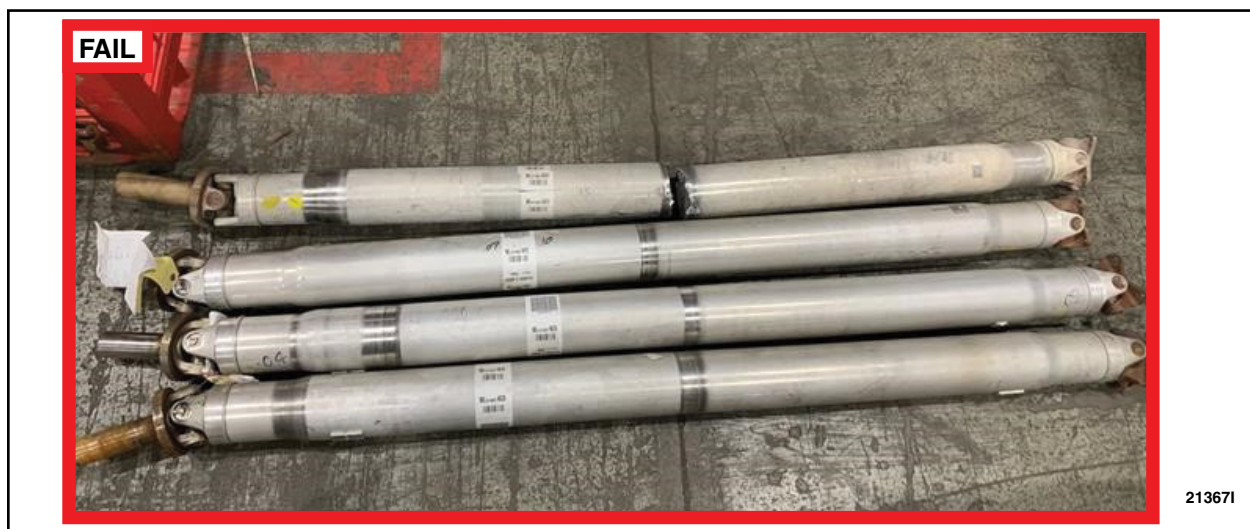
3. Inspect the rear driveshaft for any marks caused by the passenger side insulator. Are there any marks present on the driveshaft due to contact from the insulator? See Figures 2 and 3.

Yes – Does not pass inspection. Contact the SSSC and provide a picture of the driveshaft with the marks. Once approved, rear driveshaft replacement will be required, but do not install at this time. Proceed to step 4.

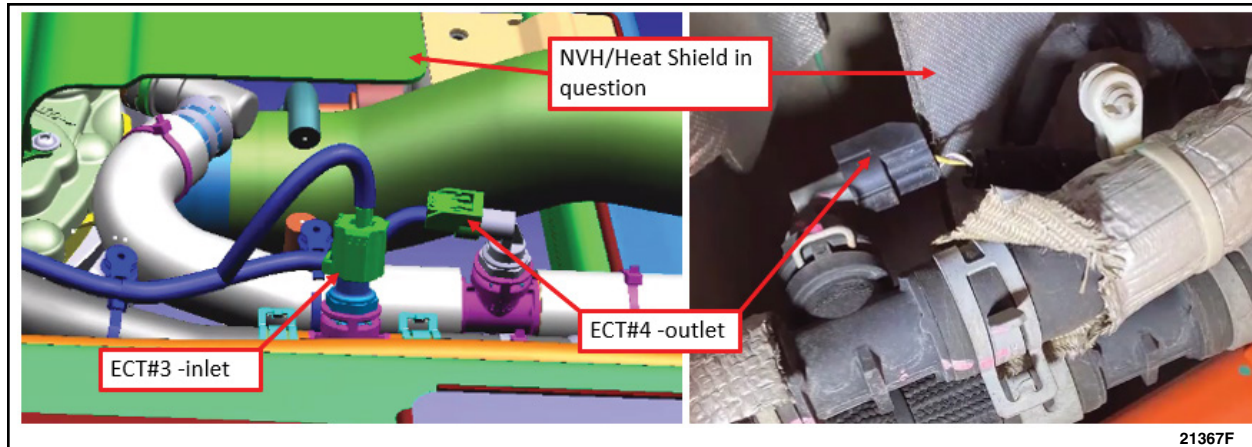
FIGURE 4

4. Inspect the front Engine Coolant Temperature (ECT) sensor connectors for any damage caused by the passenger side insulator. Is there any damage? See Figure 4.

Yes – Does not pass inspection. Contact the SSSC and provide a picture of the damage for proper technical instructions and part numbers, then proceed to step 5.
