TO: Mercedes-Benz Dealer Principals, General Managers, Sales Managers, Service Managers, Parts Managers	FROM: Gregory Gunther, Department Manager, Vehicle Compliance and Analysis, Engineering Services
RE: Recall Campaign Launch Notification Check the Power Steering Supply Connection MY20 CLA-Class (118 platform)	DATE: 12/28/2021

Campaign No. 2021120016,
December 28th, 2021

SUBJECT: **Model CLA-Class (118 platform)**
Model Year 2020

Check the Power Steering Supply Connection

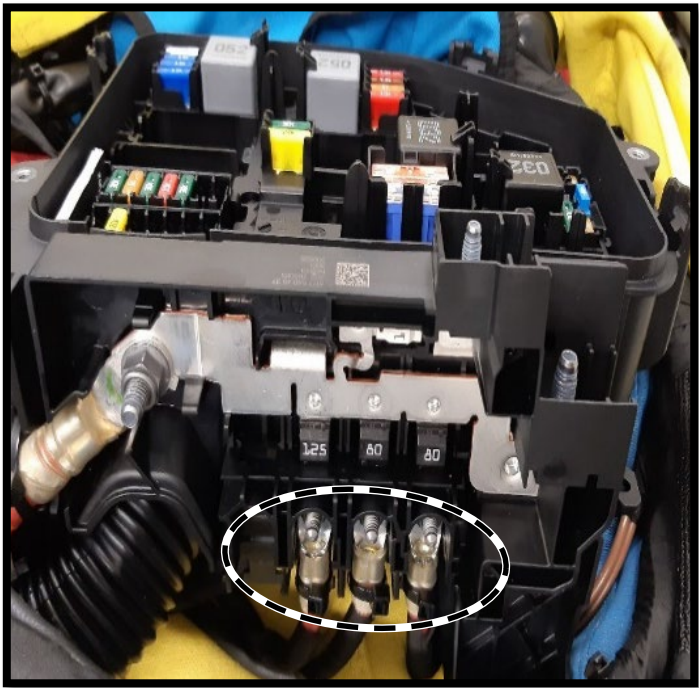
Figure 1

1. Disconnect ground line of battery (**AR54.10-P-0003MFA**).
2. Remove cover from fuse box/prefuse box at front.
i For basic data, see **AR54.15-P-1330MFA**.
3. Remove cable ties and loosen all threaded connections individually in succession on prefuse box (marking, **figure 1**)
i Depending on the equipment variant, there may be more or fewer cables present (marking, **figure 1**).

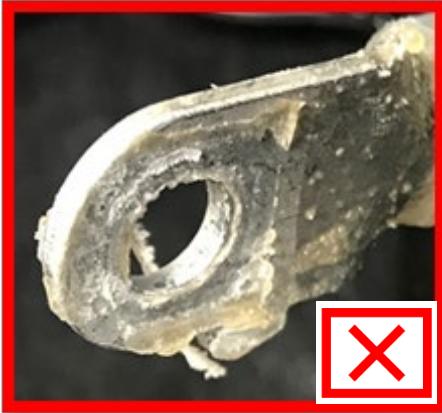
4. Check all cable connection and nuts for residual hot melt adhesive/contamination.
i Figure 2 not OK
i Figure 3 OK

Figure 2 not Ok.

- a. If one or more cable connections is contaminated with adhesive (Figure 2): Carry out **work procedure**.
- b. If **no** contamination is present (Figure 3): **End measure**.

1. Remove contamination using a suitable tool (abrasive paper).
 - i** Ensure that the contact surfaces between the nut/cable connection, and between the prefuse box and cable connection are completely clean and have a flat contact area.
 - i** For basic data, see **AR54.15-P-1330MFA**.
2. Assemble in reverse order.
 - i** All cable lug threaded connections must then be checked for the required torque.

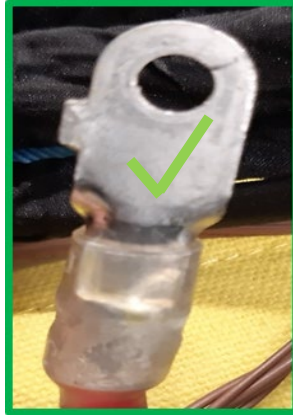
Figure 3 OK
