# Equipment Safety Recall

## N222359640 Tonneau Cover Retention

**Release Date:** April 2022

<b>Condition</b>	General Motors has decided that a defect which relates to motor vehicle safety exists in certain tri-fold tonneau covers that may have been sold as over-the-counter accessories for 2019 – 2022 model year Chevrolet Silverado and GMC Sierra trucks. The tonneau cover may become loose and could detach from the pickup bed while driving. <b>This is an expansion of NHTSA Equipment Recalls 19E066 (N192261860) and 20E024 (N192285070) (Transport Canada 2019-494 and 2020-165).</b> The hard tri-fold tonneau cover's attachment system may not sufficiently secure the tonneau cover to the truck bed rails if the attachment system is damaged or improperly installed. The soft tri-fold may become loose and detach from the vehicle if not correctly installed according to the instructions provided with the vehicle in an owner's manual insert. If the tonneau cover is improperly installed, owners may notice noise coming from the cover, damage to cover attachments, or cover movement against the truck's bed rails. If the tonneau cover detaches from a moving vehicle and falls into a roadway, it may

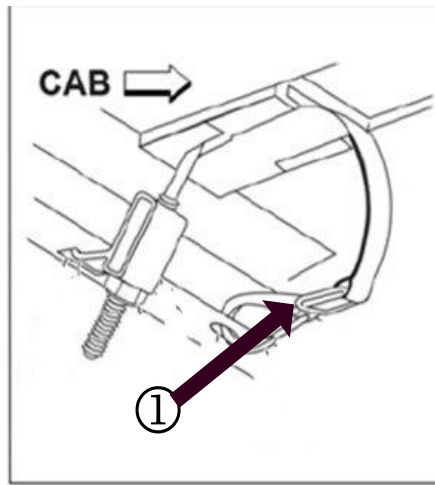
5613815

### Hard Tonneau Cover Tether

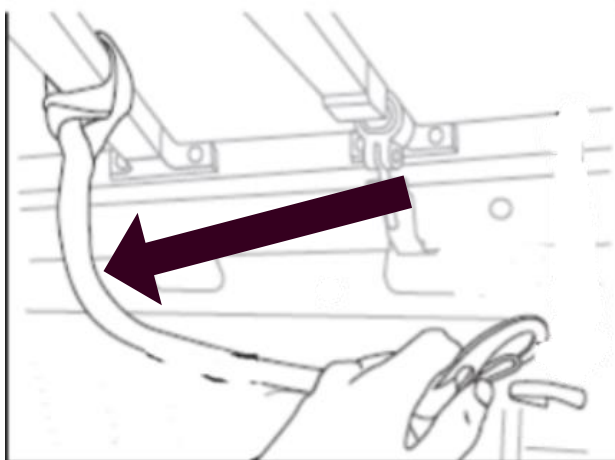
6023461

### Soft Tonneau Cover Tether

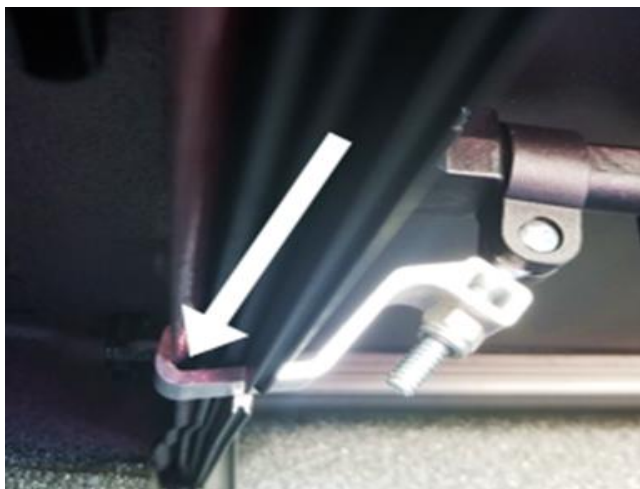
5448624

**Correct installation of bracket clamp hook**

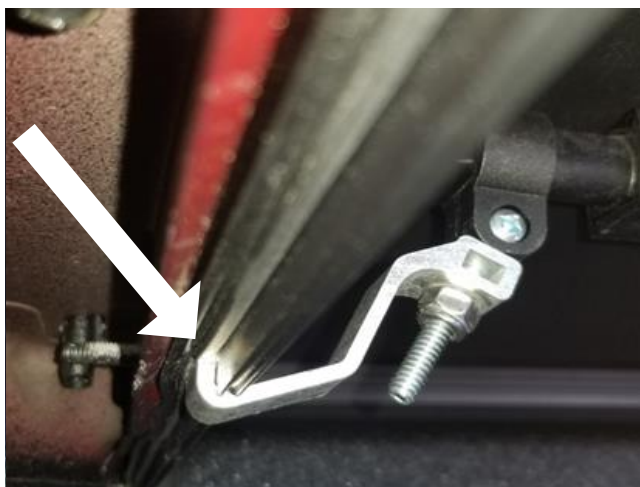
5448625

**Incorrect installation of bracket clamp hook**

9. If any of the above inspections indicate an incorrect clamp hook installation, loosen the nut on the threaded mount and position the clamp hook in the correct position. Hand tighten the fasteners.
10. Position the cover evenly side to side and rest the cab seal smoothly along the front top edge of the cargo bed.
11. Tighten the nuts until the clamp hooks are secure against the bed rail flange. Tighten each side evenly, tighten only until the tonneau cover cannot shift. **DO NOT** overtighten, overtightening may cause damage to the clamping system.
12. Close the tonneau cover and tailgate.

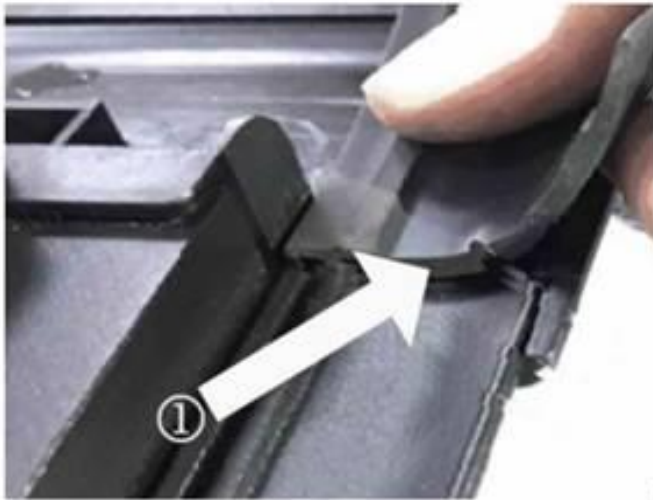
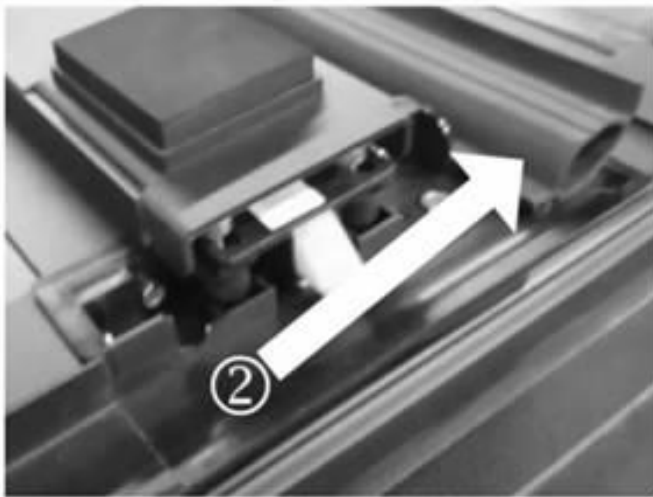
**Important:** Verify the front tonneau cover seal is the revised “fin” style seal (1). If the “bulb” style seal is installed (2), replace the seal. Refer to steps 1-5 of the Adjustment Instructions for Vehicles That Have NOT Had Recall N192217500 performed below.
