# AWNING INSPECTION AND WELD/SEAM REPAIR

Recall Number:	22E-055		
Product:	Awnings		
Date:	Original: July 15, 2022	Labor Rate:	.30 hours inspection only     .30 hours repair only 1.5 hours fabric replacement only
	Current: Sept. 1, 2022

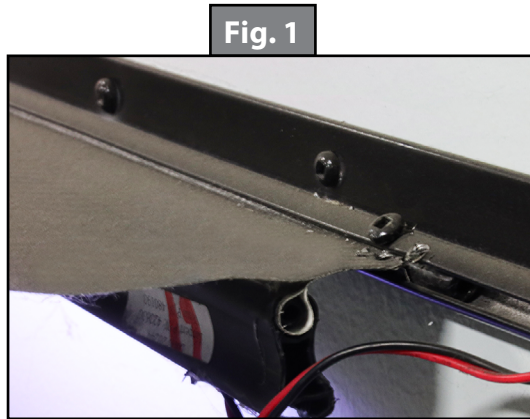
**Fig. 1**

The purpose of this document is to provide guidance, as well as visual aides, to dealers performing inspection on units that may have insufficient awning weld(s). The inspection point is at the awning fabric seam at the awning rail at the wall of the unit (Fig. 1). This only affects awnings manufactured January 17, 2022 – June 14, 2022. The date of manufacture can be located on the variant code label (Fig. 2) located on the awning.

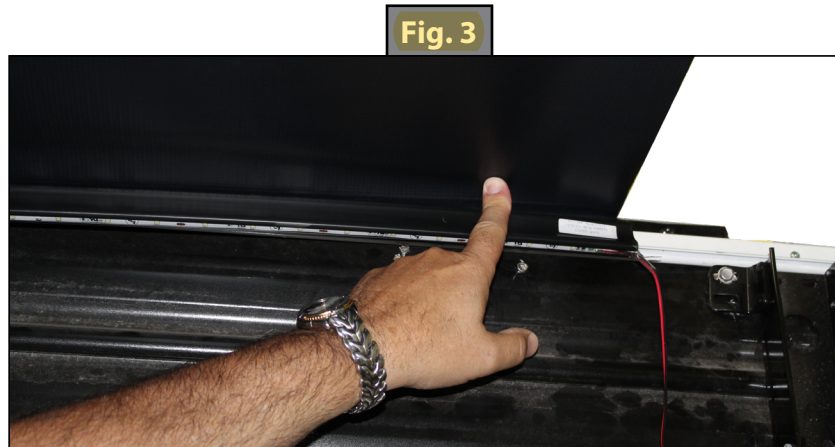
**Fig. 3**

1. Extend the awning.
2. From underneath the awning, about 1" to 1.5" from the fabric edge, push up on the fabric with one finger (Fig. 3) until the awning fabric is flush with the top of the awning rail. Look for any separation or visible daylight at the seam. Perform push test at both ends of the awning.

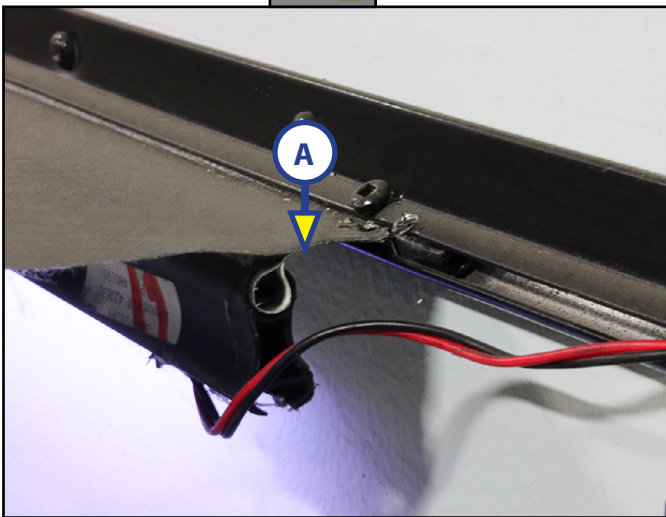
**Fig. 4**

1. Position stepladder next to the unit to view the topside of the awning at the unit wall from either end (drive/idler side).
2. Inspect the weld near the awning rail (Fig. 4A).
  - A. Fig. 4 shows no separation at the seam. It does not require repair or replacement.
  - B. Fig. 5 shows separation at the seam (Fig. 5A).
    - I. If the separation is less than 6 inches, repair can be accomplished using the procedure described in [TI-434](#).
    - II. If the separation is over 6 inches it will require awning fabric replacement using the procedure described in [TI-166](#).
