UNOFFICIAL DETAILS

Re: Inspection / Remedy for Pre-Delivery Trucks Prior to Recall Launch 22V-025

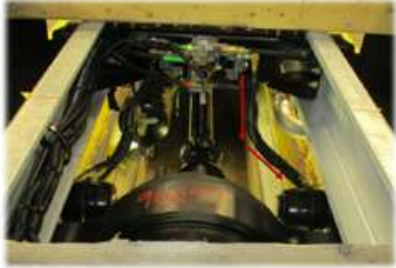
Air Brake Hose Is Exposed To Potential Damage

Meritor **did not dispute customer's safety determination** when the vehicle air hose routing is vulnerable to substantial pressure loss due to impact damage caused by the driveline and yoke assembly separation event.

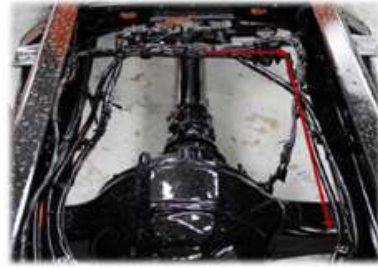
**Air Brake Hose Is Not Exposed To Potential Damage**

If the vehicle has an air brake hose routing that is not vulnerable to impact damage or substantial air pressure loss caused by the driveline and yoke assembly separation event, Meritor's position is that **this does not create a safety concern**. Based on Meritor analysis, this event does not occur at elevated speeds and does not impact vehicle handling, directional control, and the ability to stop the vehicle.
