HYUNDAI
Technical Service Bulletin

GROUP RECALL	NUMBER 22-01-029H-1
DATE APRIL, 2022	MODEL(S) SANTA FE SPORT (AN)

SUBJECT: ABS MODULE MULTI-FUSE INSTALLATION
 (RECALL 218)

THIS TSB SUPERSEDES 22-01-029H TO UPDATE THE PARTS KIT PART NUMBER TO 91KIT-4Z000QQH.

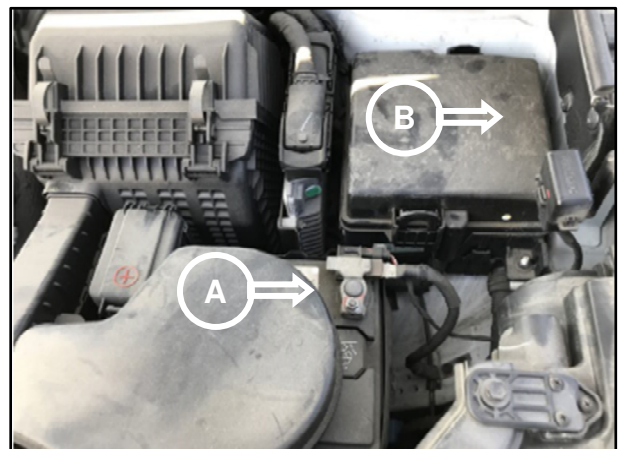
1. If applicable, record the customer’s radio preset stations and turn the ignition switch OFF.
2. Disconnect the battery negative (-) terminal (A) and remove the junction box upper cover (B).

Battery (-) Terminal Nut Tightening Torque:
4.0~6.0 N.m (0.4~0.6 kgf.m, 3.0~4.4 lb-ft)

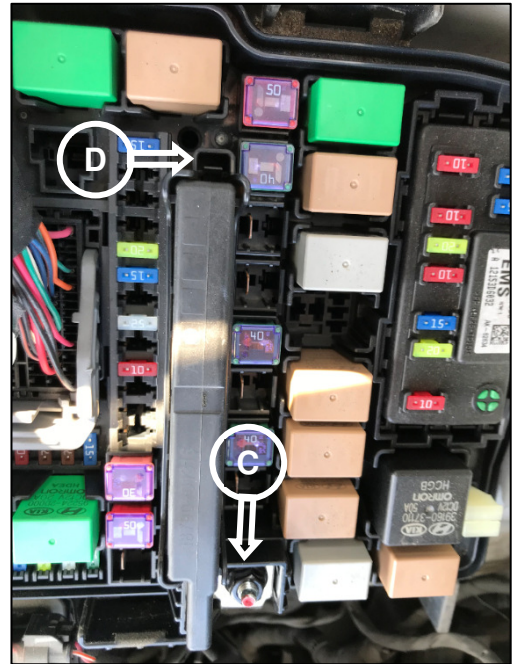
3. Remove the 10 mm nut (C) and lift the cable over the stud. Release the locking tab (D) and remove the multi-fuse.

Do not re-use the multi-fuse. A new multi-fuse and upper cover from the service kit must be installed.

4. Install the new multi-fuse, placing the junction cable over the multi-fuse mounting tab, and the retaining washer on top. Torque to specification.

9.8~11.7 Nm (1.0~1.2 kgf.m, 7.2~8.7 lb-ft)
